Independent Advisory Panel to IDB Invest
IAP Report N° 1, September 2018

Ituango Hydropower Project
Colombia

The emergency-originating event was a collapse of the tunnel with a sinkhole that obstructed the river diversion tunnel (GAD). The collapse was caused by the interaction of water with the rock mass. It is most likely that local unevenness of the lining, due to the rock mass structure and, possibly, very weak rock in the area over the tunnel, which went undetected during excavation, may have favored rapid propagation of localized erosion and, consequently, progressive failure. The subsequent mass movements, that took place in different parts of the waterways, were a consequence of the uncontrolled flow of water through interconnected galleries, some of which were never intended for conducting water.

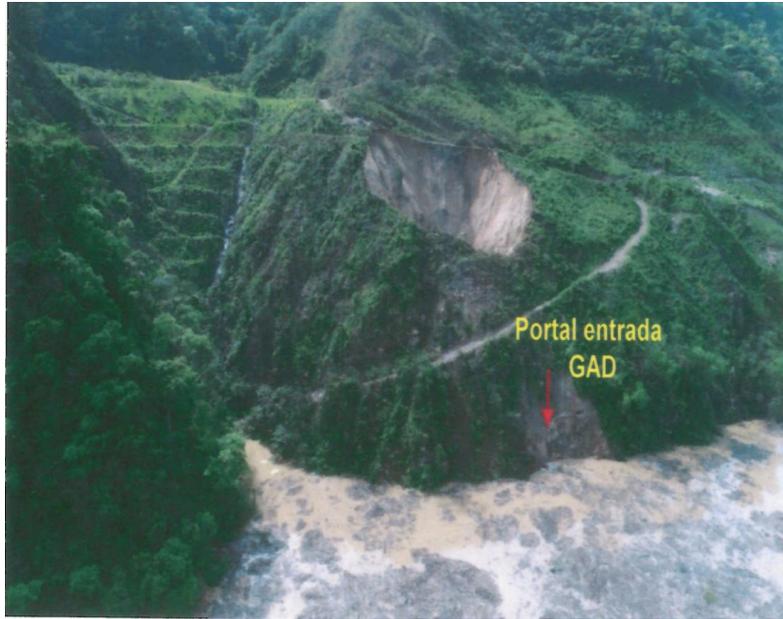
Figure No. 1: 30 April 2018. The sinkhole from the chimney collapse in front of the portal area of GAD (Photo from the files of the project)

The zone where the collapse and the sinkhole occurred (figure No.1) consists of slightly to weathered gneiss, moderately to highly jointed, with some shears and sub horizontal foliation (type IIB in figure No.2). No weak ground was present at the alignment (IC, IIA soil-rock transition zone).

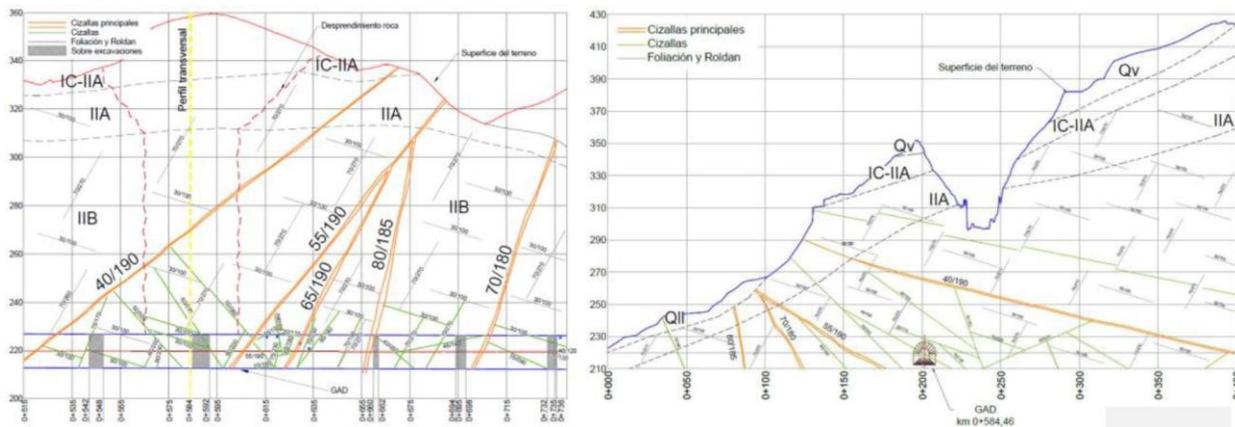
Figure No.2: Longitudinal and transversal section of GAD at the area of the collapse. From construction data (from “Analysis de taponamiento Galeria Auxiliar de Desviación”, May 2018)

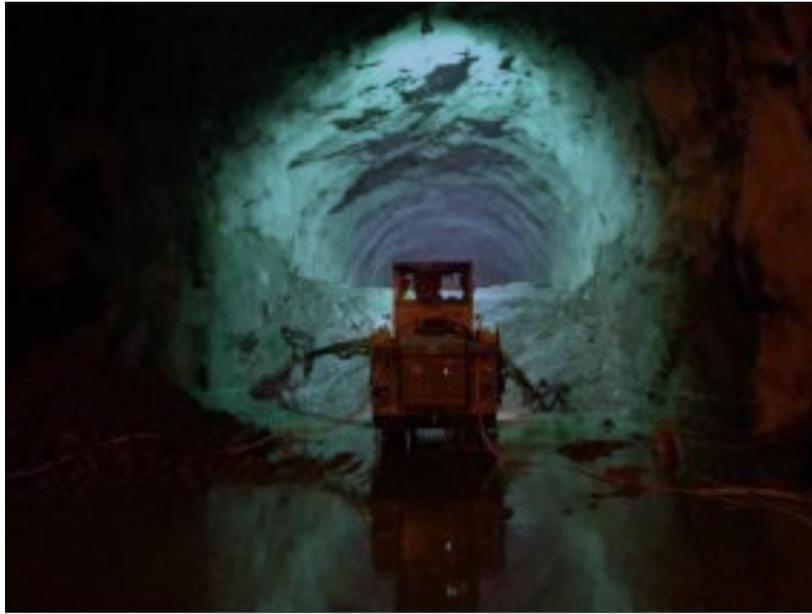
GAD was constructed by drill and blast and the applied support followed the “Q” method’s recommendations: 2 layers of 5 cm each of fiber shotcrete, and rock bolts of 6m length with a spacing of 1,5m and 2m in the vault or the sides of the tunnel (type III support). In some points, important over break was treated to re-establish, as much as possible, the design section (see Figures No.3 and No.4).

Figure No.3: Top heading and bench during construction of GAD. Small overbreaks present (photo from the report of the Board of Advisors #12, February 2017)

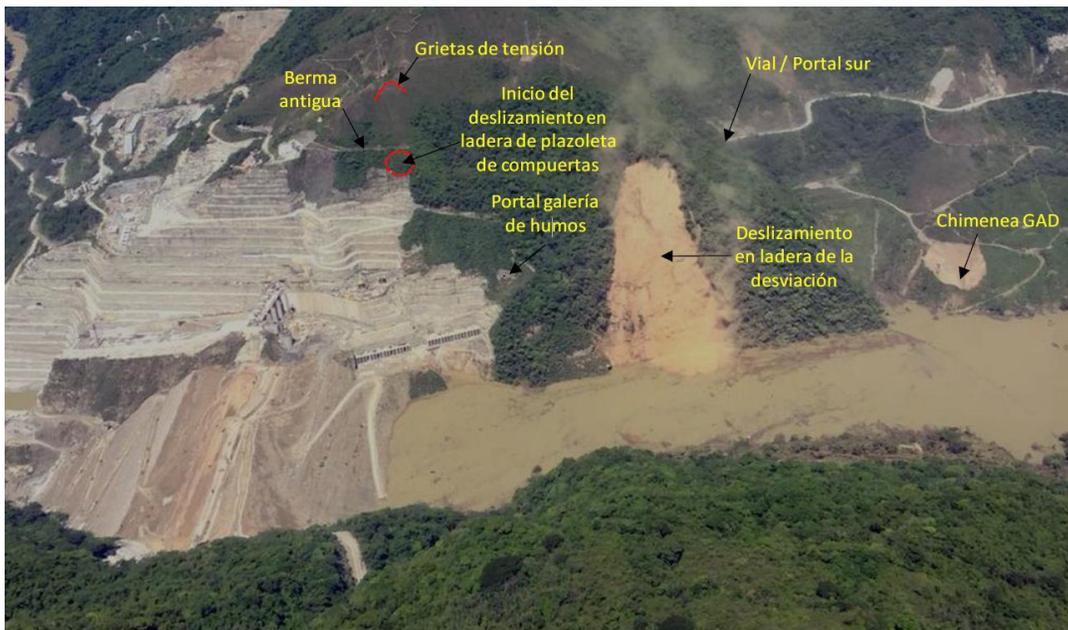
The flow likely triggered pulsating pressures and probably penetrated trough the joints inside the rock mass and destabilized wedges. The roughness of the periphery of the tunnel and anomalies from over breaks, can indeed, induce sub- pressures. After the first smaller collapse on April 28th, the main one on April 30th was an unavoidable development in an already disturbed zone. The presence of a possibly thick distressed zone over the tunnel, possibly associated with a particularly weak rock zone at this location could be an unforeseen factor and the reason of the propagation of the sink hole to the ground surface. Figure No. 5 shows the localization of the events on the right side of the project. The slide over the intake shafts of May 26, 2018 had not yet developed, but cracks are already present in that zone.

Figure No.5: Photo from a ppt of Prof. G. Fernandez, June 2018

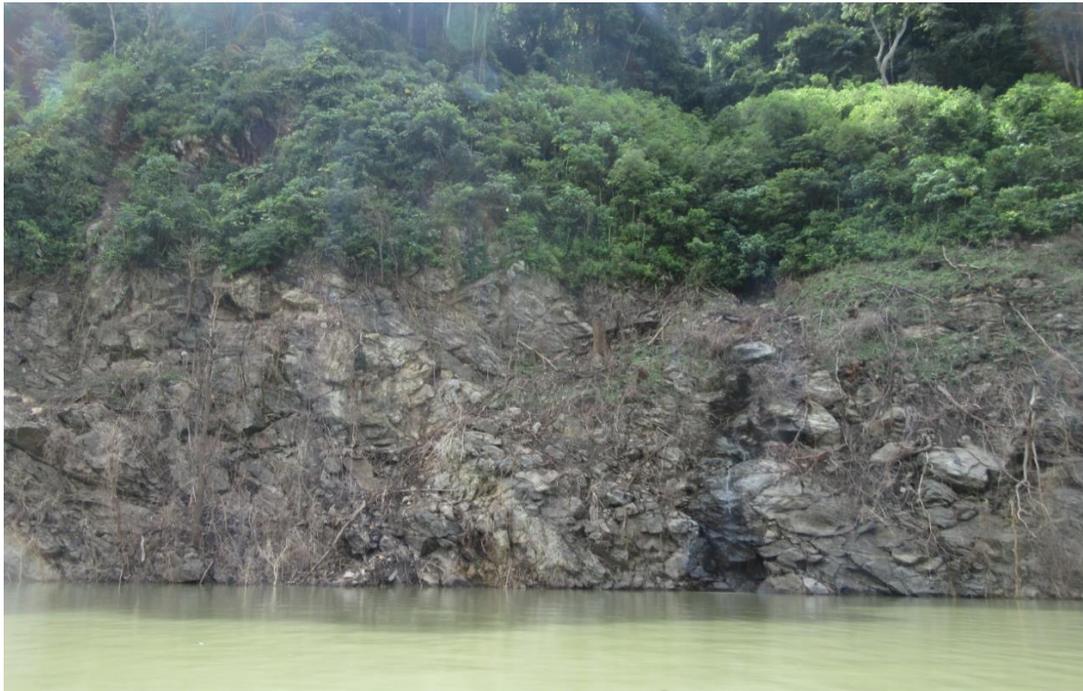
Figure No.6: Distressed gneissic mass, heavily fractured. Photo on the 2nd of August 2018

This weak distressed zone demands treatment or removal in important foundations, construction cuts, and slopes over intakes. These zones may host perched aquifers. The following pictures (No.6, 7, and 8) provide examples of distressed rock zones.

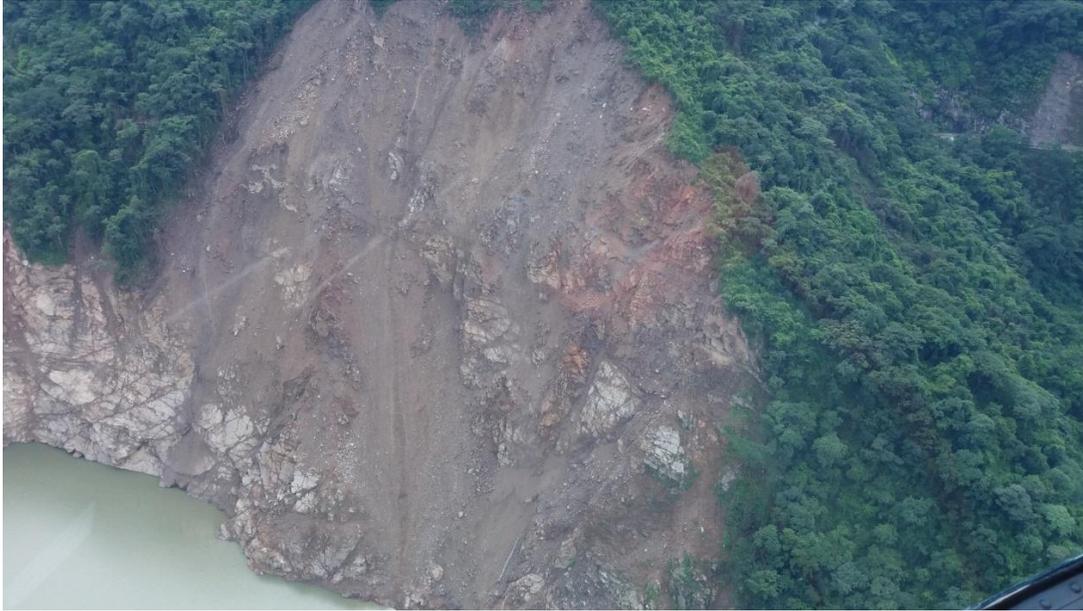
Figure No.7: Distressed rock mass and weathered zone. Landslide over the 2 diversion tunnels area. Photo on the 3rd August from the helicopter.

The IAP recommends extending the same treatment and protection upstream of the spillway slopes, as far as the intake of the Intermediate Discharge Gallery and the destabilized area over the two diversion tunnels.

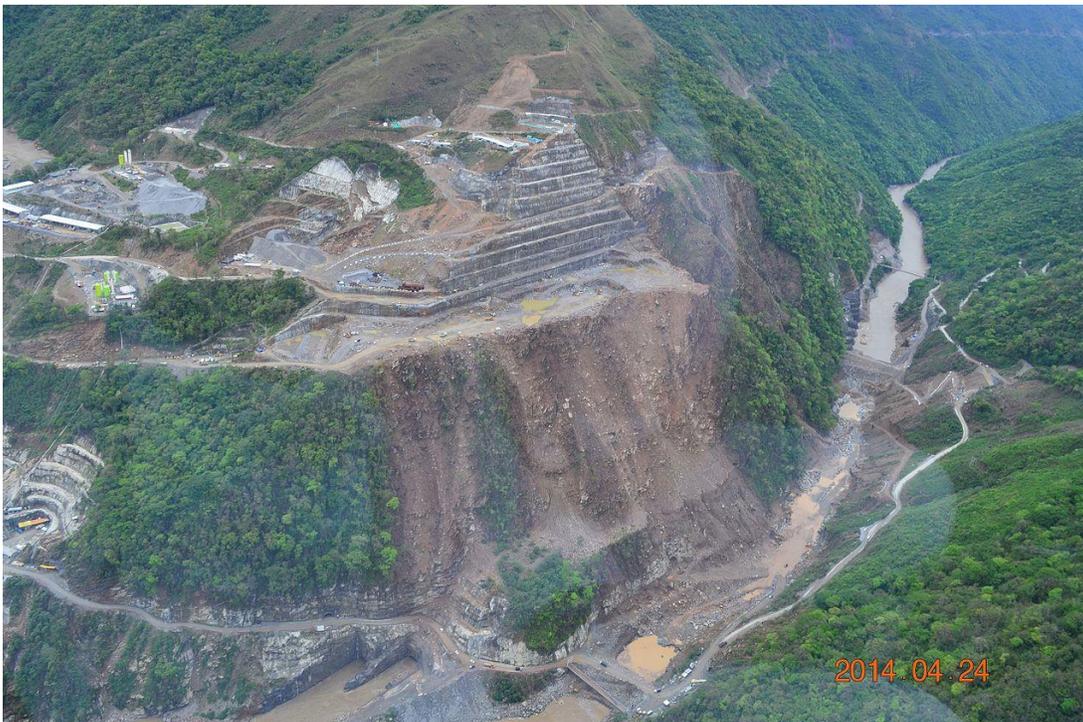
Figure No.8 The site of the project at the beginning of the construction, 2014. Skin slide on steep slope, behind the spillway cuts. In this area instability events occurred in spring 2018. Photo from Google.

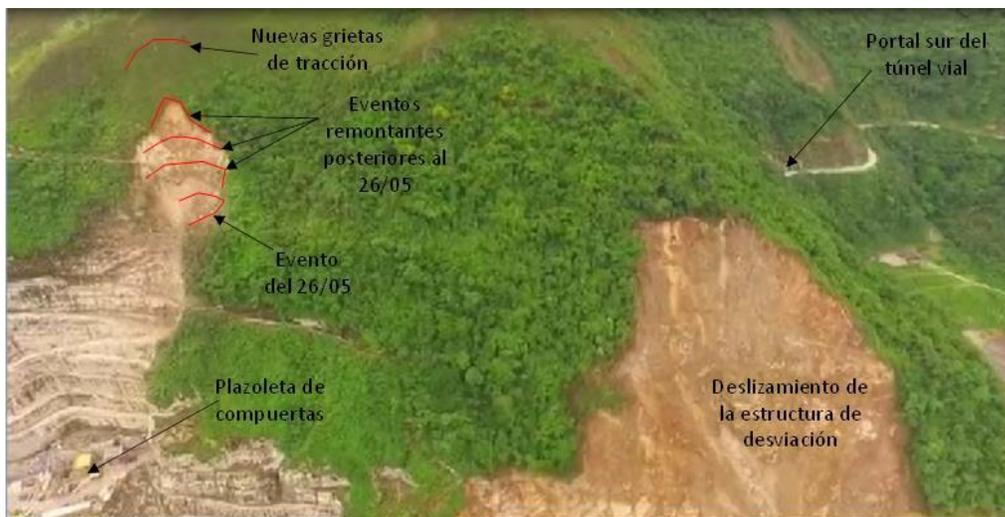
The upstream extension of the slope protection measures is also necessary to safeguard the intake to the powerhouse ("El Romerito" zone) as well as the intake of the scheduled new Intermediate Discharge Gallery. Parts of these slopes are already in a metastable condition and are evolving retrogressively. The slide that occurred on May 26th, over the intake gates is a case in point.

Figure No.12: "El Romerito" landslide. Photo 28/05/2018 (from ppt Prof. G. Fernandez, June 2018)

The protection works should aim to remove as much as possible of the distressed zone and proceed by benching. Cable anchoring could be used mainly at the lower part, as appropriate. Fortunately, the morphology of the slope is terminating soon uphill where geomorphology exhibits a concavity that can be probably associated to an old landslide (see Figures No. 12 and 13).

A catch water drain is an essential measure to limit surface water access to the slopes. Monitoring should be extended in the area, as for other slopes around the dam.

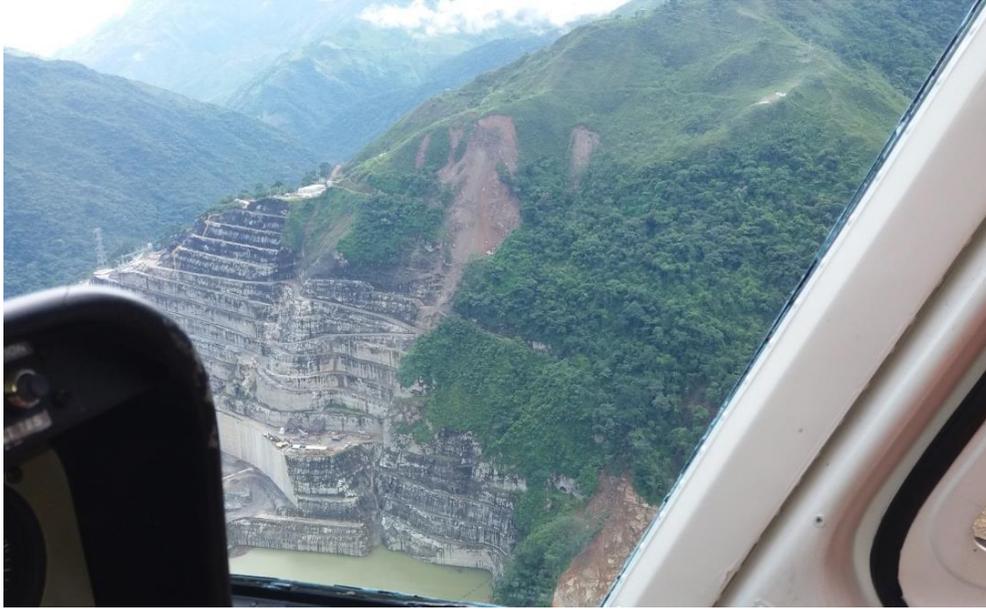
Figure No.13: The landslide over the intake structure is developed on the 26th of May. A concave form of the terrain uphill may denote the presence of an old slide (photo from helicopter August 3,2018)

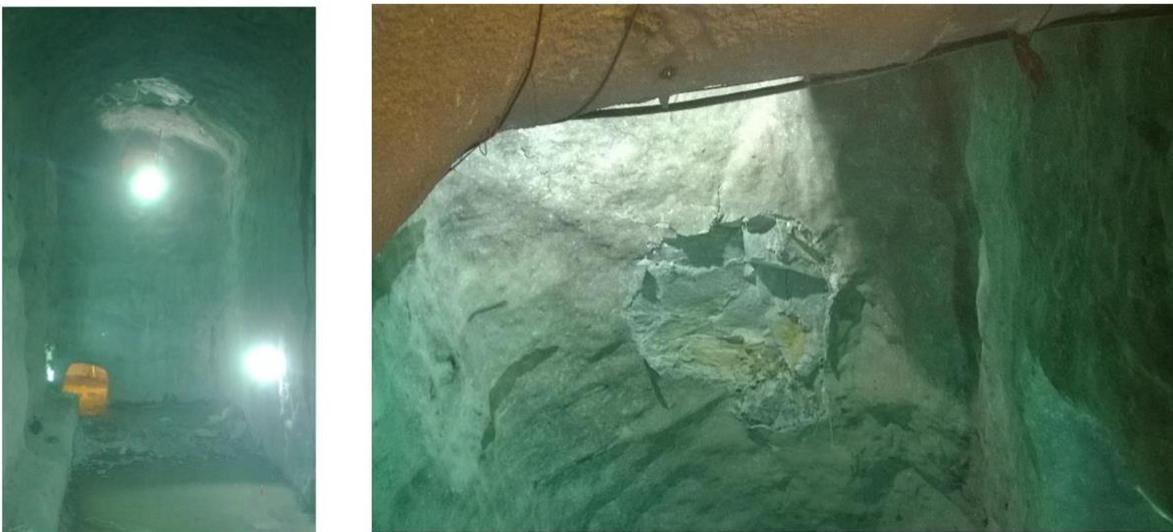
Cavern excavation encountered only wedge failure, sometime significant, from the cavern roof, which required strengthening of reinforcement (Figure No.15).

Figure No.15: Desprendiment bòveda Casa de Maquinas – Costado norte

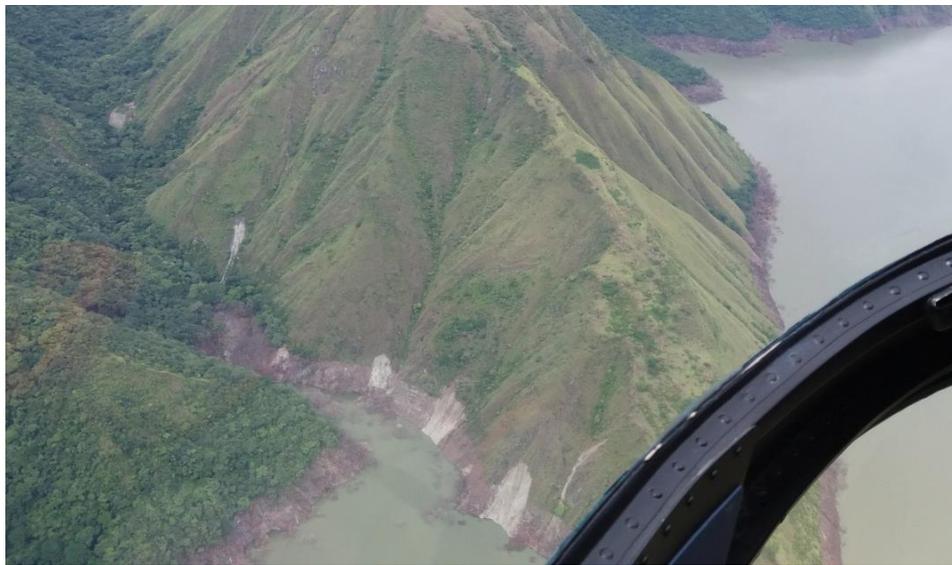
Such mass movements are not deemed to generate dangerous impact waves, but rather slowly contributing to reservoir silting.

Figure No.19: Small landslides at the margin of the reservoir.

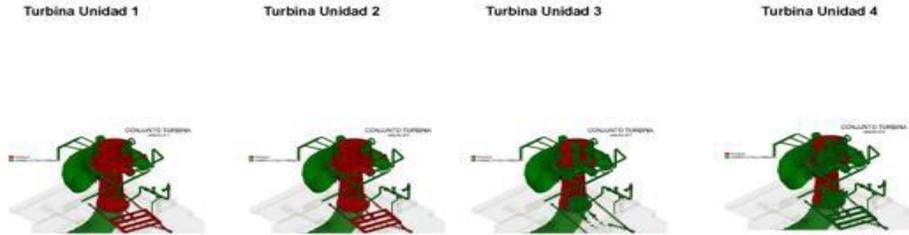
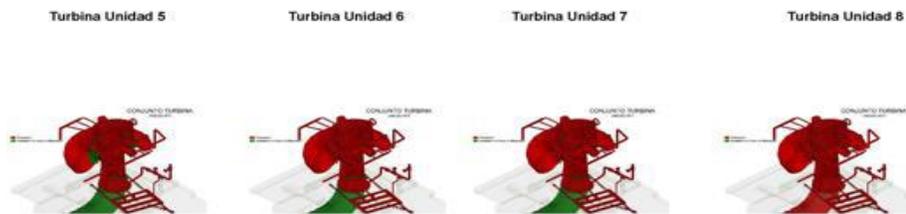
Figure No.22: Progress of installation of Turbines in the powerhouse

Installation of the north side turbines was well advanced, especially Unit 3 and Unit 4 that were to be commissioned first. On the south side (units from 5 to 8) only three draft tube had been installed.

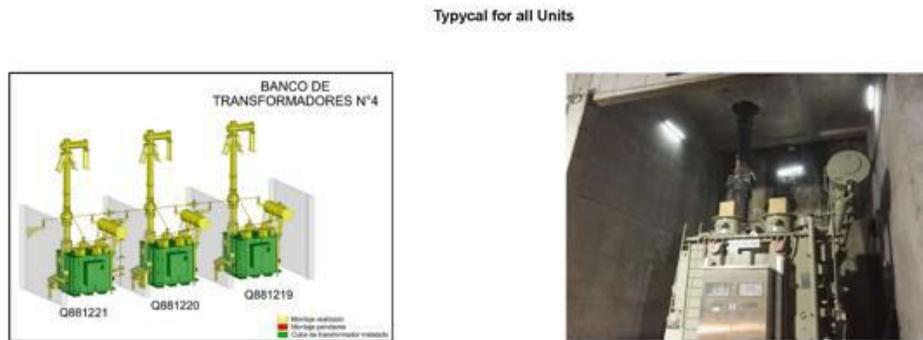
Figure No.24: Progress of installation of Transformers

Two single-phase transformers of the south powerhouse were in similar conditions, 4 were in transport condition (with nitrogen) while 6 are currently in standby in a Colombian port.

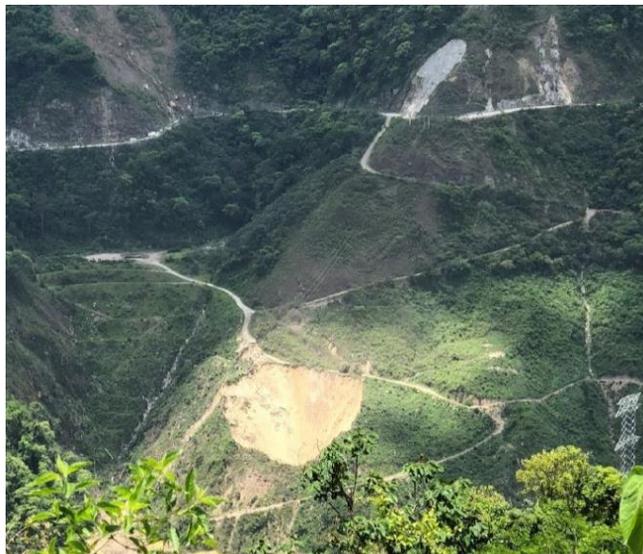
On April 30th at 14:30, a new decrease in the flow through the GAD occurred, and a sinkhole (with a diameter of approximately 12 m at its narrowest bottom, and up to 100 m at the outer rim) appeared at the surface of the mountain immediately over the tunnel (see Picture No.1). About 220,000 m³ of soil and rock definitely blocked the GAD.

Picture No.1: Sinkhole above the ADT

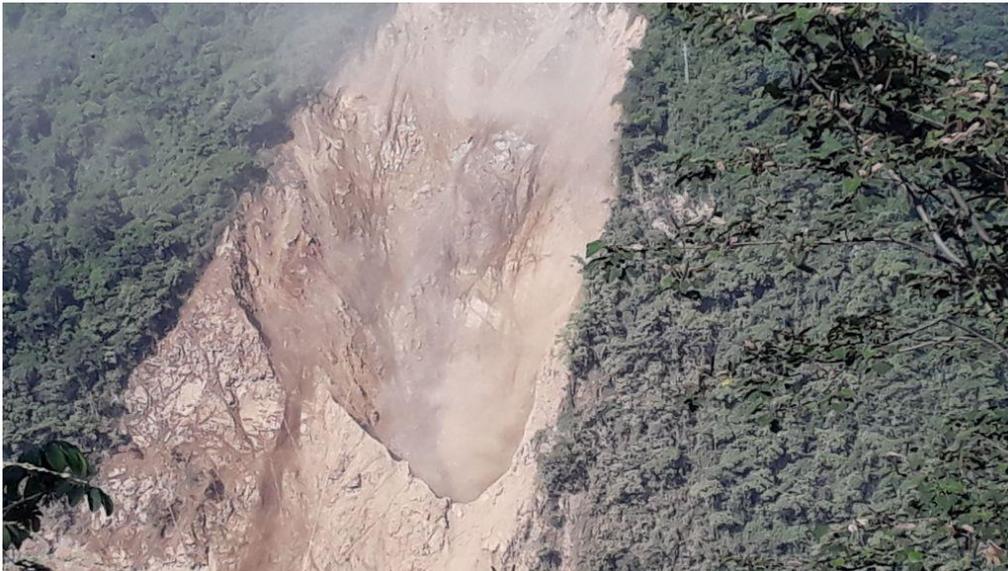
With the continuous increase of the water level, some fines and rocks were washed out and once again, the water flowed shortly through the right diversion tunnel, until a new sinkhole formed above it, stopping the water flow again (see Picture 2).

Picture No.2: Landslide and sinkhole at the diversion tunnel portals
