**Independent Advisory Panel to IDB Invest
IAP Report N° 2, April 2019**

**Ituango Hydropower Project
Colombia**

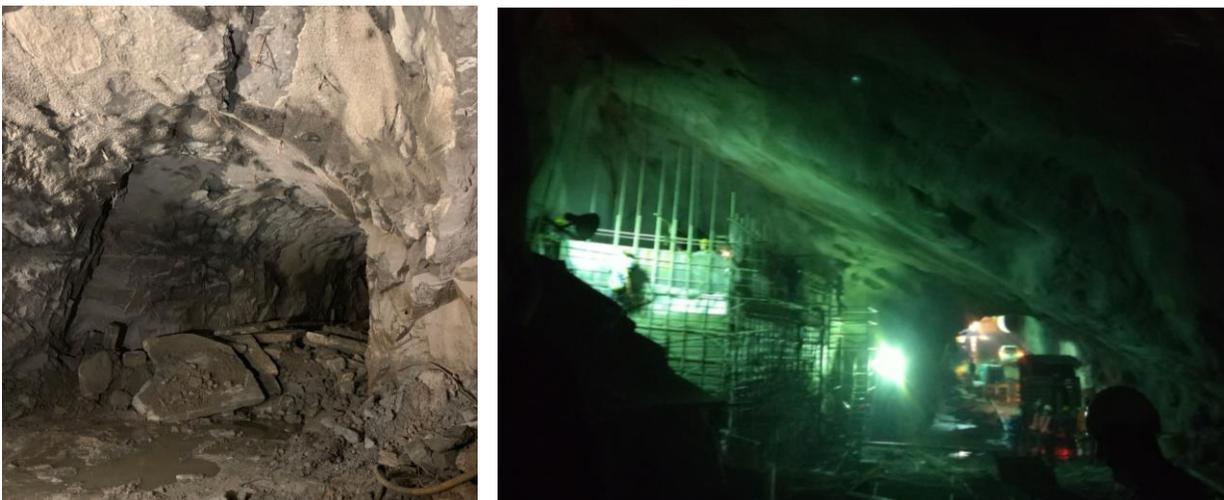
During the protracted emergency discharge period, water flow must have triggered pulsating pressures and probably penetrated through the joints inside the rock mass and destabilized wedges. The roughness of the shotcreted tunnel walls and the anomalies due to even small over breaks, could indeed, induce sub-pressures. In most of the tunnels visited, such mechanism caused the fall of roof slabs and wedges limited by rock-mass' discontinuities. The tunnels where such failures occurred can be rather easily restored.

Figure No.2: Erosion and failure mechanisms - Wedges and slabs collapsed from tunnels' roof

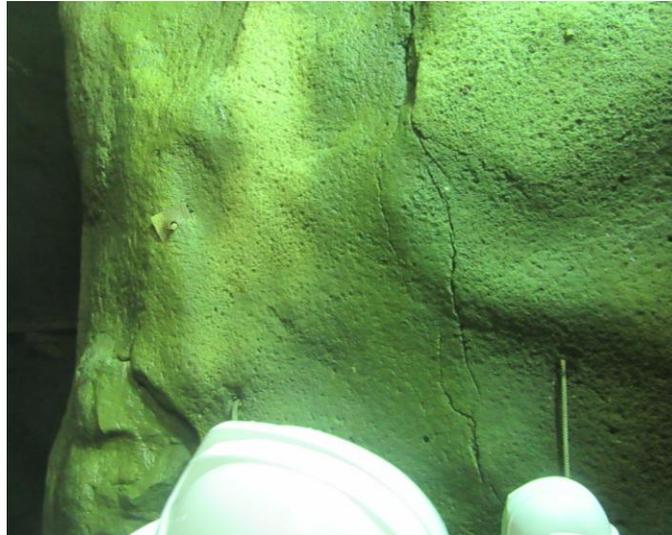
Sharp corners or junctions of differently oriented underground openings are typical areas of stress concentration. Such overstressed areas are in the corner of the access tunnel, where it meets the machine hall cavern, as evidenced by a number of fissures that form unstable portions of the rock mass. They can be treated by reinforcement or concrete support. A collapse, most likely due to this failure mechanism occurred on March 5th, during IAP visit at the cavern area, at the junction of the air shaft and the surge gallery (“almenaras”).

Figure No.3: Fissures in the corner of the access tunnel at the entrance to the power house cavern.

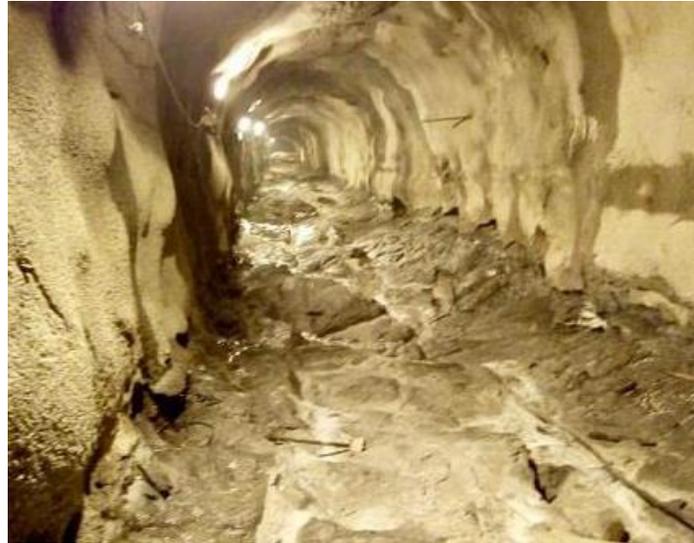
Total destruction of the invert has been observed in several stretches along the emergency waterways. That may be attributed to either washing out of the floor material, or to crumpling of a light invert, which was probably not connected with the tunnel lining. Erosion may have progressed, from the floor, undermining the tunnel’s walls. If an invert was present and affected, a new one should be reconstructed and structurally connected to the tunnel’s lining to form a continuous shell.

Figure No.4: An eroded and destroyed tunnel invert

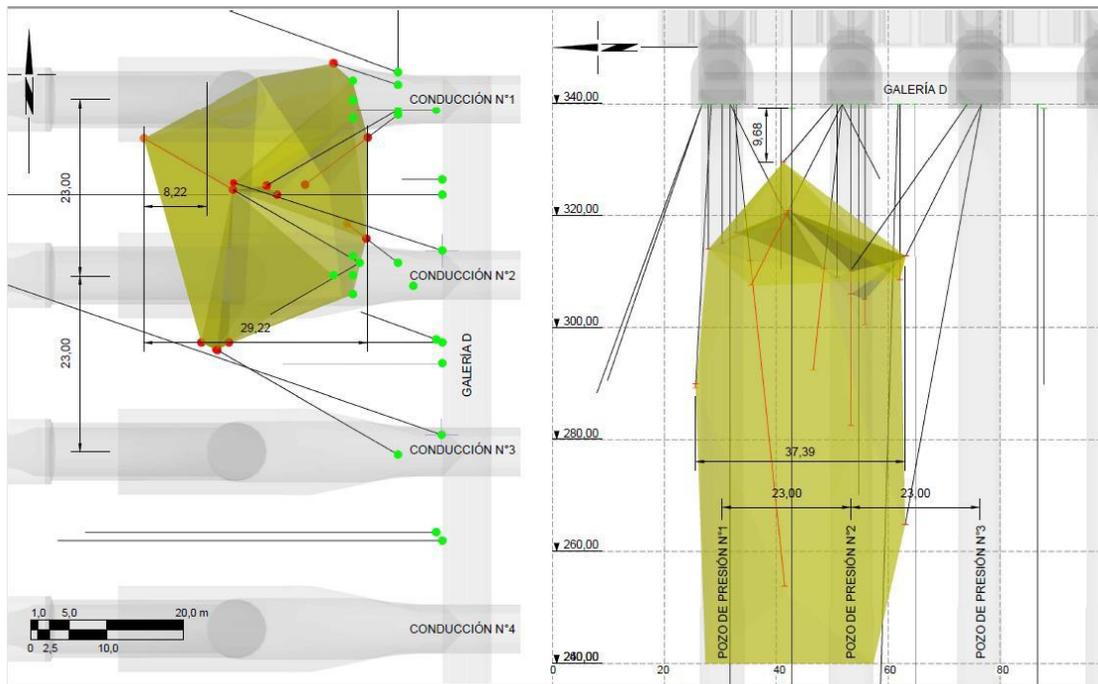
The more severe damages that have been identified to date are in the inlet shafts (see Figure. No.5). Exploratory boreholes revealed that shafts 1 and 2 are severely affected. Sidewall's collapses have caused large voids and certainly created a loose and unstable rock mass at their boundaries. A reconstruction is obviously necessary. Backfilling and grouting to consolidate the surrounding ground should precede shaft reconstruction. Adequate rock reinforcement should be installed as the shafts are sunk. A self-standing steel lining is going to be necessary because no rock mass collaboration can be counted on in withstanding internal pressure during plant operation.

Figure No.5: Reconstruction of the cavity in the area of shafts 1 and 2 (from Integral report, March 2019)

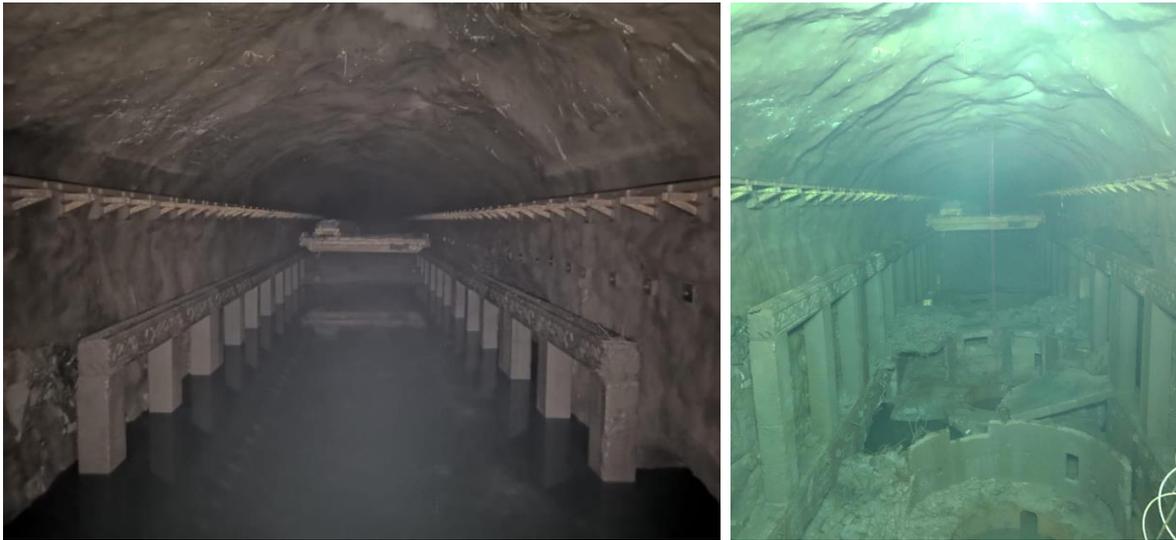
No major general collapses were observed in the cavern complex constituted by the machine hall and the transformers cavern. The surge chambers (“almenaras”) deserve separate consideration in the following paragraph. The power house’s cavern seems to have kept its geometry and no irremediable damages are evident. At the same time there may be parts in metastable conditions that need treatment. A detailed inspection is planned to define the reinforcement measures required to ensure short term safety and long-term stability of this vital part of the Project. A remote survey for the caverns with LiDar is recommended as a first step of the inspection.

Figure No.6: The cavern of the Power House; in February 2019 (left) and March 2019. The fundamental geometry is conserved.

New convergence readings and those of other monitoring devices will provide fundamental data for revising the cavern’s stability analysis. Stability appraisal and detailed inspection of the cavity will permit to decide appropriate remedial measures, which could include:

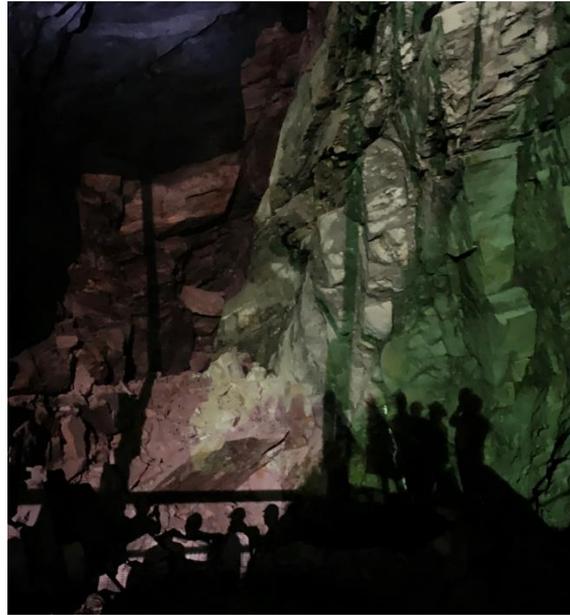
An area of expected massive instabilities is that of the surge chambers (“almenaras”). The limited access revealed extensive failure on the northernmost limit of the “almenara norte” with clear connection to the PH cavern. Most likely, the raging waters found its way to the tailrace through the almenara norte. This resulted in the local collapse of the 30 m wide rock pillar separating PH and surge chamber. Reconstruction will require detailed design and careful mining techniques. Although the current access limitations do not allow full appreciation of the volume involved, it is expected that rehabilitation measures will be of

comparable complexity to those of the pressure shafts 1 and 2. The following figures show the collapse, as visible from “*galería de construcción superior norte*”, and a cross section of the underground openings.

Figure No.7: Extensive collapse on the almenara norte with direct connection to the PH cavern

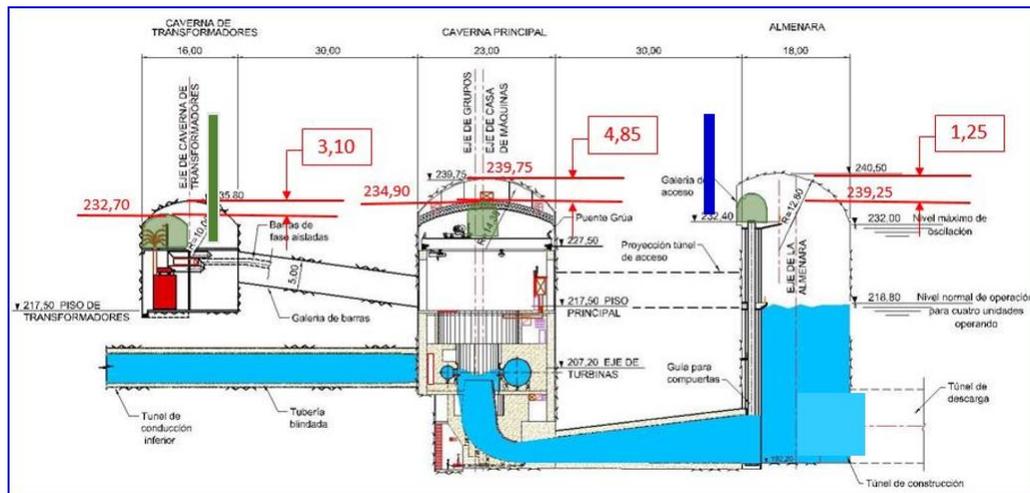
Figure No.8: 30m wide rock pillar separating PH cavern and almenara norte, which has been removed, on the north side, by the raging waters.

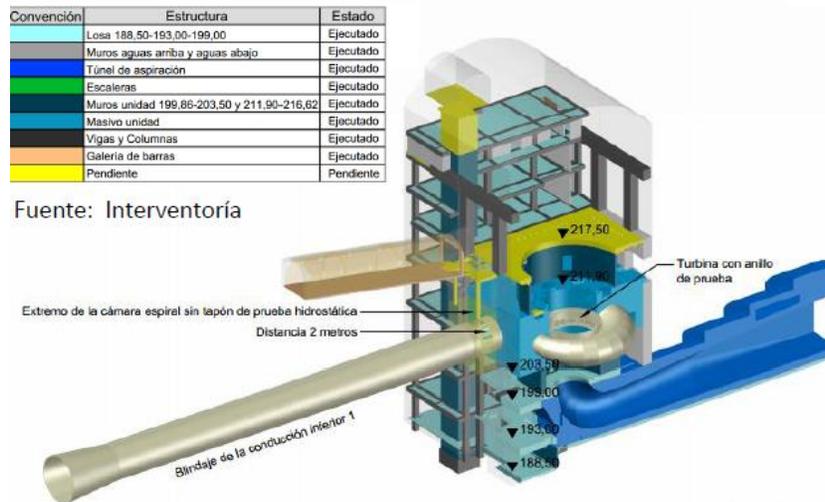
Estado de la unidad 1 al momento de inundar CM

Unit 2 is in bad conditions and Unit 1 is the most affected. Situation of the draft tubes are little known, and their situation should depend on the length of time the flow of water needed to find an alternative way to flow through the tailrace tunnel.

Figure No.10: Progress in the installation of unit 1 at the time of flooding

The need of replacing the draft tube(s) may have consequence on the schedule as detailed in the relevant paragraph.

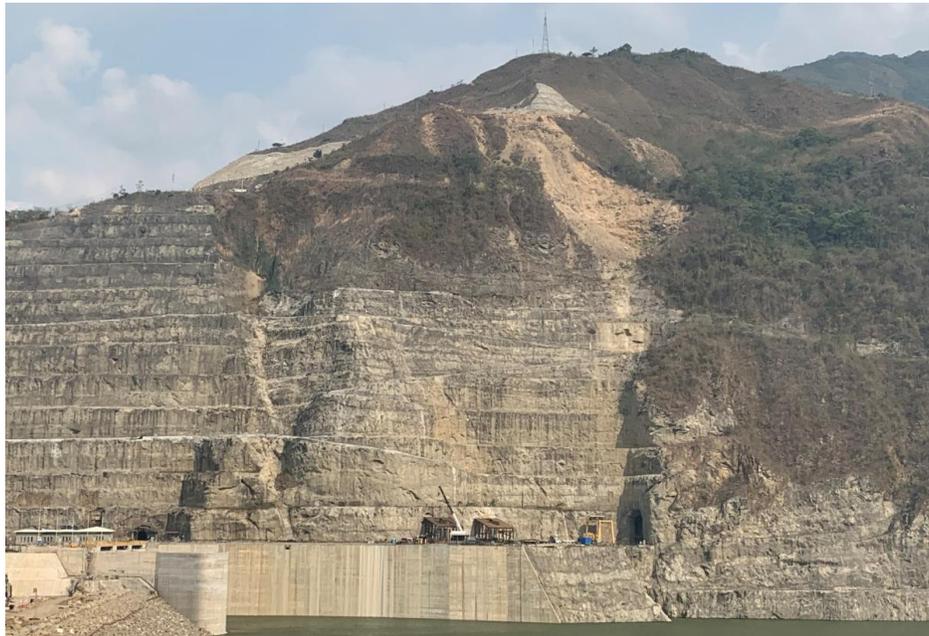
The IAP recommended the protection works should aim at removing as much as possible of the distressed zone and proceed by benching. Cable anchoring to be used as appropriate. Fortunately, the morphology of the slope flattens soon uphill where a concavity, probably associated to an old landslide, is present.

Figure No.12: The slope over the intake structures and the treatment works initiated uphill.

The uphill extension of the slope protection measures is necessary to safeguard the intake to the powerhouse (“El Romerito” zone) as well as the intake of the Intermediate Discharge Gallery.

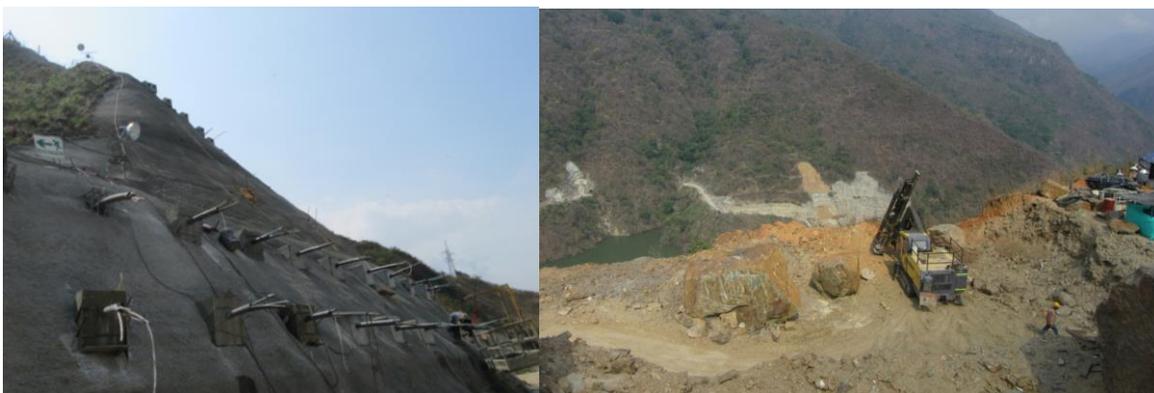
During this mission the panel visited the works in progress in the higher part of the slope, which feature reprofiling with benches and stabilizing by anchors the “El Romerito” landslide; surface drainage and perforated drains are foreseen. Both design and implementation are considered satisfactory. This treatment will also contribute to the stability of the extended slope re-profiling recommended by the IAP.

Figure No.13: The upper part of the “El Romerito” landslide under treatment with shotcrete and anchors. Benching down in the right photo.

The IAP understands that the design of the recommended extension of the stabilization works is being developed.

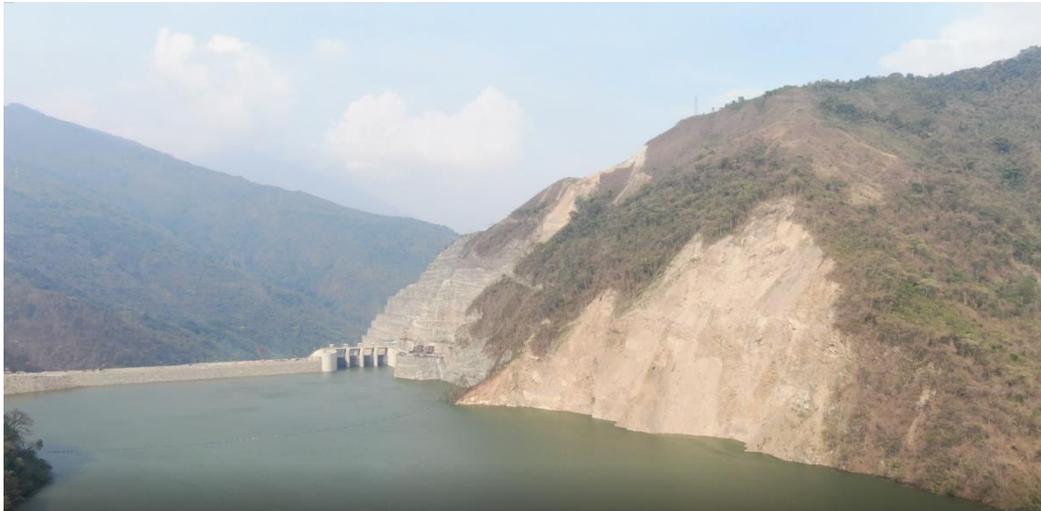
Figure No.14: The destabilized area above the two diversion tunnels. In the far upper end the shape of the “El Romerito” landslide

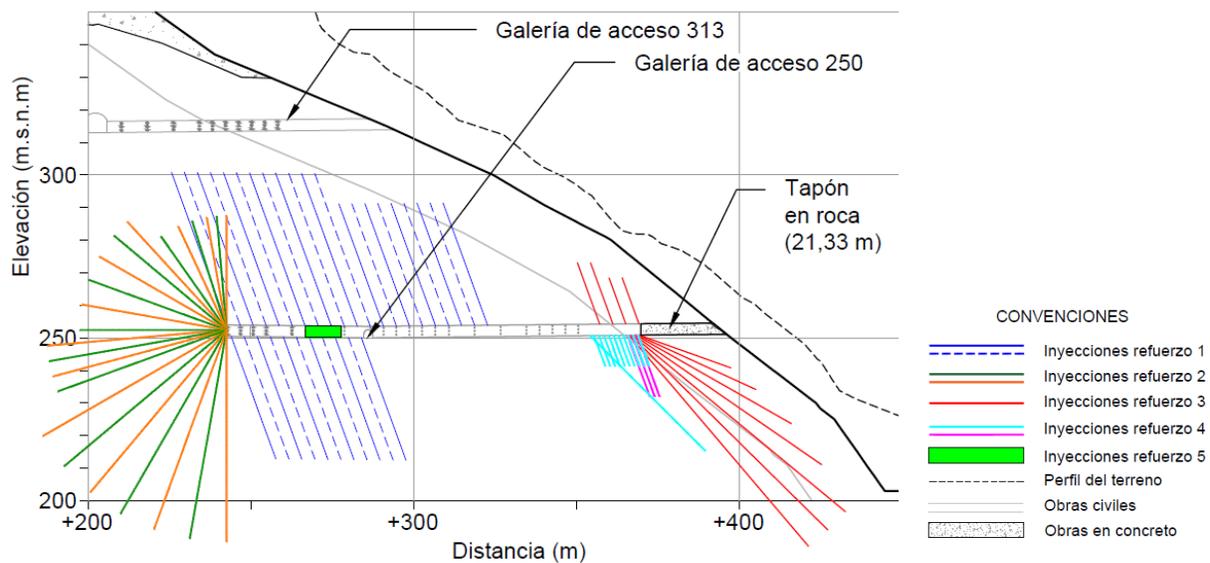
The need of additional grouting works in the left bank was discussed in the IAP's report of September 2018. The origin of such seepage is the left drainage gallery at level +250, where initial curtain grouting holes were not oriented to intercept sub vertical joints. In this abutment total seepage reached 80 l/s. Although not excessive, remedial measures were identified, and additional grouting executed. However overall seepage is today not substantially changed. Currently is reported of about 50 l/s and follows fair well reservoir levels. Additional multidirectional grouting is recommended. All seepage water is reported clean.

Figure No.16: Additional grouting in the left abutment (From Integral 2019)

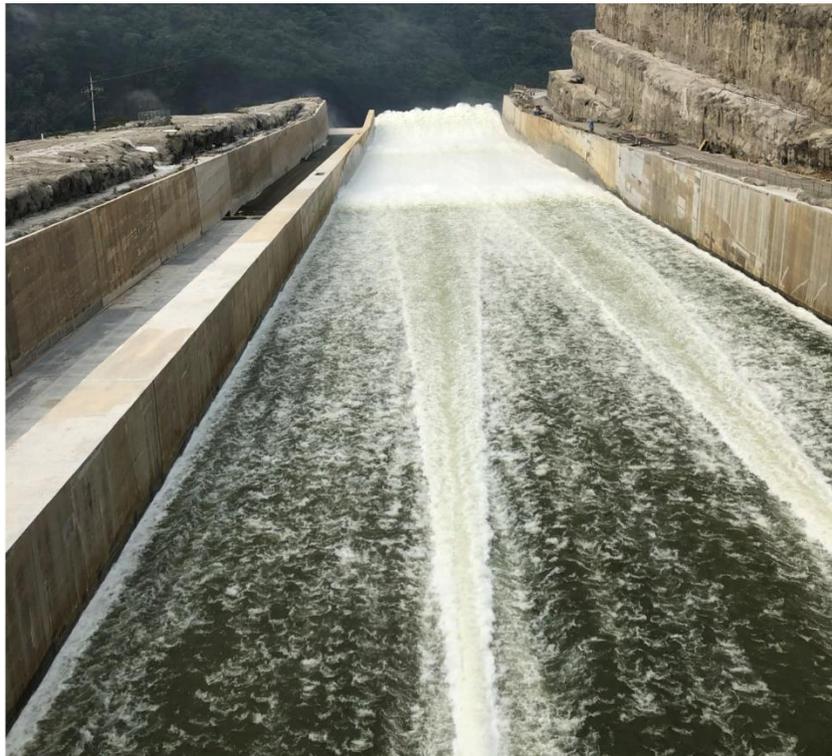
During the March visit, the spillway was discharging 650 m³/s and the flow pattern was according to design. The two aeration lines were providing the required air entrainment (see figure below).

Figure No.17: Spillway in operation

Surveys of the plunge pool area will be necessary during operation, and following high discharge events, to check the evolution of the pool boundaries.

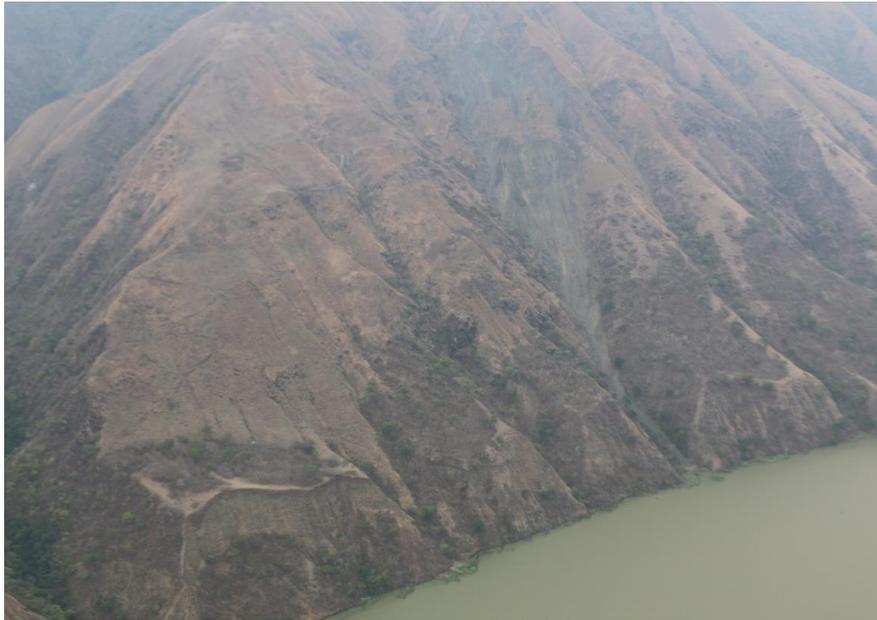
In the upstream part, the basin' slopes present erosion landforms. These forms indicate a stable background in terms of slope retention. They cannot generate significant landslides.

Figure No.18: Erosion forms in the reservoir basin, on stable overall background

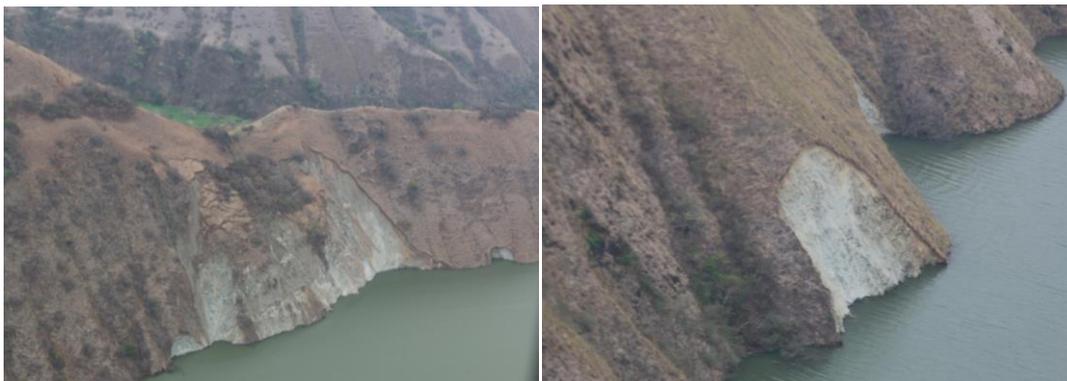
Landslides of reduced size and small scale, either rotational or planar, are observed in places and new ones may be generated by the operation and fluctuations of the reservoir. They cannot generate waves of concern.

Figure No.19: Small scale landslides at the rim of the reservoir. Similar are frequent

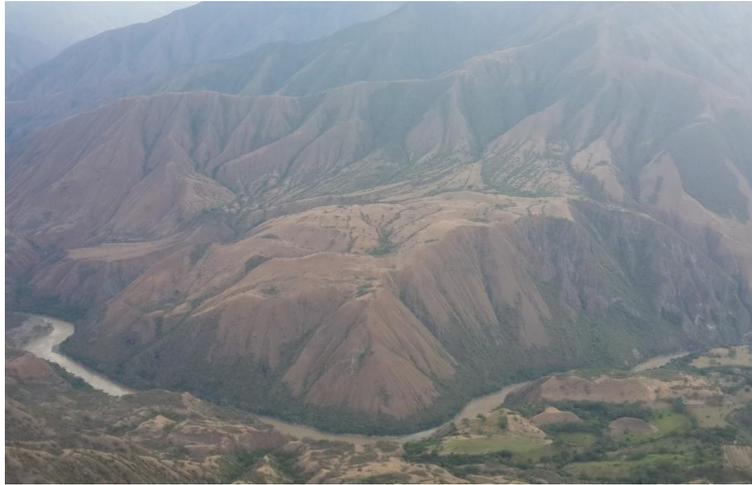
Existing studies hinted at the possibility of an old mega slide, 50 km upstream of the dam site, at the left side of the reservoir (“Guasimo” mega slide). No strong evidences were observed in the geomorphology and features of the area. There is no well-defined morphology of an old escarpment from where the landslide might have originated. Heavy erosion is present denoting overall stability of that escarpment area. The size of the downhill mass supposed to have slid is not compatible with the uphill morphology. The whole area is characterized by persisting erosion.

Figure No.20: The Guasimo area, hypothesized to be an old mega slide. No strong evidences were found in the geomorphological form and features.

Even in the extreme hypothesis that this were an old landslide, there are no features that allow to forecast its future re-activation.

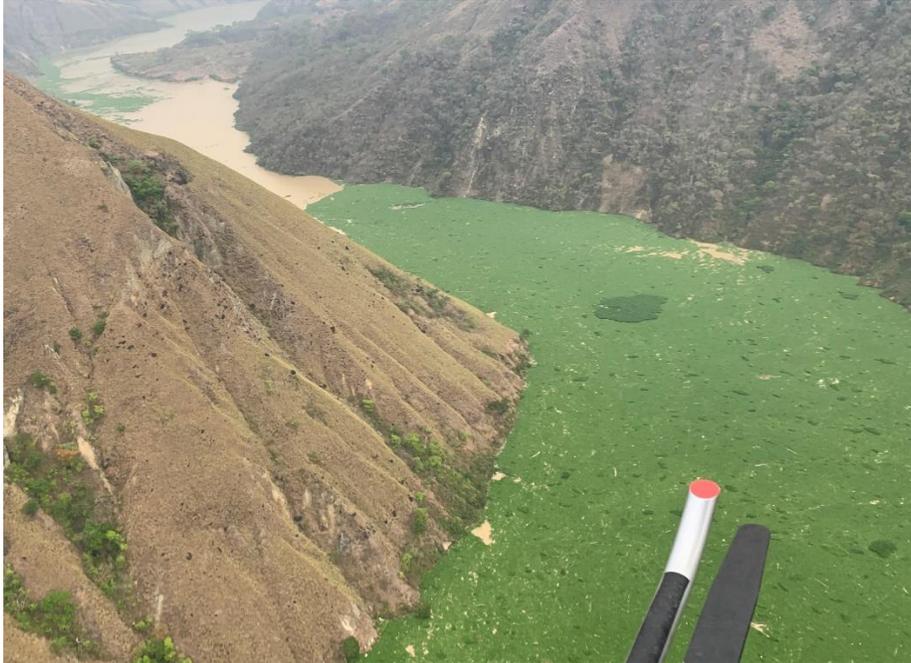
The April 2018 emergency did not permit to complete the vegetation matter produced by reservoir clearing operations. Floating logs have formed a base on which vegetation has grown producing several islands in concave areas of the reservoir rims. In some places, where the reservoir narrows, the “green carpet” covers the entire reservoir width (see photo).

Figure No.21: Vegetated debris floating on the reservoir

Inevitably, the next large flood will move such debris towards the spillway. A dedicated section of the emergency preparedness plan (EPP) should be prepared to manage that eventuality.
