**Independent Advisory Panel to IDB Invest**

**IAP Report N°3, October 2019**

**Ituango Hydropower Project**

**Colombia**

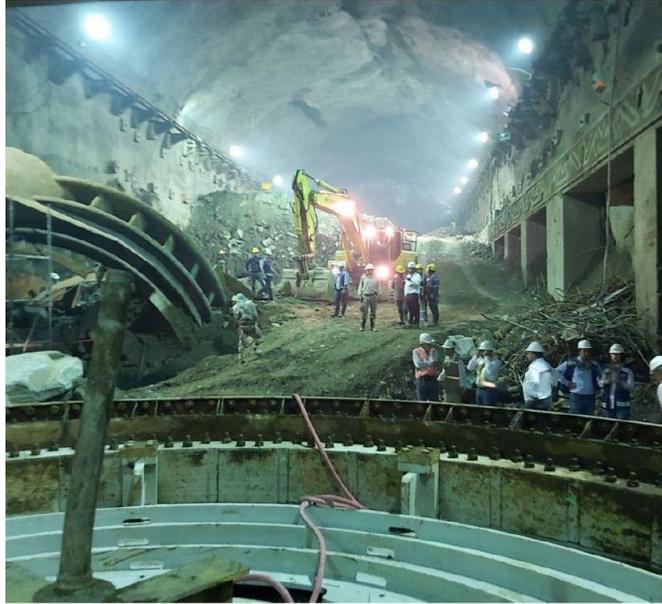
The caverns have an overall stability. There is not a disorganization of the rock mass. The monitoring (extensometers) before the event showed a stable condition. No changes are now measured regarding deformations. The rock mass is thus not distressed, no disturbed, no loosened, showing no indications of an overall stability problem. The geodetic measurements do not show any closure of the opening. No seepages from above is observed, having already an important head of reservoir water. Rock detachments certainly exist in places and reinforcement is necessary. Already rehabilitation is ongoing. With the completion, an additional monitoring net has to be installed. With the completion, an additional monitoring net has to be installed.

Figure 1 – PH cavern seen from the loading bar. Overall stability of the rock mass is recognized.

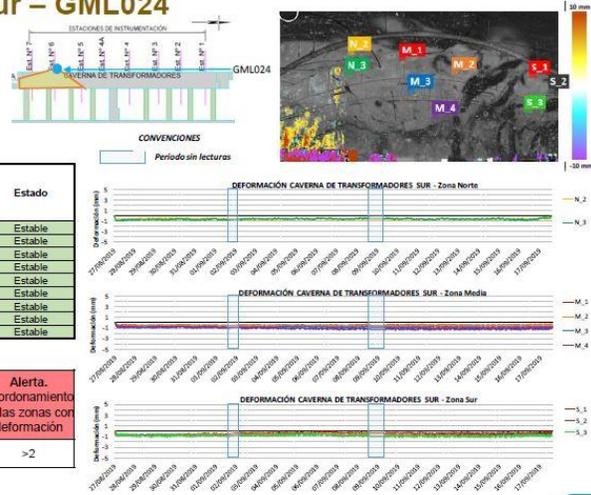
El monitoreo de la caverna de transformadores se inicia el 17/05/2019, a la fecha se mantiene estable.

Figure 3 – Underground complex, southern transformation cavern.

Figures 3-6 showed above, selected from the monitoring of the caverns since May 2019 and September 2019, no deformations are measured, or those are in the frame of the accuracy of the instrument of measurement. The rock mass is not overall distressed, no loosened, showing no indications of an overall stability problem. The geodetic measurements do not show any closure of the opening. This does not mean that the additional reinforcement of the caverns has to be neglected (rf. IAP report of March 2019).

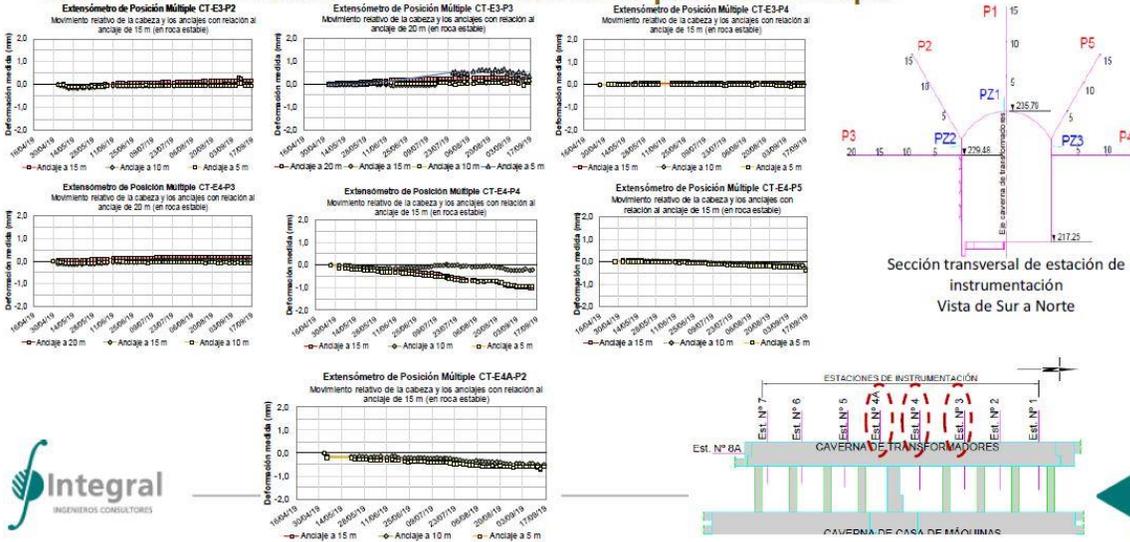
Figure 4 – Underground complex, multiple position extensometer.

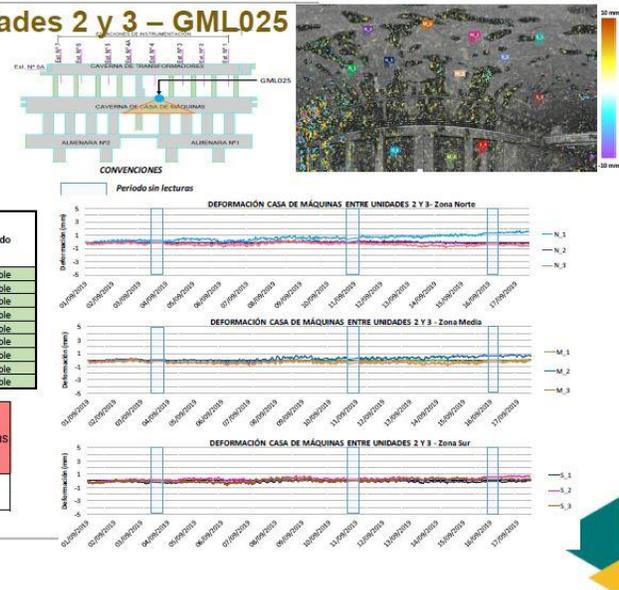
Figure 5 – Underground complex, engine room between units 2 and 3.

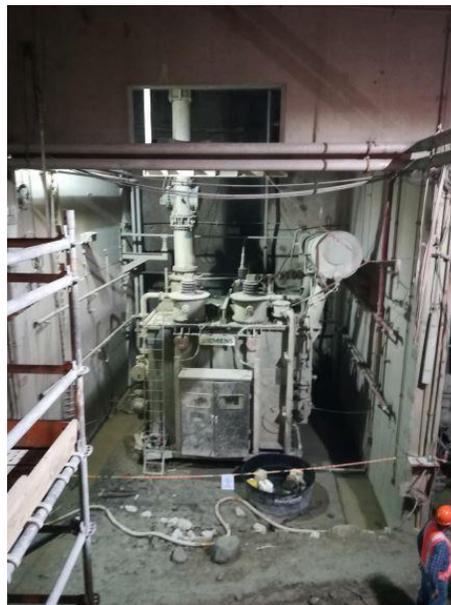
The first visual investigation by EPM, as reported to the panel, did not remark any sign of losses of oil from the transformers (the transformer tanks were unaffected). Oil was subsequently removed from the transformer tanks and properly disposed.

At the time of the site visit the transformer cavern was fully accessible: very limited damages to the civil structures were except for the presence of thin debris and all the transformers were in place.

**Figure 6** – One of the single-phase step-up transformers.

EPM has in the warehouse only 6 out of the 25 single phase transformers of the original supply; they are enough for the first two units but, having long-delivery items the other ones shall be timely procured.

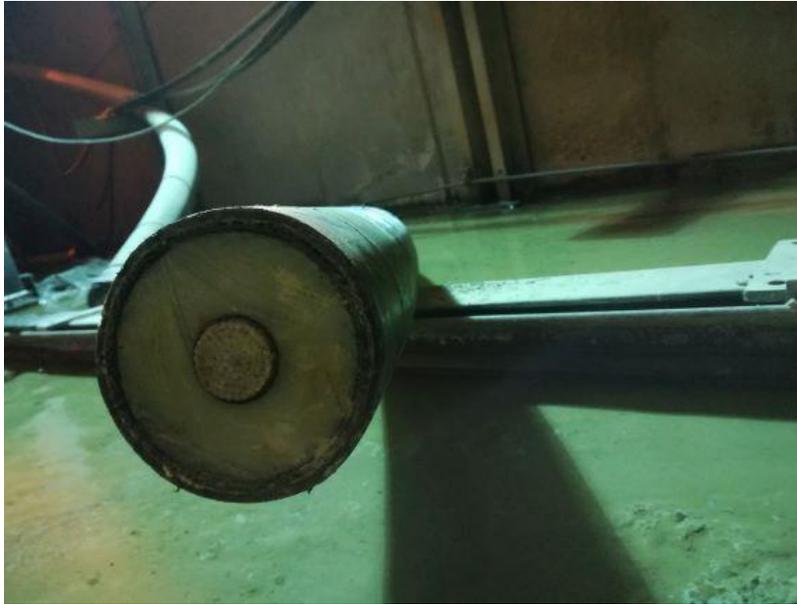
**Figure 7** – One of the HV single phase cables.

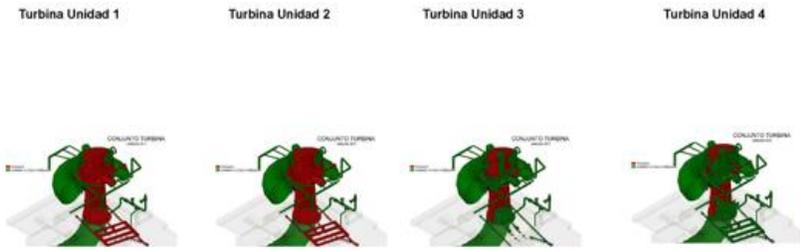
At the time of the Power House flooding, the progress of the installation of the lowest part of the units was as shown in the Figure 9 (green color shows installed equipment).

**Figure 8** – Progress of installation at the time of flooding the north and south power houses.

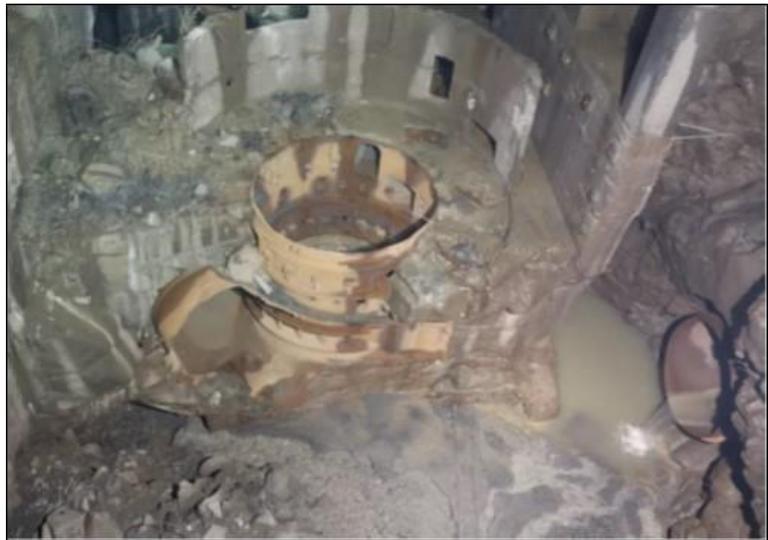
The lowest part of units 1 and 2 as well as the corresponding first and second phase concretes with their embedded parts are completely lost and their erection will start from the beginning. They were not available for a visual inspection as included in a temporary bank.

**Figure 9** – Units 1 and 2. Pictures by EPM.

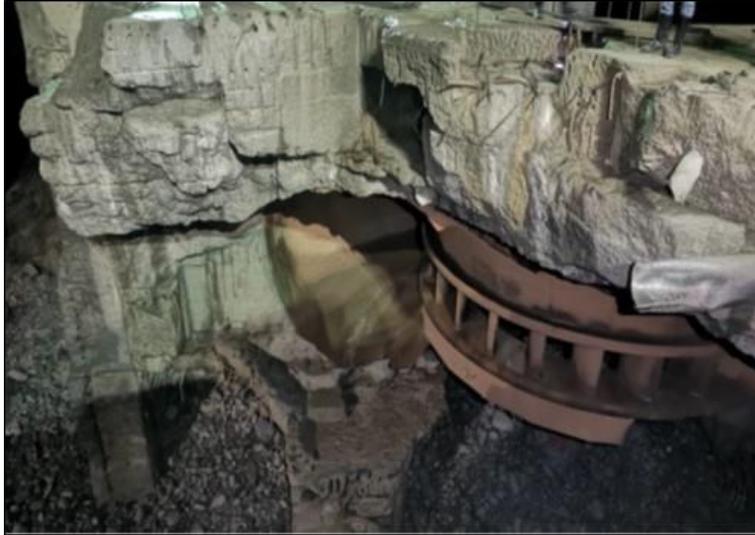
**Figure 10** – Units 1 and 2. Pictures by EPM.

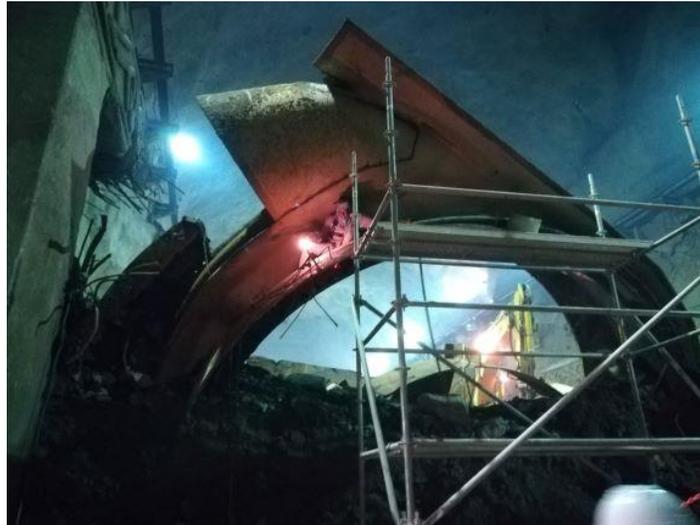
**Figure 11** – Unit 2, stay ring displaced by water flood undercutting and removing.

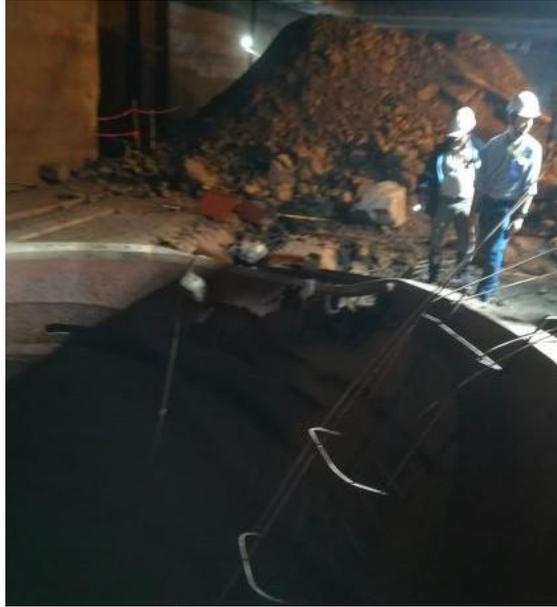
**Figure 12** – Damaged Unit 3 draft tube.

Units 3 and 4 were partially available for visual inspection. Part of the lowest part are damaged, draft tube cone and draft tube of unit 4 are not in place anymore and the one of unit 3 are damaged. The question mark is the status of their first and second phase concretes and their embedded parts. EPM expects to complete the assessment by November 2019.

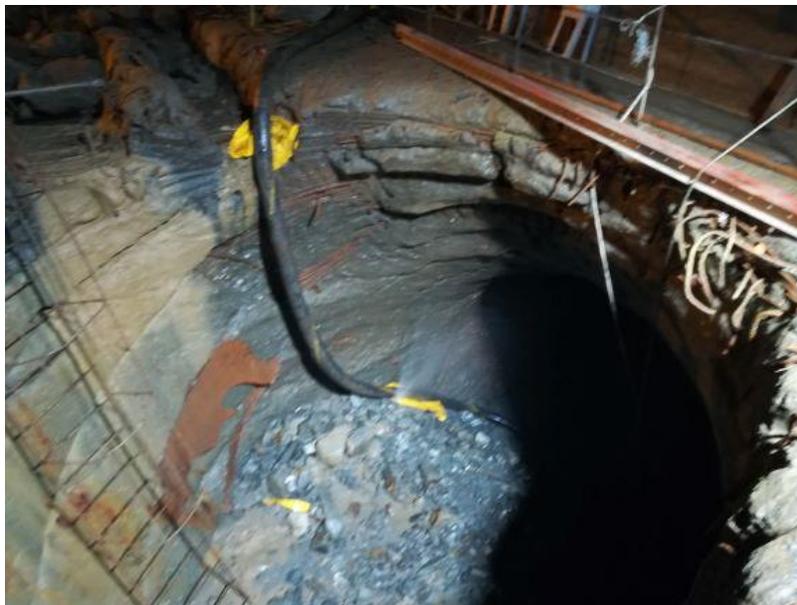
**Figure 13** – Remaining of Unit 4 draft tube.

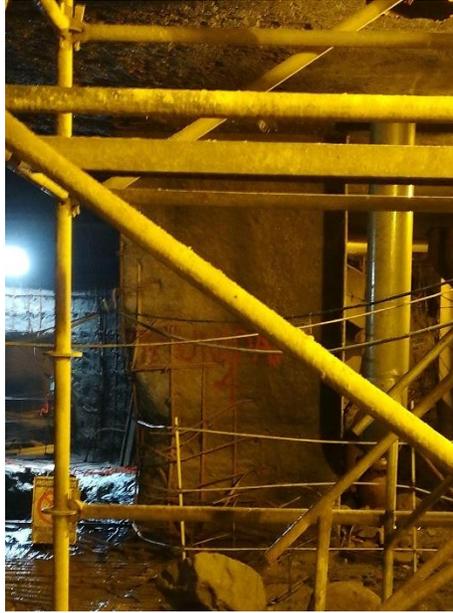
**Figure 14** – Massive wall at draft tube cone level with exposed steel bars and signs of erosion in the lower left part.

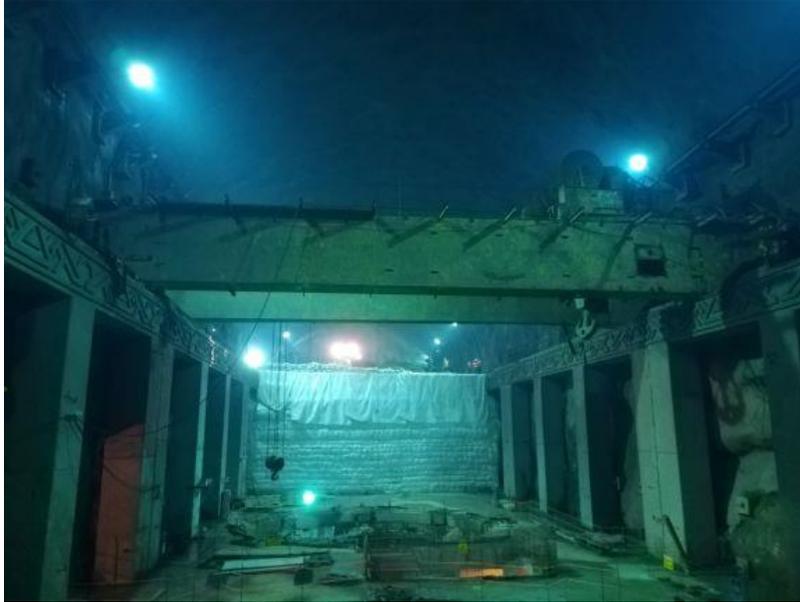
The two overhead cranes that were soundly fixed with cable to the two rotors in the loading bay are still in place but hopes to obtain a crane suitable for temporary activity (by cannibalizing the two cranes and replacing all electrical components) failed.

**Figure 15** – One on the cranes.

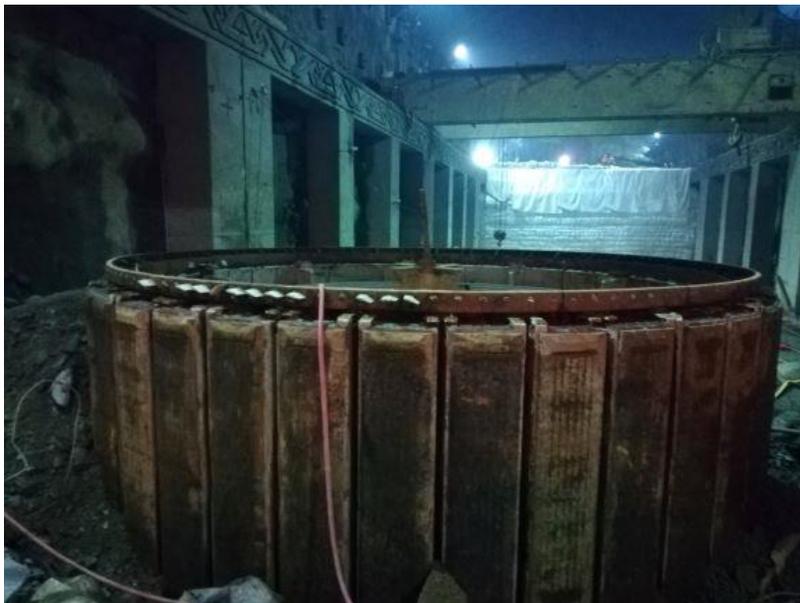
The pit where generator No.3 was in advanced status of assembly was clear of debris while stator of generator No.4 was still partially covered by debris (the two rotors were instead completely assembled in the loading bay).

**Figure 16** – Unit 3 rotor on the loading bay.

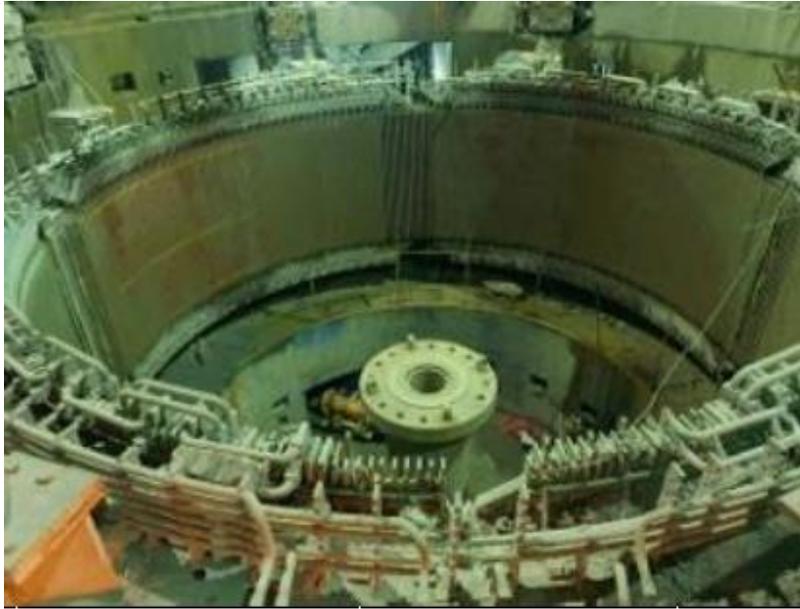
**Figure 17** – Stator of Unit 3 clean and ready to be removed.

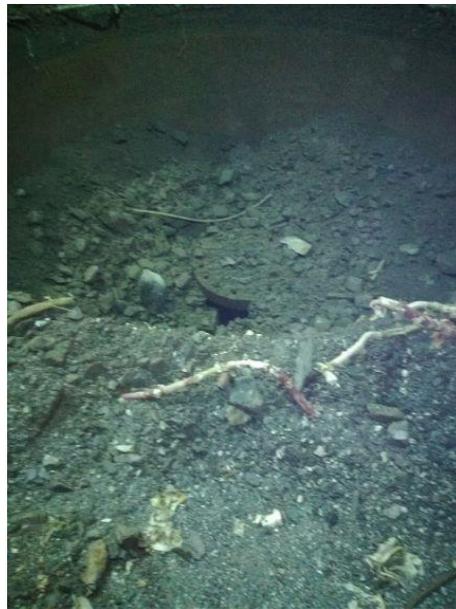
**Figure 18** – The flange of turbine shaft emerging from the debris inside Unit 4 stator.

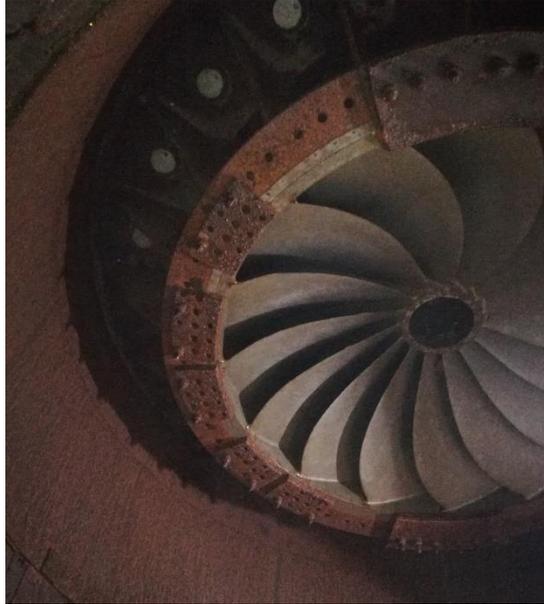
**Figure 19** – Unit 3 runner seen from below.

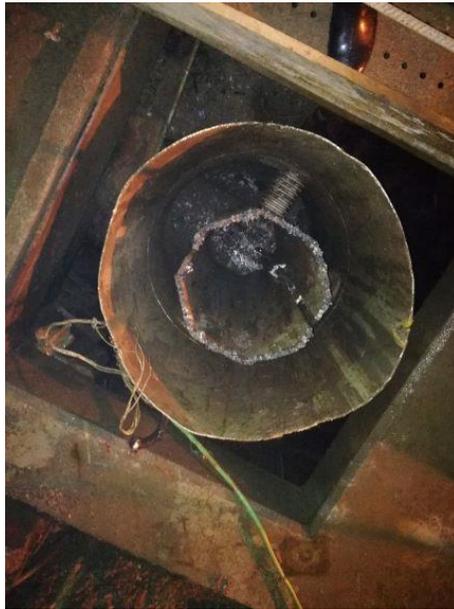
The isolated phase bus ducts of unit 3 and 4, which are mechanically fragile are lost, as anticipated.

**Figure 20** – Damaged and cut section of isolated phases bus duct of Unit 3.

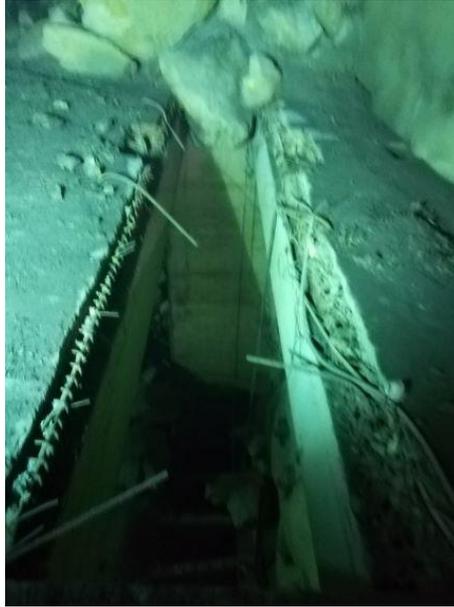
Three out of four draft tube gates in the north shaft chamber are no more in place, collapsed together with the portion of shaft chamber where they were installed. They were identified in the discharge channels.

**Figure 21** – Relatively well-preserved slot for Unit 5 draft tube gate in the south shaft chamber.

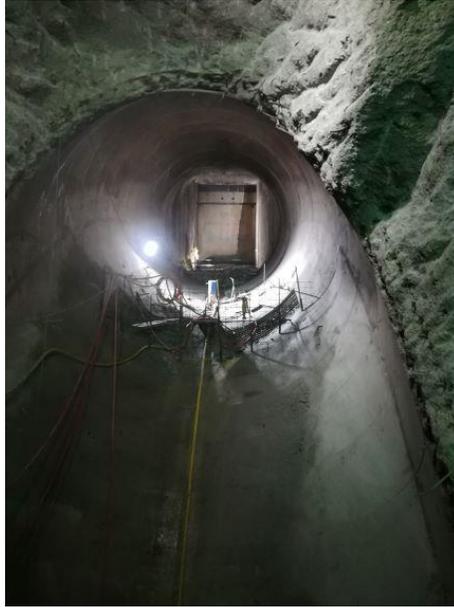
The original design foresaw steel lining only on in the horizontal section between the lower elbow and the spiral case of the Units. Given the severe damages to the rock mass in the area of the pressure shafts, it must be assumed that the ground has lost its capacity to collaborate with the lining in withstanding internal pressures. The adoption of a self-standing, ductile, steel lining seemed inevitable and was recommended by the IAP. EPM adopted the recommendation and the relevant contract with ATB Brescia was scheduled to be signed few days after the completion of the IAP mission. The decision had to be rapid to avoid delays in commissioning the first unit.

**Figure 22** – Upper elbow of penstock n 1 “open” for facilitating installation of steel lining with on the background the downstream face of intake gate.

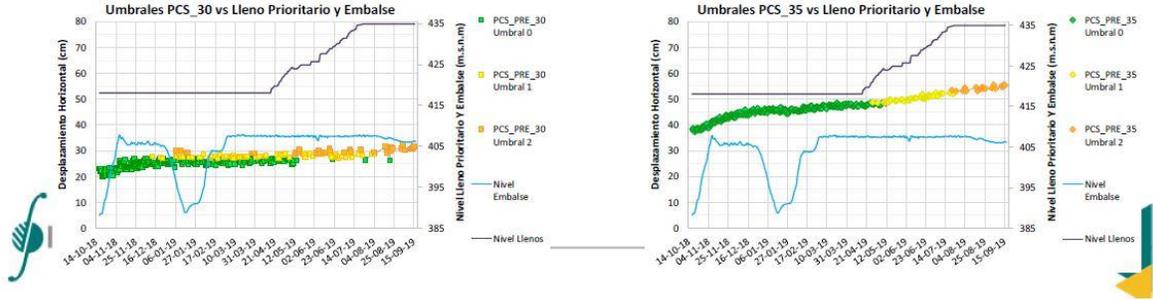
Los PCS 29, PCS 30 y PCS 35 registran deformaciones asociadas tanto al incremento del nivel del embalse y de los llenos de la presa. En las gráficas se observa un aumento en las deformaciones, atribuido al inicio de la conformación de los llenos de la presa por encima de la cota 418, el 07 de abril de 2019. Y culminando el 19 de julio de 2019.

Figure 28 – Deformations of the dam, since October 2018, following the rise of the dam and the reservoir level. The values are in line with the values that could be expected.

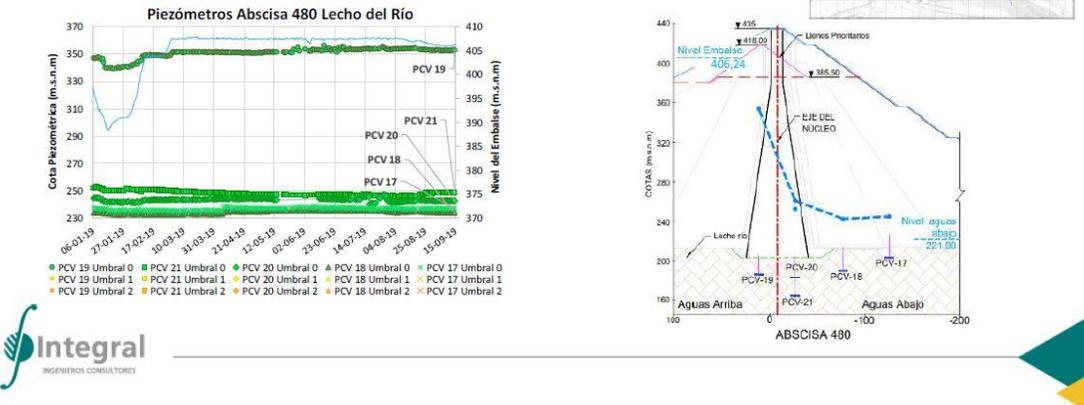
Figure 29 – Piezometric profile at the left side of the dam and its foundation, and its evolution with time. Good behavior of the core of the dam. Piezometric heads downstream of the grout curtain, higher than expected. Leakages are recorded in the inspection gallery, left side. Although no high (170 l/sec), additional grouting in this area is foreseen.

Leakages in the inspection-grouting galleries are low to very low. The need of additional grouting works in the left bank was discussed in the IAP's report of March 2019, although the extent of leakage was not excessive. Additional grouting was executed. However overall seepage is not substantially decreased. With the present reservoir level, in this abutment total seepage is reported having reached 170 l/s. Additional multidirectional grouting was recommended and is to be performed after having the grouting gallery lined. All seepage water is reported clean.

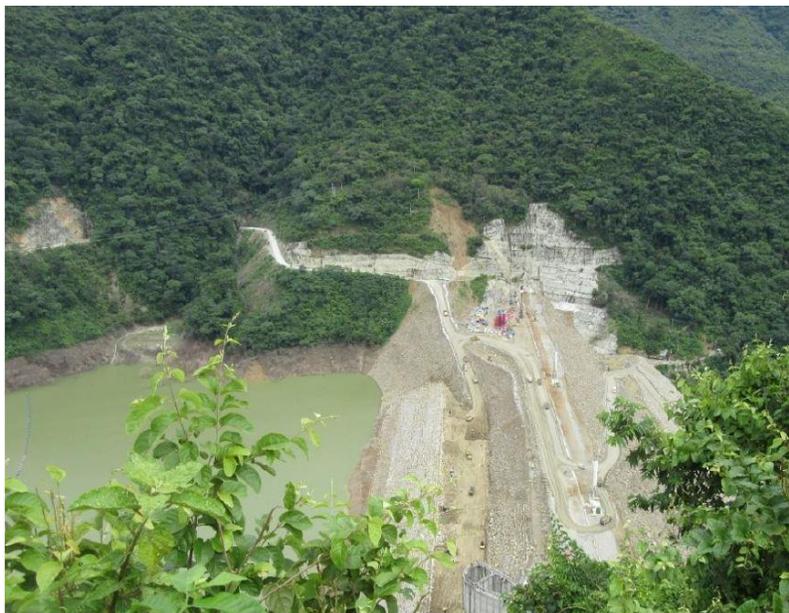
The left abutment does not show forms that could correspond to unstable ground or old slides. Skin slides could occur as the one at the upstream side of the abutment. The geodetic monitoring since June 2018 shows stable conditions. No displacement trend is recorded.

**Figure 30** – Aerial view of left abutment. Geomorphology exposing no unstable forms. Skin slides only.

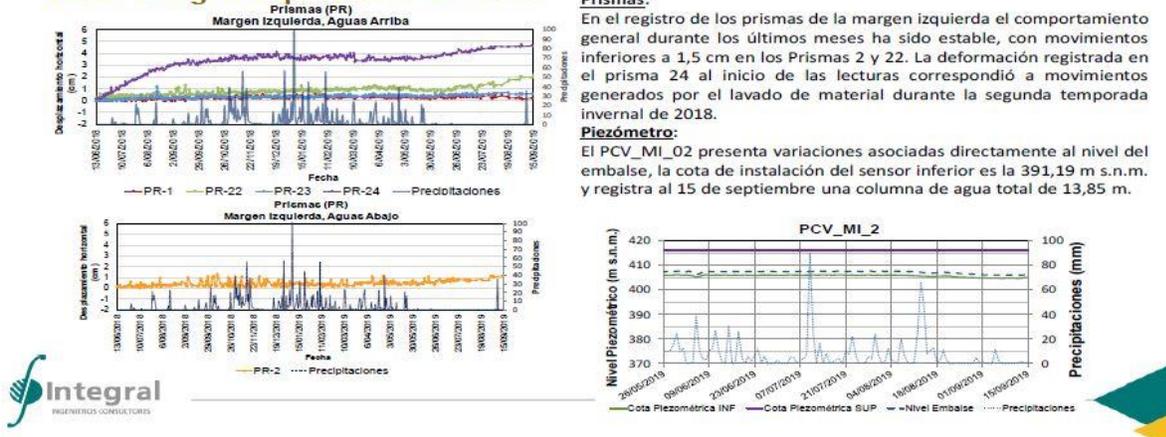
**Figure 31** – Left abutment. Geodetic monitoring since June 2018 stability. No signs of deformation to be considered, no trend.

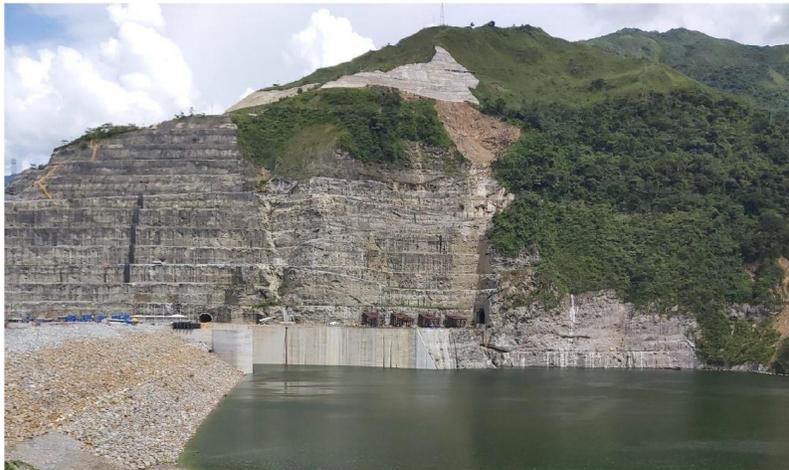
The slopes at the higher part of the right abutment are already reshaped, benched and anchored. The stabilization is proceeding downhill with another bench to the area of El Romerito sens strict. During the mission the panel visited the works in progress at the slope. Both design and implementation are considered satisfactory. This treatment will contribute to the stability of the abutment and unload the El Romerito part of the slope over and behind the intake structures.

**Figure 32** – Right abutment and “El Romerito.”

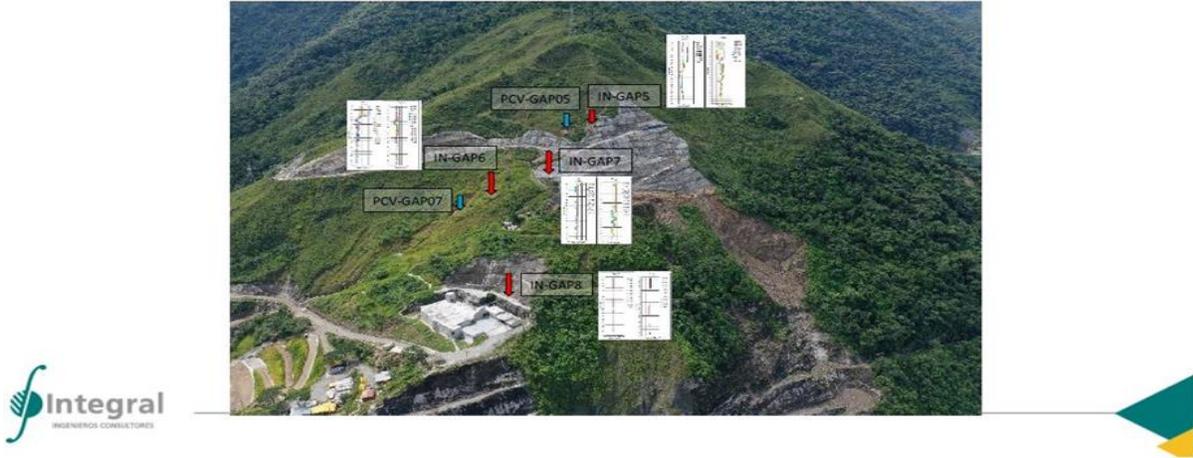
**Figure 33** – Right abutment and zone over “El Romerito.” Position of inclinometers. Monitoring results are satisfactory. Only the IN-GAP-05, nevertheless over the terminal part of the natural slope, shows a displacement of about 1cm at a depth of 18m.

Monitoring results are satisfactory. Only the inclinometer IN-GAP-05 over the terminal part shows a displacement of about 1cm at a depth of 18m; monitoring has to follow for verification.

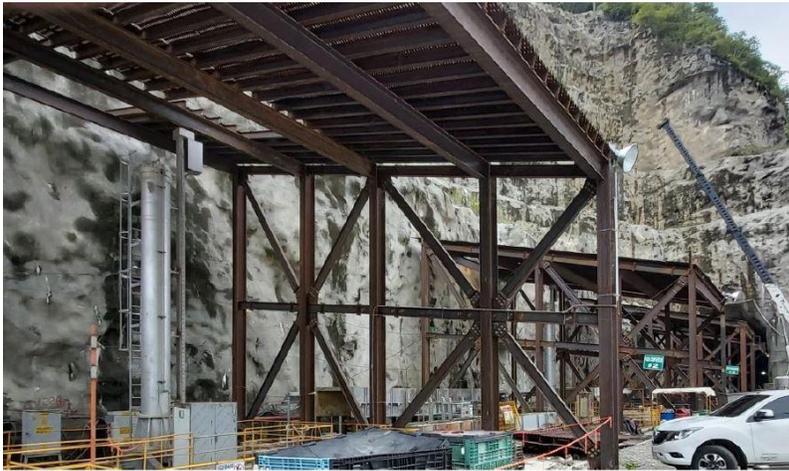
**Figure 34** – Structural protection above the power intake gates 2, 3 and 4 to be enhanced.

Cracks were observed in the shotcrete layers on the slope above the platform of the power intakes. The stability of those slopes should be revisited and monitoring continued.
