**Independent Advisory Panel to IDB Invest**  
**IAP Report N°4, June 2020**  
**Ituango Hydropower Project**  
**Colombia**

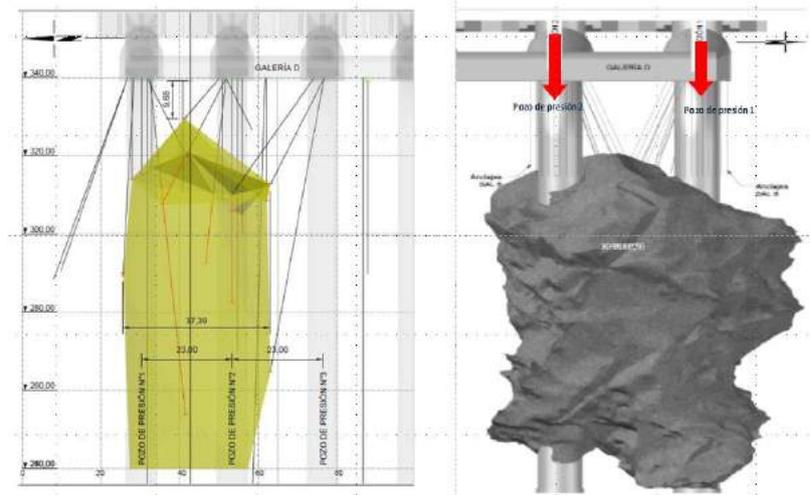
Fig. 3 Cavity between pressure shaft 1 and 2. March 2019 forecast (left) and April 2020 as built.

Cavity stabilization and backfilling (60,000 m<sup>3</sup>) has now been successfully completed. Remarkably, contrary to last year's expectations, the rock mass at the boundaries of the cavity was found in good conditions. Monitoring did not show signs of noticeable deformations of the cavity boundary. The backfill will act as a stiffening element and maintain the long-term stability of the rock mass in this area.

Minimum, localized seepage was observed during the works. Drilling for contact grouting and control boreholes showed satisfactory results, and low grout absorptions. A few additional control holes are planned.

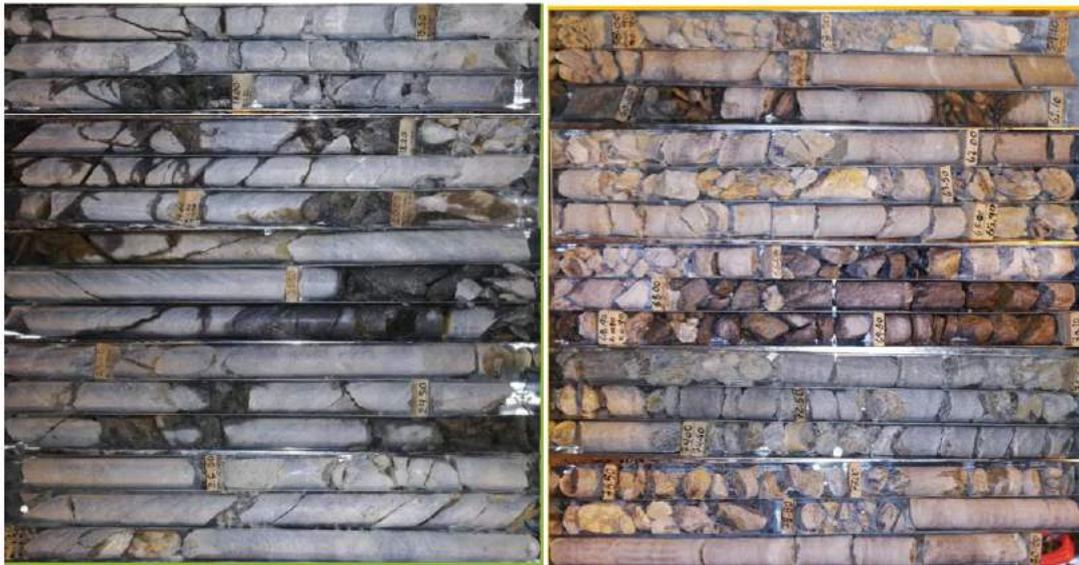
Fig. 4 provides the rationale for the IAP opinion. The structure of the rock mass (joints and discontinuities) is recognizable in the left box. That is not the case in the right box where core ruptures are perpendicular to the borehole axis; that feature characterizes a sampling which is not representative of the in-situ conditions of the rock mass. The cores in the right box are clearly affected

by the drilling process and by the extraction of the cores from the barrel. As such those cores are not representative for deriving rock mass quality indexes.

Figure 4 Representative (left) and non-representative (right) coring.

The IAP recommends preparing a zoned classification of the rock mass, giving due consideration to the reliability of the cores. The GSI method could be used for that purpose. The design of rehabilitation works should be based on actual rock mass defects (open joints, shear zones, loose rock, cavities etc.) and associated potential mechanisms of failure.

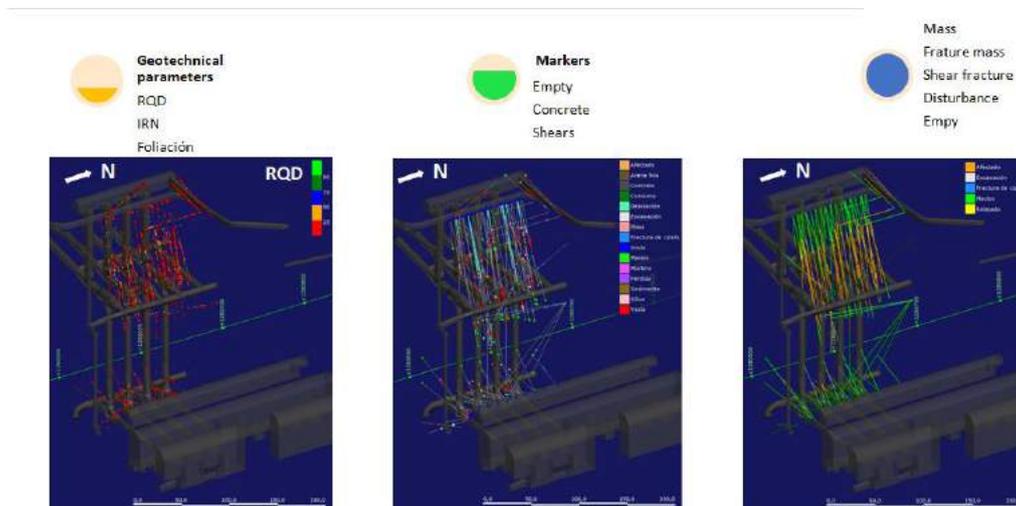
An extensive campaign of boreholes and grouting has been carried out in the area (see Fig. 5). From the information provided, the IAP is not sure that voids exist in the upper part of the shafts. In the lower part of the shafts, voids are reported to exist, but the examined borehole data do not permit to confirm that. In any case, the information collected should be adequate for a detailed characterization of the rock mass.

Figure 5 Exploration campaign South zone. Shafts 5 to 8

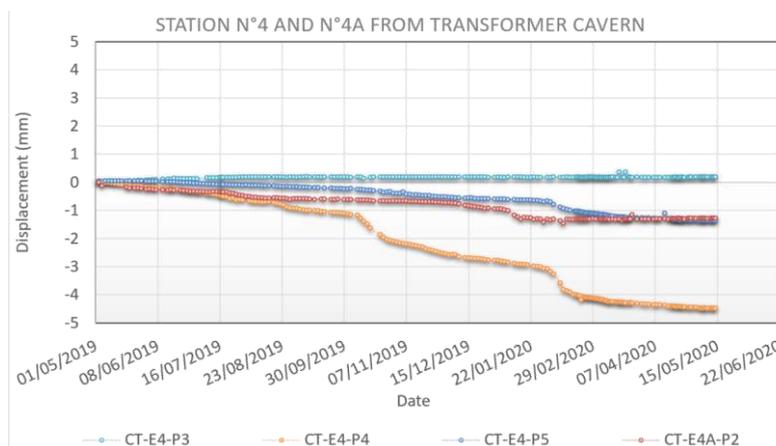
In few places slight deformations have been recorded. Reportedly, the largest displacements (5mm) have been recorded at specific locations where major interventions took place. That is evident from the orange line in fig. 7.

Figure 7. Multi-Point Borehole Extensometer reading, where some displacement reached 5mm.

Such movements, albeit small, go beyond the level of instrument's accuracy, therefore an increased monitoring frequency should be adopted in case those displacements would not show sign of stabilization. Obviously, monitoring should continue everywhere.

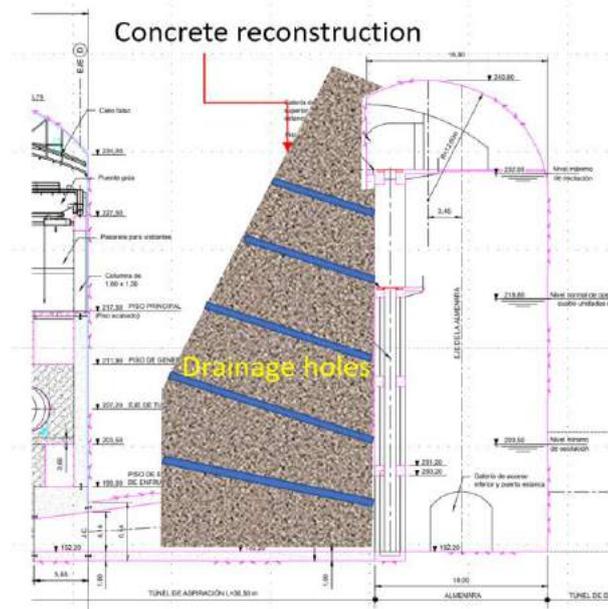
The rehabilitation design foresees reconstructing the Almenaras with concrete backfills, after rock mass reinforcement. The backfill will be particularly massive in the case of Almenara 1 and the build-up of water pressures could be destabilizing, especially in consideration of the oscillations in the surge chamber. The IAP recommends that the Designer assesses the need of drainage holes: Fig 10 shows a notional layout.

Fig 10 Drainage to massive concrete reconstruction of Almenara 1.

Pressure conduits and underground openings in the North side of the Power Complex are in advanced phase of rehabilitation and the remaining repair works are substantially defined. The IAP recommends considering the adoption of drainage holes through the planned backfill of Almenara 1.

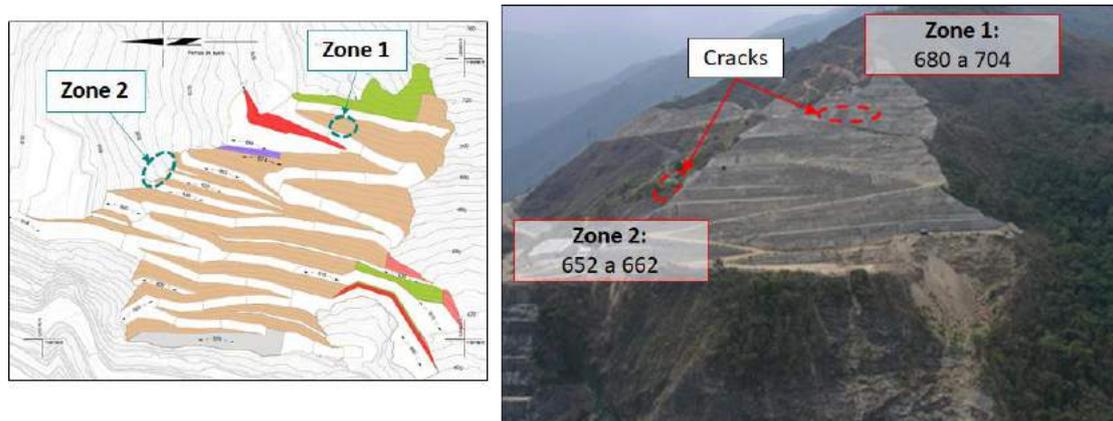
Some cracks have appeared on the upper parts of the slope. Of these, the cracks in Zone 1 do not necessarily agree with the results of stability calculations and may need to be reconsidered in modelling the slope (e.g. tension cracks).

Figure 16: Power intakes- Localized cracks in the upper part of the slopes

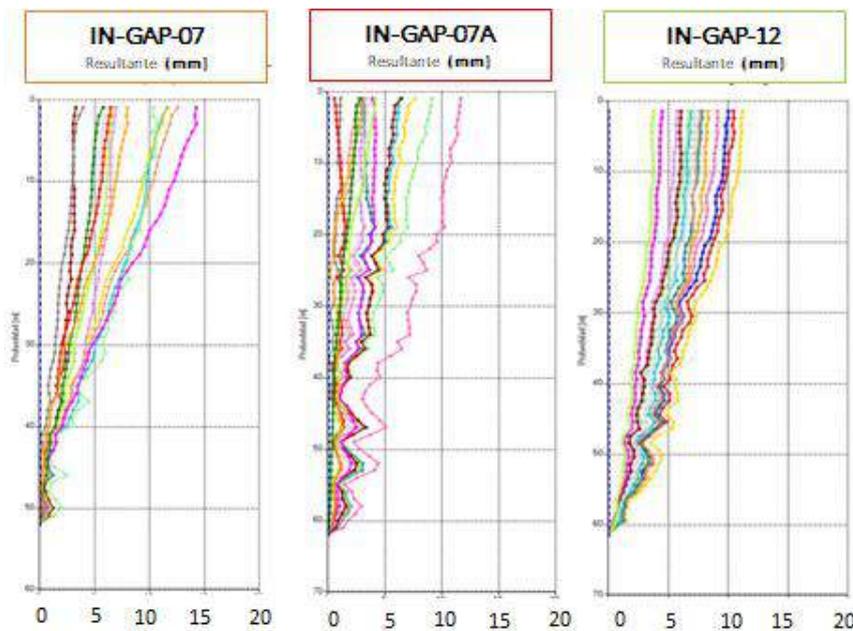
Inclinometer measurements in the area, indicate a pattern of displacements (fig. 18) that does not correspond to a recognizable sliding surface at any level. No abrupt changes of slope are visible along the inclinometer alignments. Most probably, the recorded movements result from incomplete or defective fitting of the inclinometer's tube in the drill holes.

Figure 18: Inclinometer readings in the slope over the platform of gates. The curves do not evidence any deformation or rupture of the inclinometer tube.

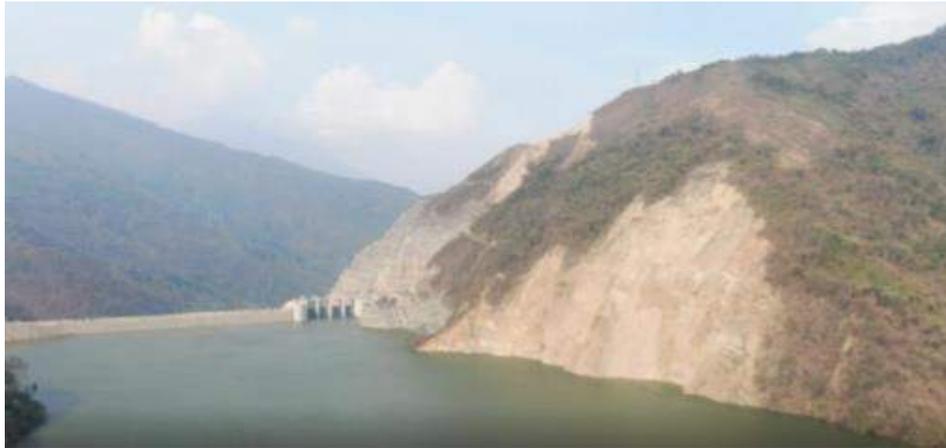
EPM informed that, after the treatment works in the Romerito area are completed, the design of slope stabilization works in the upstream southern areas will be re-assessed. The present evidence is that this upstream area does not show any of retro or lateral evolution.

*Figure 19: The destabilized area above the two diversion tunnels. In the far upper end the slopes of Romerito, before the reshaping and treatment*

Treatment works on the right bank slopes above the intake works are proceeding satisfactorily. The IAP renews its recommendation to extend the necessary treatments to the slopes further upstream, where mass movements took place in 2018.

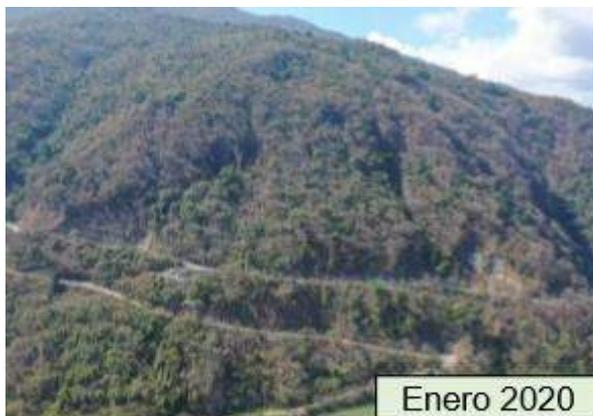
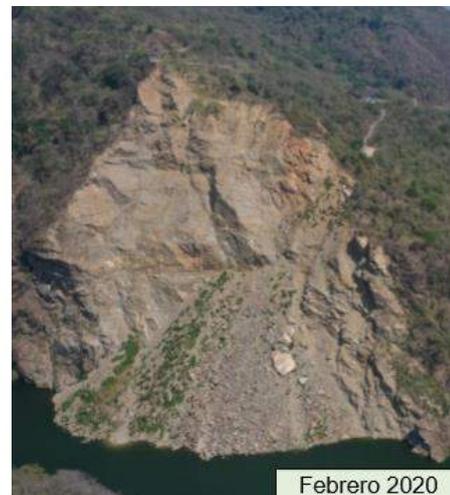
On the left reservoir slope, near the dam site, two instabilities occurred, one at 0+900 to 1+290 and the second at 2+255 (fig. 20). The first case affects the alternative road. The IAP has neither been involved on these slides, nor visited the sites.

*Figure 20: Instabilities near the complex of the project, at the left side, over of the reservoir, Left, at 0+900 to 1+290 and right at 2+255*

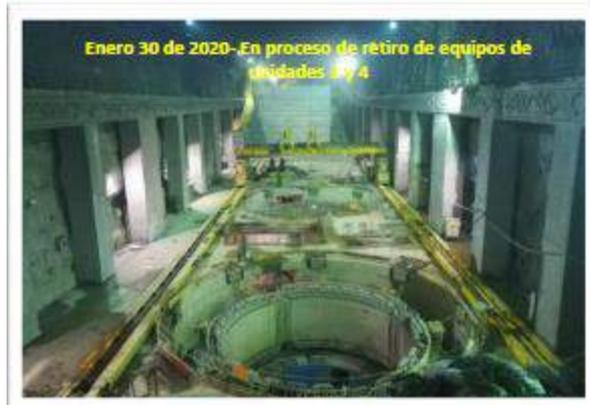
The lowest parts of units 1 and 2 and the corresponding first and second phase concrete were assessed to be completely unsuitable for any remedial action. The same assessment was extended to units 3 and 4 at the end of 2019. Rehabilitation of units 1 to 4 has therefore started from first phase concrete (see fig 24).

Figure 24: Removing Unit 3 and 4 equipment as scrap material

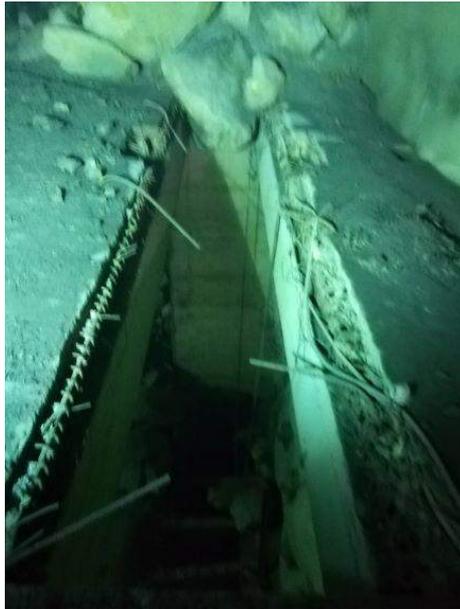
Both the control gates of draft tubes 1 to 4 and the guides of 5 and 6 were lost in the contingency; some parts of gates were found destroyed inside the tailrace tunnels and the entire hydraulic circuit and its control system disappeared (see fig. 26).

Figure 26: Slot for unit 5 draft tube gate in the south shaft chamber: guides are lost

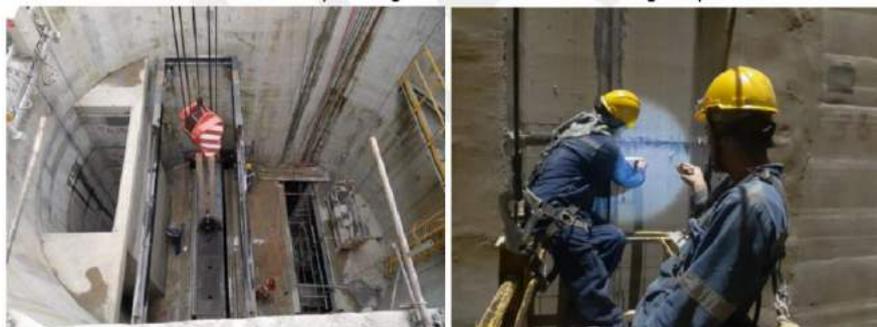
Activities on the Intake gates and their operating systems are proceeding at low pace because they are not on the critical path. Priorities, in this area, are underground reinforcement and slope stabilization works. Activities are currently concentrated on intake gates 3 and 4, the only ones in “dry” condition because isolated from the reservoir by concrete plugs (Fig.28, left). All other gates are currently lowered to their close position, 1 and 2 with their lifting devises, 5,6,7 and 8 by cranes (Fig. 28, right). Moreover, activities are underway on the guides of intake gates 5 and 6 to remedy the minor deformations suffered by these guides at the time of flooding the powerhouse.

Fig. 28- Intake gates: Left, lowering gate 3 in its pit using temporary crane. Right: Inspecting guides of gates 5 and 6

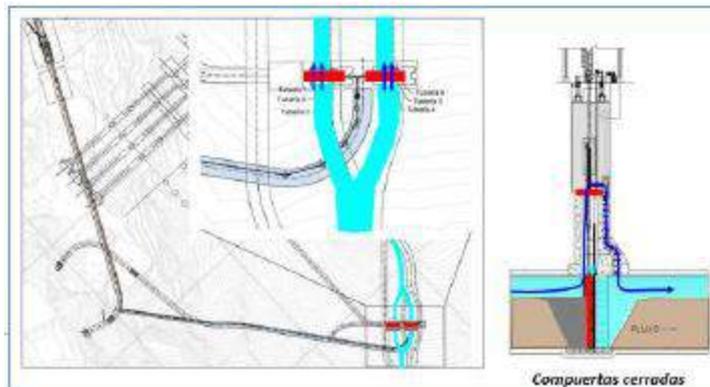
The two GAD vertical sliding gates have successfully been lowered. A by-pass pipeline has been installed to alleviate the reservoir pressure on the gates, to increase safety when the permanent plugging to GAD and DT2 will be built. The temporary by-pass is routed through the IDG (see fig. 30).

Figure 30: GAD gates in their final position with temporary by-pass system

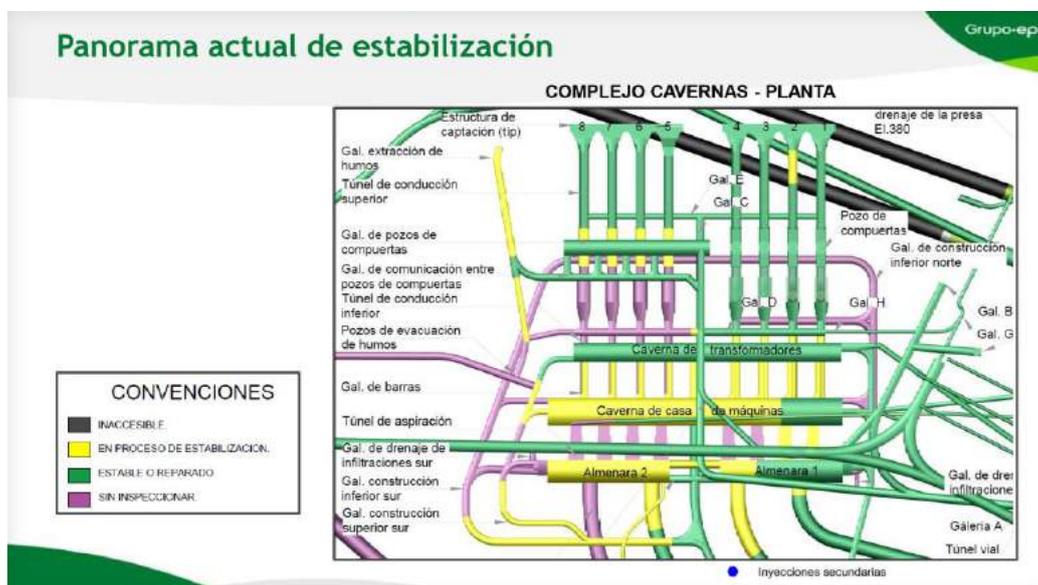
- The transformer hall is fully recovered (green colour).
- Most of the waterways and underground structures associated with units 1 and 2 has been repaired/ recovered (green) or in the process of being stabilized (yellow).
- Recovery works pertaining to units 3 and 4 are slightly behind 1 & 2, because the draft tube areas have not yet been inspected (violet).
- The waterways of units 5 to 8 have not yet been inspected and repairs are underway in the underground structure of the South part of the plant.
- Treatment of the pressure shafts to units 5 to 8 is under definition.

Fig. 32: Recovery of underground works, progress overview at April 2020
