**Independent Advisory Panel to IDB Invest  
IAP Report N°5, March 2021  
Ituango Hydropower Project  
Colombia**

## EXECUTIVE SUMMARY AND RECOMMENDATIONS

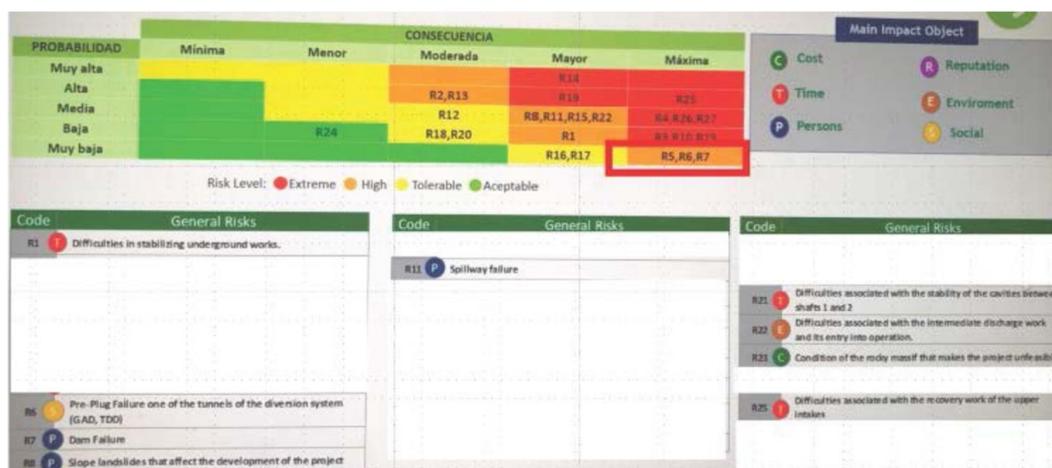
Figure 2: Matrix of Project's Technical Risks in February 2021

The IAP agrees, in principle, with the risk assessment of the different events, except in the case of R5 (GAD and TD2 sealing). Its probability of occurrence cannot be of the same level as that of “Dam Failure” (R7). Until successful sealing is achieved, the probability of occurrence of R5 should be moved up to «Baja».

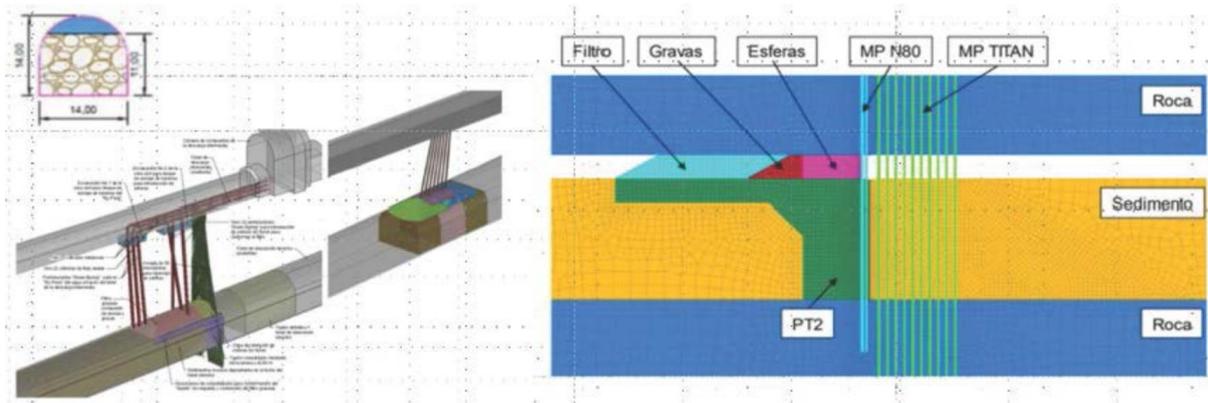
Figure 3: Solution for sealing the TD2

Sealing of the TD2 must take place while water is flowing and therefore requires a complex and carefully planned procedure. Due to its unprecedented nature in hydropower projects, TD2 sealing has been thoroughly studied and a feasible solution is being implemented (Figure 3).

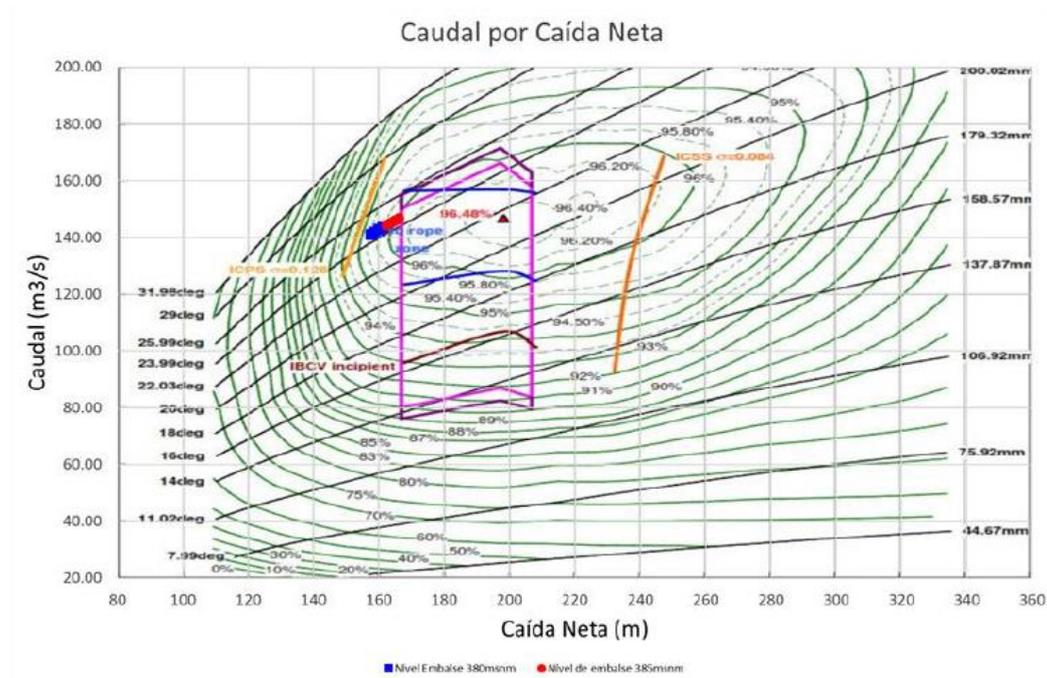
*Figure 7: Turbines Hill Chart with guaranteed operating range and cavitation limits*

Such phenomena can be triggered when the turbine operates outside the head and discharge (H-Q) values for which it has been designed. Fig. 7 shows the “hill chart” of Ituango’s turbines along with guaranteed operating range and cavitation limits.

Should the units need to be operated outside the design limits, in emergency conditions, monitoring vibrations should be an obvious requirement to be specified in the Project's Emergency Preparedness Plan.

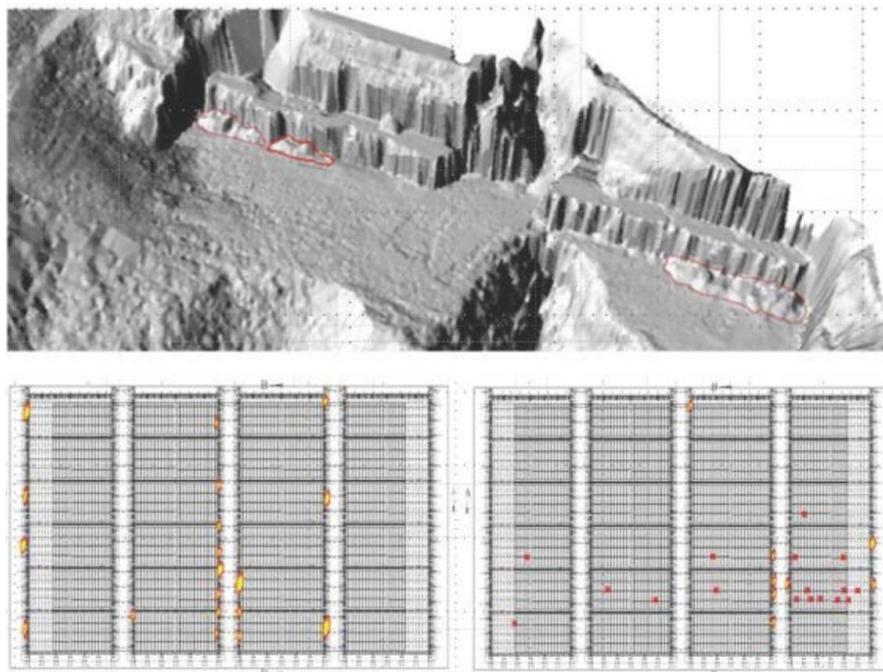
Figure 8: Repair works at Intakes 1 to 4

No significant geotechnical aspect to report, except that civil works for the rehabilitation of shafts 1 and 2, which were affected by the large cavity, have been satisfactorily completed. The focus is currently on assembling and installing the steel lining to the pressure shafts, starting with 1 and 2. Underwater works contract has been signed and activities are about to start in correspondence of the intakes, which will require the use of metallic bulkheads, the removal of debris in front of the intakes, and the repair/ replacement of the trash racks (see figure 8), the completion of the 20 m concrete lining to Intake 2 and the removal of concrete plug to intakes 3 and 4

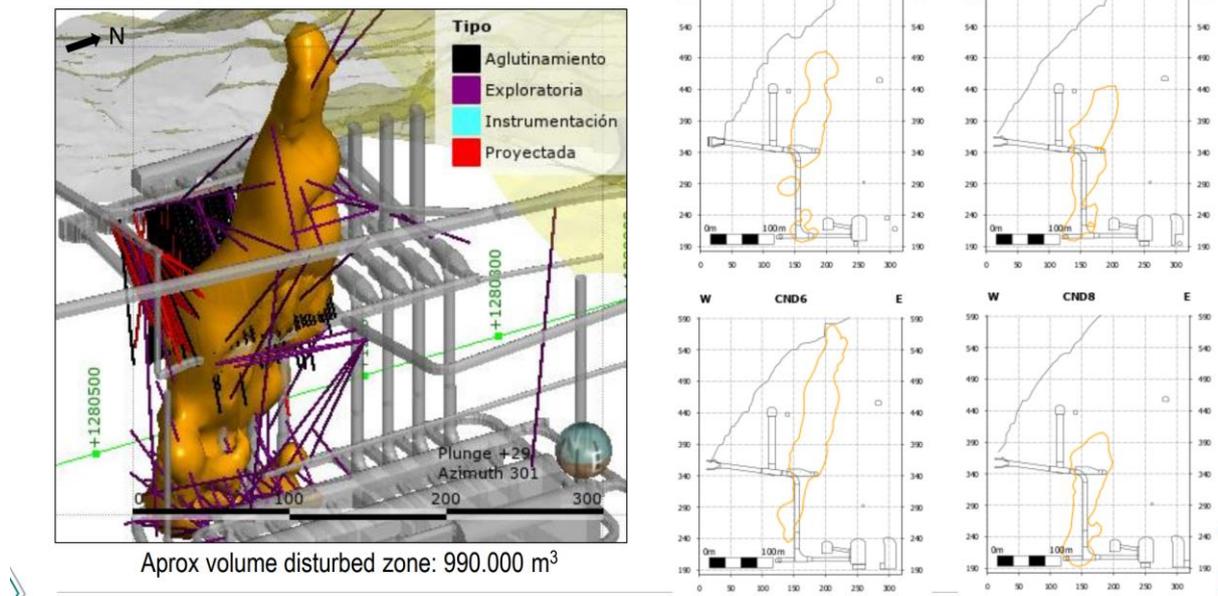
Fig. 9: Delineation of the “disturbed rock mass”

The key for assessing the treatment of the DRM requires understanding the status of the rock mass within the zone and that, in turn, necessitates appreciating what was the mechanism of failure.

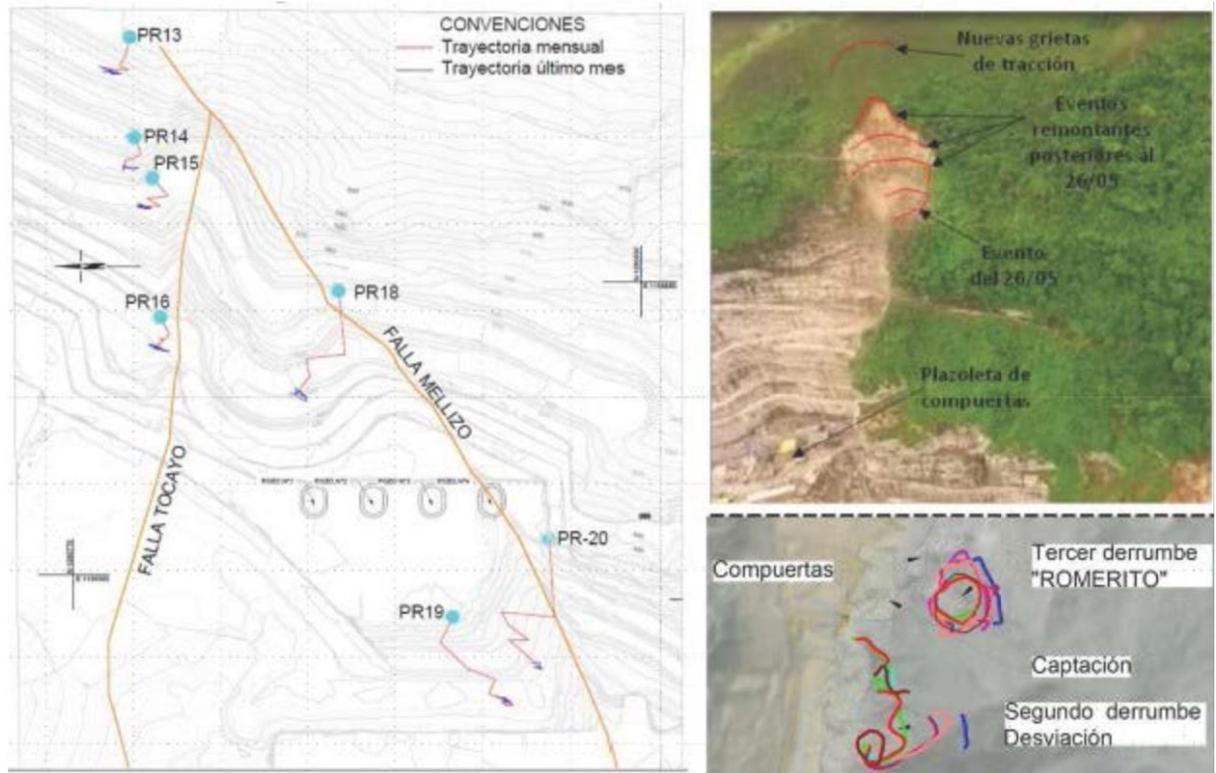
Fig. 10: El Romerito landslide, located above the top protrusion of the DRM

It is expected that the intense dynamic actions that occurred in that relatively short period stressed the rock mass and caused a progressive propagation of the disturbance towards the surface. That left behind voids in the lower part of the DRM and in its upper part near the *Romerito* landslide. The rest of the DRM is likely to have experienced dislocations of maximum extent along the Mellizo fault and of progressively reduced extent away from the top and lower portions.

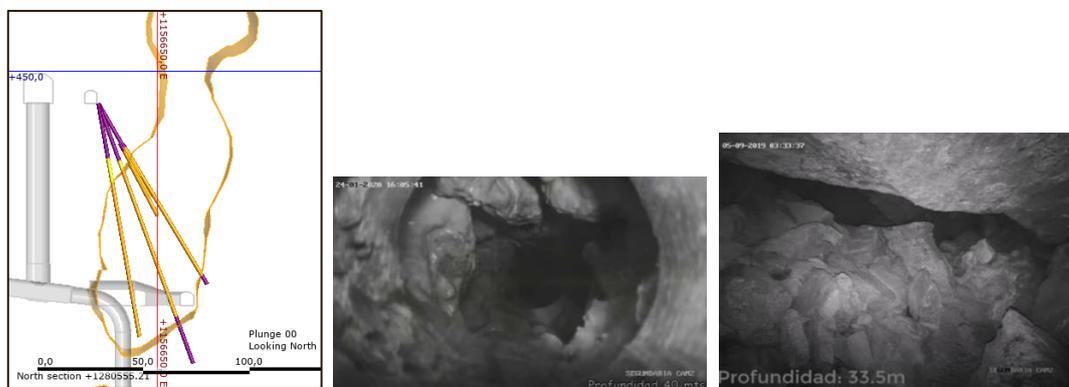
Figure 11: Voids inside boreholes in the area of the shaft 5

Presence of voids has been evidenced by the extensive drilling and grouting program implemented in the DRM zone. Such voids are expected to be of a much smaller scale of those encountered in pressure shafts 1 and 2. Figure 11 shows images of boreholes in which voids are clearly visible.

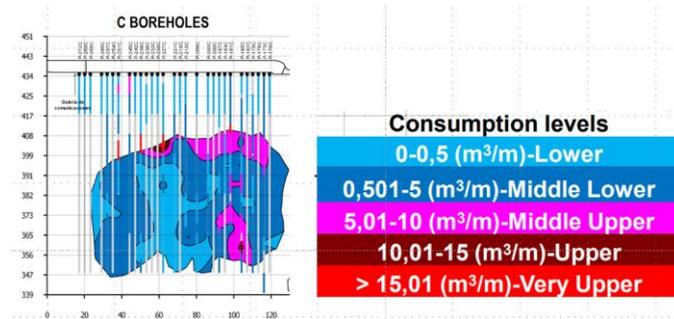
Fig. 12: Grout absorptions in the investigation boreholes

Grouting has identified zones of different grout consumption levels<sup>3</sup> (Figure 12). Absorptions above 5 m<sup>3</sup>/m can only be associated with large voids, absorptions up to 0.5 m<sup>3</sup>/m can be representative of jointed rock mass of negligible or minor disturbance.

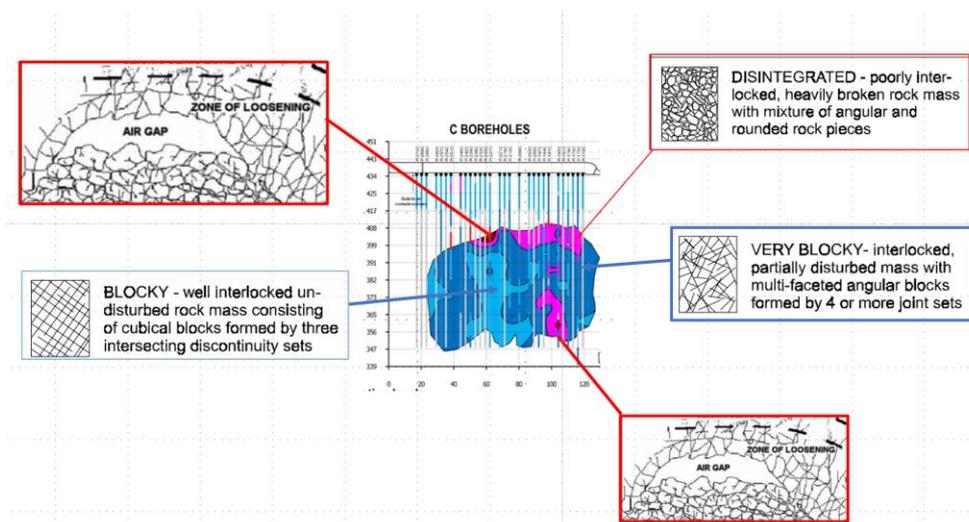
Figure 13: Conceptual model of the Disturbed Rock Mass

It seems plausible that the mechanism of failure, certainly associated with the dynamic forces during uncontrolled water discharge, can be described as a progressive movement of the rock mass disturbance upwards under the effect of gravity until the effects reached the *Romerito* area and produced the landslide.

The postulated failure mechanism has implications on the nature of the DRM. It is expected that large voids exist in the upper part and in the lower part of the DRM. Such voids are not expected to extend to the rest of the DRM, which should feature various degrees of disturbance, from disintegrated in the vicinity of the voids, to blocky and very blocky, with discontinuities of variable openings: more open in the vicinity of the borders, closer in the inner, vaster, part of the volume. Fig. 13 illustrated a conceptual model of the DRM based on the above considerations.

Permeation grouting should be carried out radially, from inside the shaft conduits while they are rehabilitated. Given the inevitable uncertainties associated with the volume of the DRM, the IAP recommends adopting systematic grouting patterns.

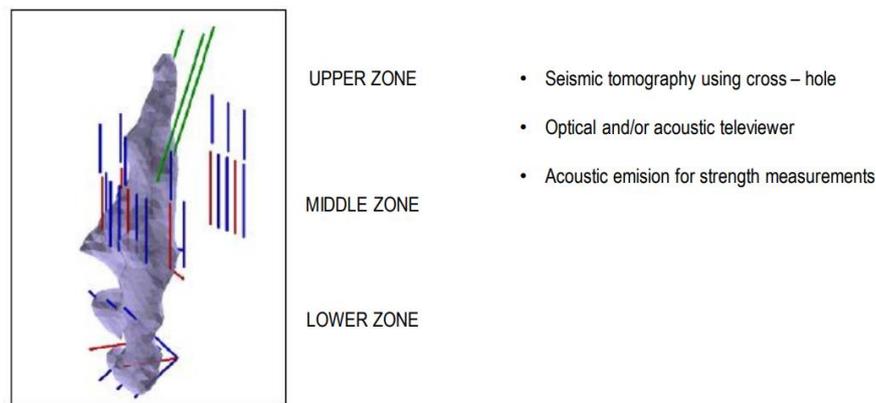
*Fig 15: Geophysical investigations planned to assess quality of the grouting works*

To check grouting's effectiveness, a series of geophysical investigations are planned (figure 15). IAP concurs noting that inclined boreholes will also be used. Drilling core will be collected, and water pressure tests performed.

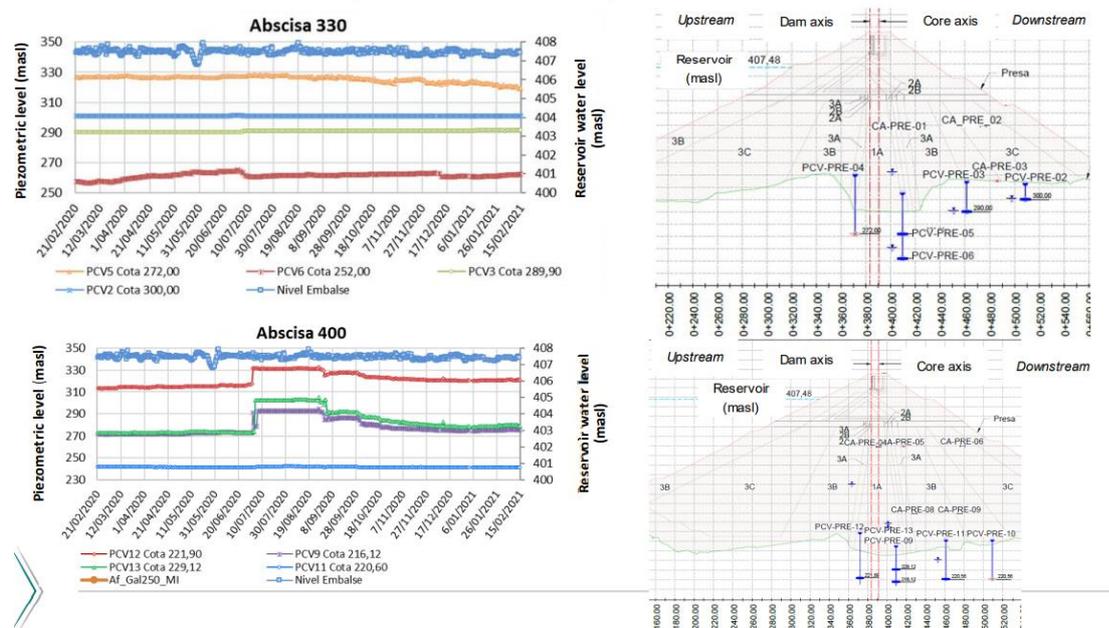
Figure 21: Foundation piezometers

Foundation piezometers indicate a good performance of the grout curtain, with low elevations of the piezometric line. Variations in the readings of some piezometers at chainage 400 have been attributed to the grouting performed from gallery at el. 250 towards the deep curtain. In the section at ch. 330, two piezometers show levels that would imply a flow in the upstream direction (fig. 21). Since this cannot be real, a check should be done.

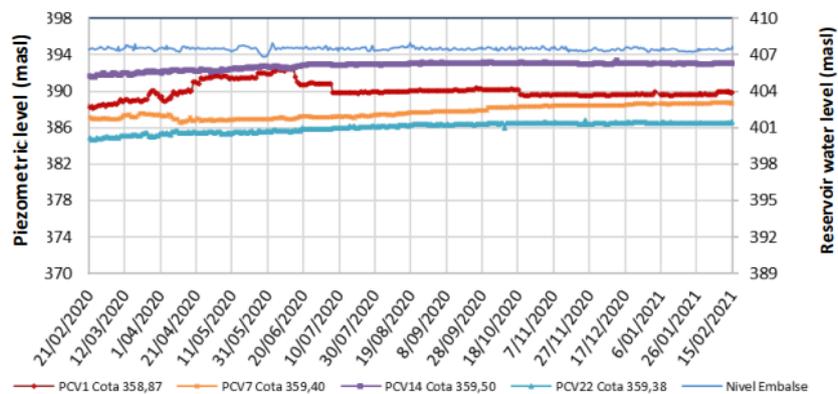
Figure 22: Piezometers downstream of impervious core

The piezometers in the dam body show good behaviour in relation with the reservoir level (fig. 22). No abnormal changes were observed that could be associated with deficiencies of

the transition zone next to the core, or the integrity of the core. An anomaly presented in the readings of one of the piezometers went back to normal (fig. 22). Piezometric readings also indicate good performance of the priority fill (fig. 23).

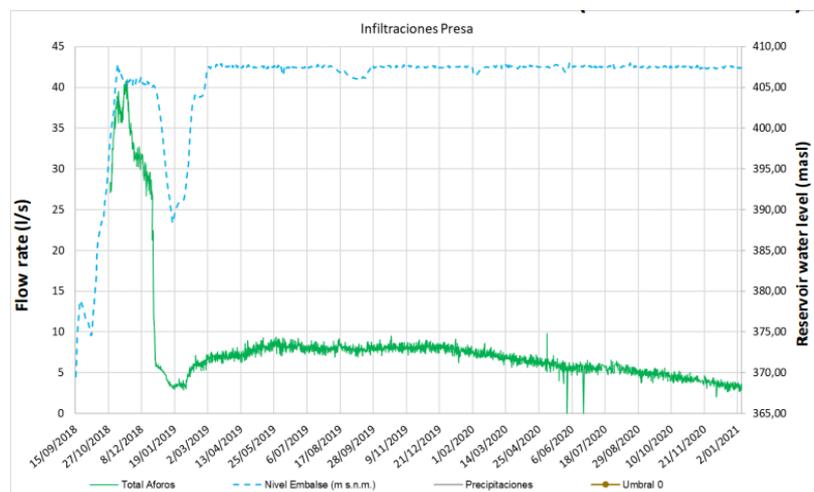
Fig. 24: Seepage rates and reservoir levels

As shown in fig. 24, seepage rates through the dam body are very low. Seepage reduced from 40 to 2.9 l/s after the construction of the diaphragm wall. Another proof of the diaphragm's effectiveness. 2.9 l/sec is the rate recorded on February 23<sup>rd</sup>, with reservoir level at 407, 31 m. asl.

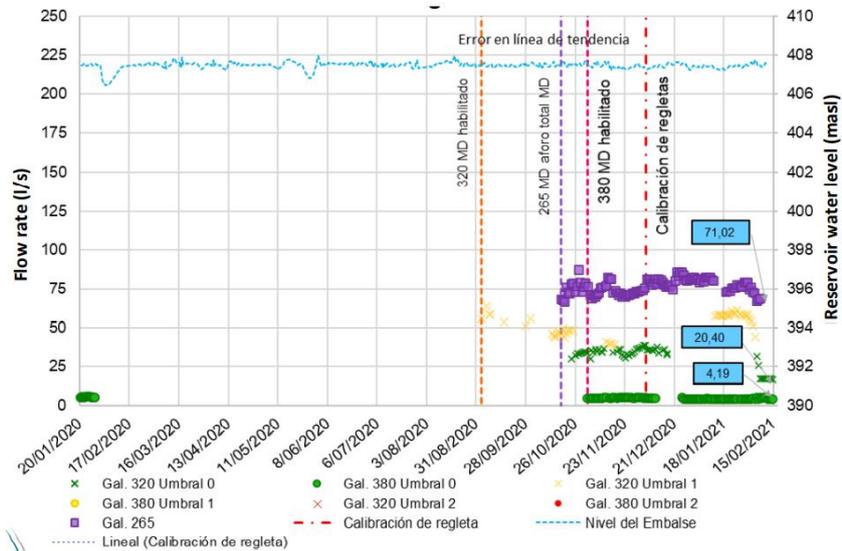
Figure 25: Seepage flows in the right abutment

In the left abutment, where additional grouting was undertaken, overall seepage is about 45 l/sec. In the absence of turbidity, the IAP considers the recorded flow acceptable. In the right abutment, total seepage went gradually up to 100 l/s since October 2020, which is higher than previously reported (fig. 25). The Designer should assess the situation to determine whether additional grouting is required. The assessment should consider the spatial distribution of the seepage locations i.e., localized or distributed.

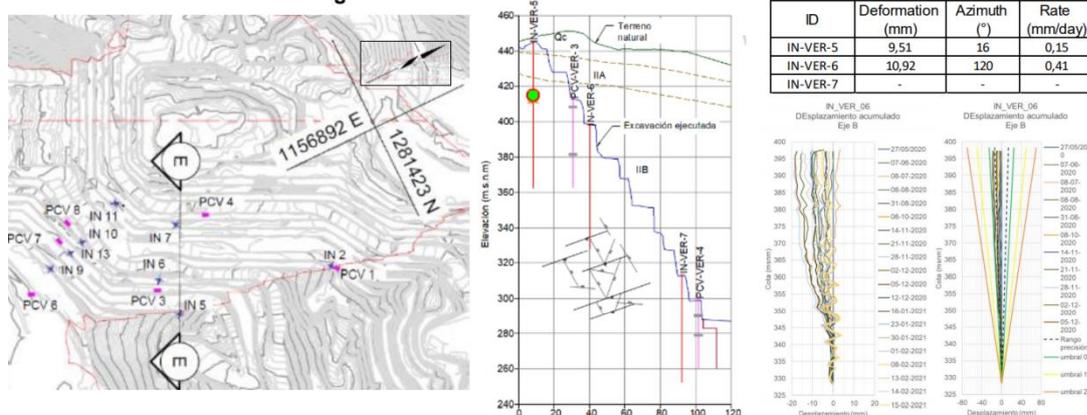
Figure 26: Plunge Pool inclinometers - Section E

The monitoring system continues showing satisfactory slope performance. The plunge pool's geometry is designed to perform over the life of the project, and there is no evidence of abnormal conditions. From existing data, the rock mass at the pool is sound with few main discontinuities. The IAP concurs with the monitoring programme of the plunge pool's slopes and surroundings, which should be permanent. The displacements from the inclinometers are below those anticipated. The form of movements, shown in some of the inclinometer graphs, cannot be attributed to ground displacement because the movements should not start from the bottom of the inclinometer pipe. They are likely imputable to exogenous reasons (fig. 26).

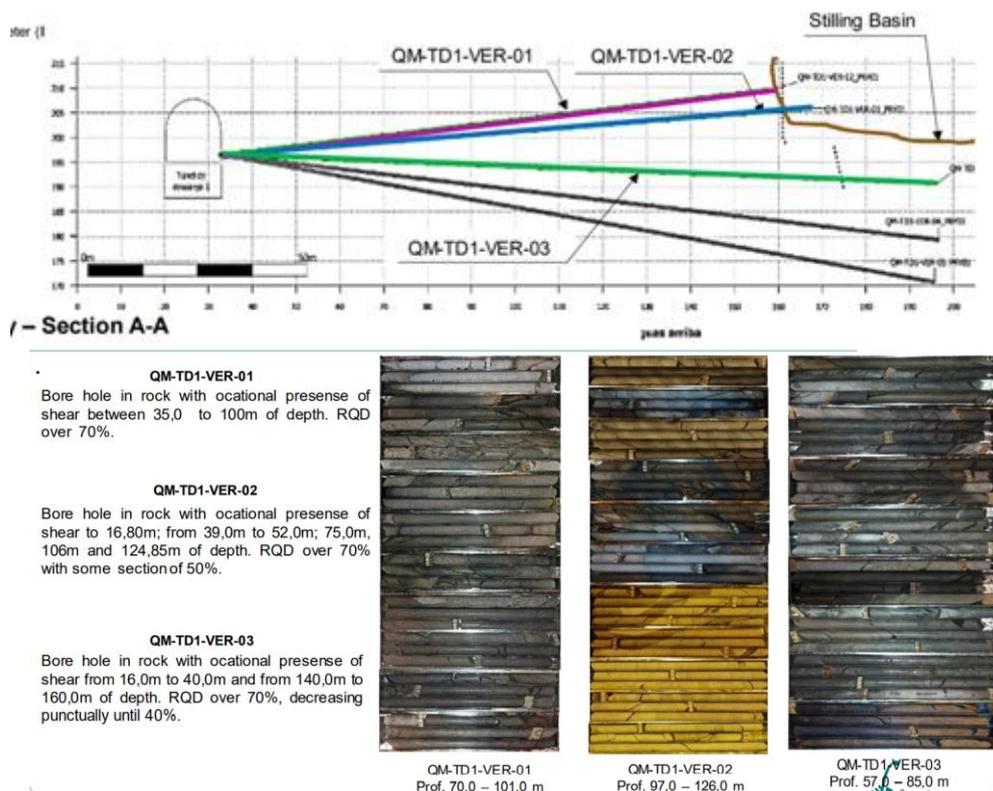
Figure 28: Rock mass quality in the plunge pool area

Boreholes drilled in the vicinity of the plunge pool's border do not indicate excessive scouring. Their cores show a good quality rock mass (fig. 28).

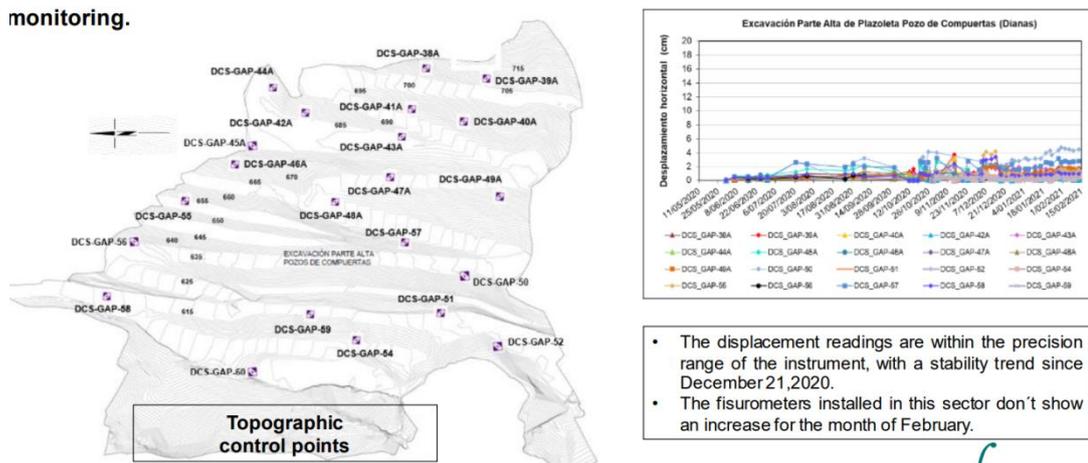
Figure 30: Slope above the intakes. Topographic monitoring

This is the slope over the platform of the intakes, including the *Romerito* collapse area. Excavation and stabilization work of the high part of the slope, down to elevation 570, is almost complete (fig. 29). Instrumentation continues to show an overall satisfactory performance of the slope (fig. 30).

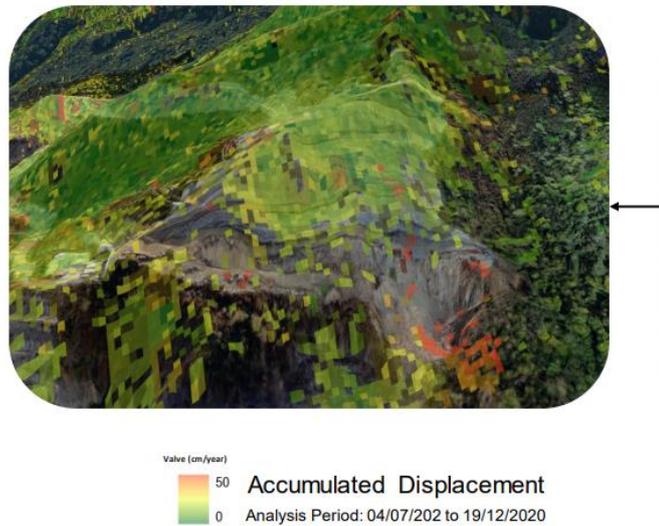
Figure 32: Satellite monitoring, July-December 2020.  
Red points represent accumulated displacement up to 4 cm.

Satellite monitoring of the area showed some accumulated displacements in the lower, upstream part of the slopes (fig. 32). The morphology of this location is not in favor of displacement. Installation of surface monuments is recommended to follow the evolution of the movements.

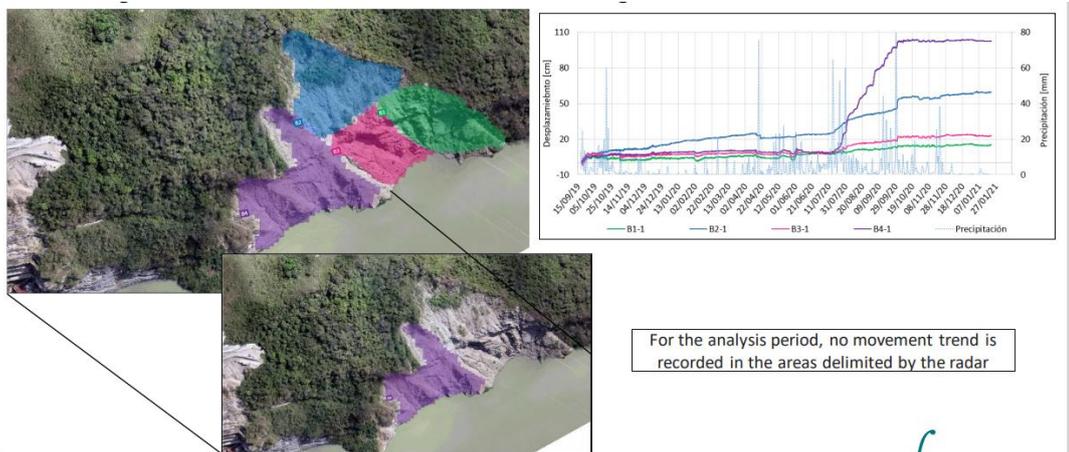
Figure 33: The upstream right-side slope. Radar monitoring.

This slope is situated over the diversion works which was disturbed by the landslide in May 2018. The slope shows detachment of surface material from the upper part, left side as seen from the reservoir. These detachments, which correspond to a regression of the limits of the disturbed zone, have been detected by radar monitoring (fig. 33).

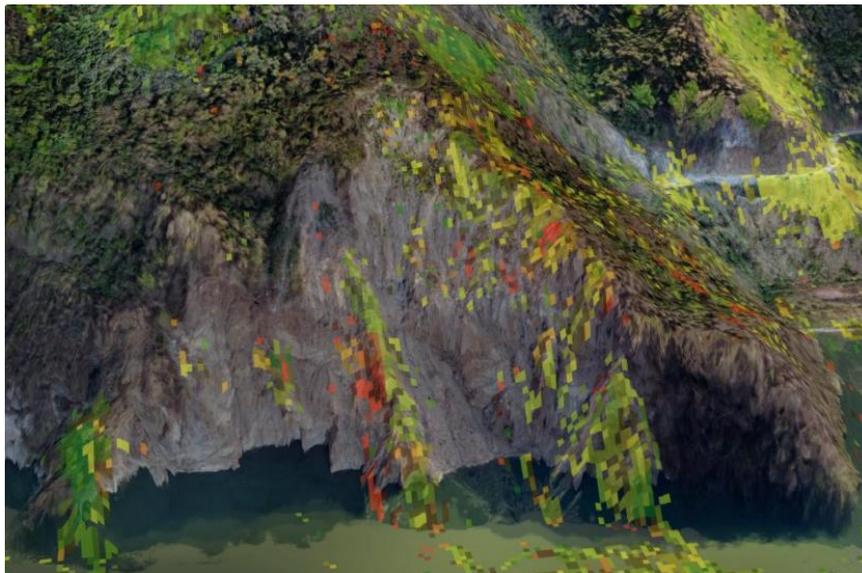
Figure 35: The upstream right-side slope. Satellite monitoring. Red points correspond to displacements.

Recent radar monitoring shows a stable condition for the whole disturbed mass. However, the presence of concave sections, and satellite monitoring indicating several “red dots”, possibly associated with displacements (fig. 35), suggest that erosion could still progress inside the disturbed slope. That could be triggered by a storm and put at risk the entire slope by undercutting it. The IAP recommends that surface monitoring is undertaken with permanent interpretation of measurements.

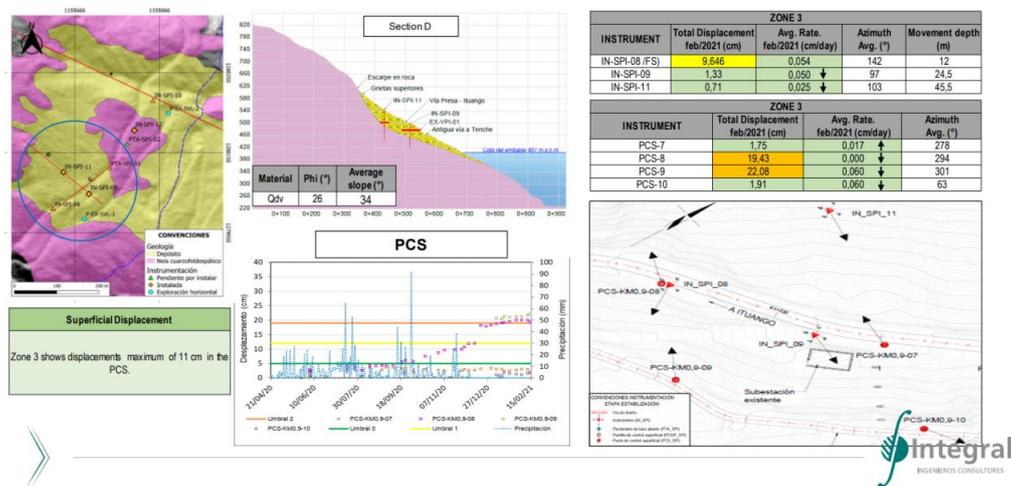
Figure 36: Left side of the reservoir. Area of questionable stability, 0+900 – 1+300

Site investigation is ongoing between km. 900 and 1+300 of the diversion road on the left side of the reservoir. The beds of the gneissic schist dip into the slope in its high parts, which is a favorable element. At the same time, the morphology of the area indicates a potential for rotational slope failure. The three inclinometers, although relatively close to each other, show big differences of the sliding surface depth: 12 - 24.5 - 45.5m respectively. The few piezometers are reported not to have encountered ground water (fig. 36).

IAP believes that additional instrumentation should be installed, and a parametric stability analysis performed using reasonable soil properties. Surface signs of ruptures/ tension cracks should be mapped.

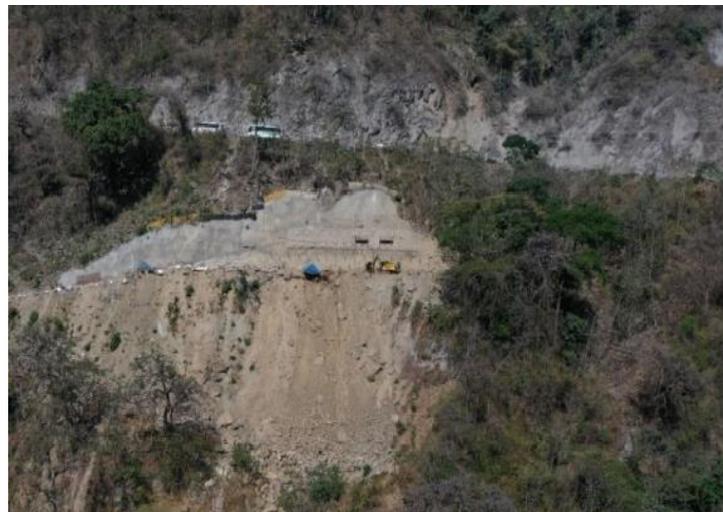
Figure 37: Ongoing slope reinforcement works

The IAP agrees with the ongoing reinforcement measures, that feature the anchoring of the slope over the lower road, which retains the upper one (fig. 37). A drainage ditch to intercept and drain the surface water away from the instable areas, should be foreseen.

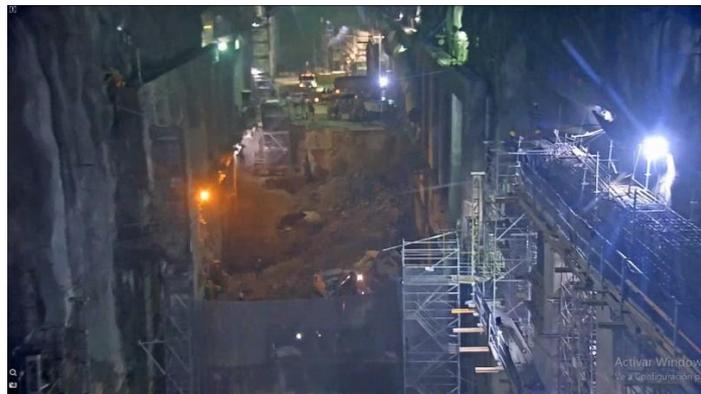
At the end of 2019, the lowest parts of the units 1 to 4 and corresponding first and second phase concretes were finally assessed to be unsuitable for any remedial action. Rehabilitation of units 1 to 4 therefore started from first phase concrete.

*Figure 43: Unit 3 and 4 demolition of concretes*

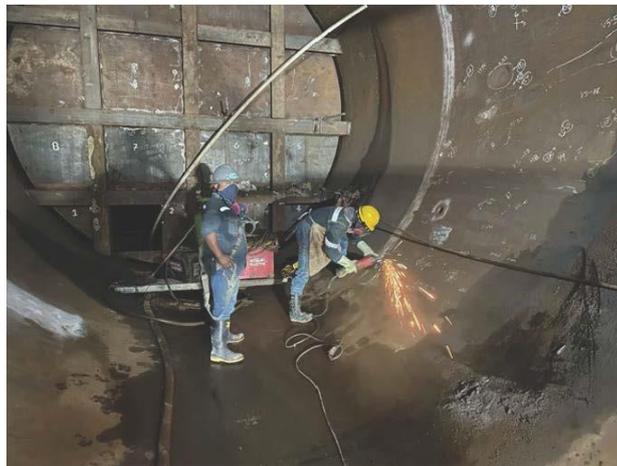
Figure 54: Lower elbow: steel lining repairing
