Independent Advisory Panel to IDB Invest

IAP Report N°6, July 2021

Ituango Hydropower Project

Colombia

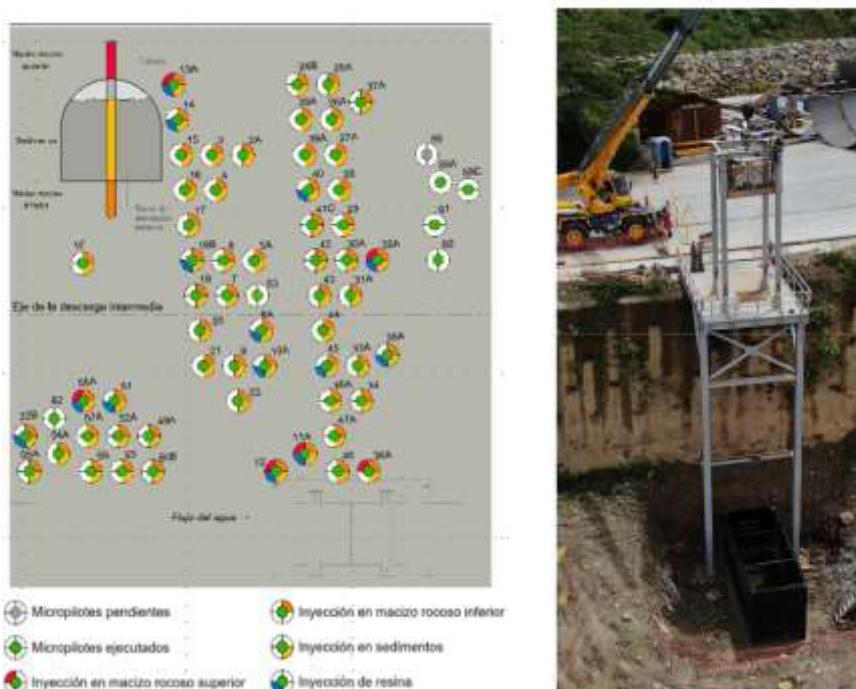
Figure 3: Micro piles and structure for testing the launching of the plastic spheres

To date, all the 63 micro piles have been installed, 58 of which fully grouted (figure 3). The 9 additional piles had to be installed to minimise gaps associated with piles' deviations from the vertical.

A dedicated steel structure (figure 3) has been built to test the launch of the plastic spheres that will be floated to be trapped by the steel piles grid to clog the upper part of the TD2,

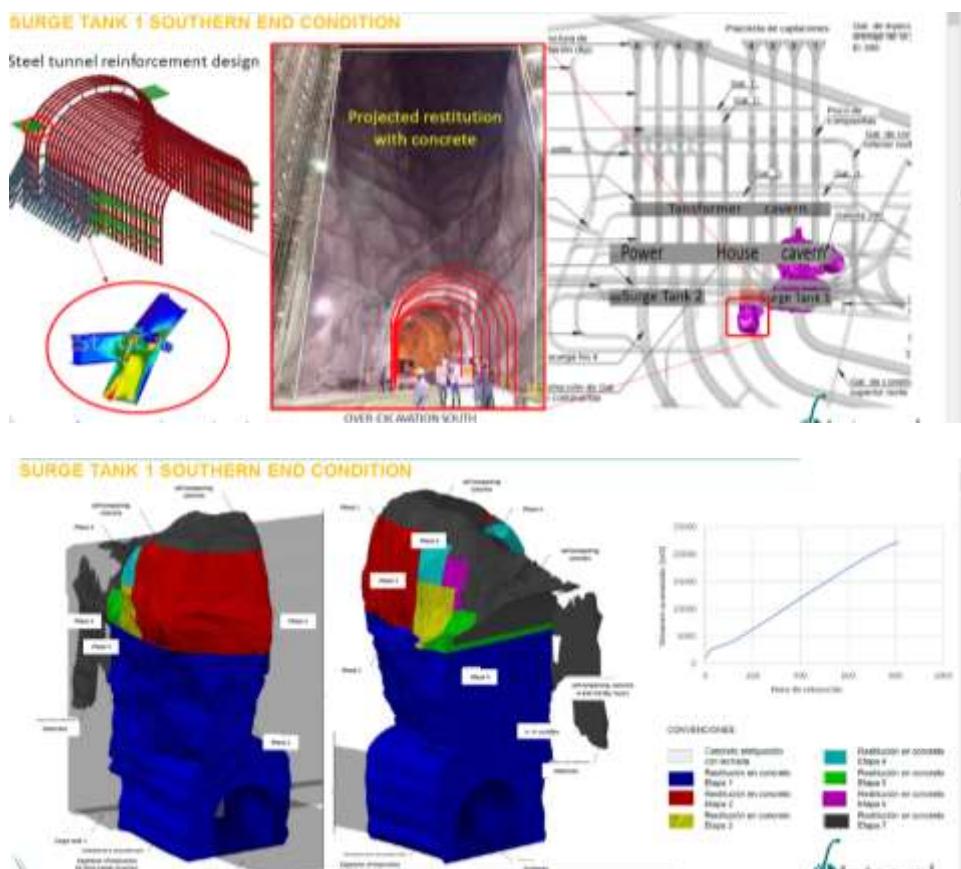
Figure 9: Massive cavity backfilling in surge tank 1

Rock mass strengthening is proceeding satisfactorily. Massive cavity filling with concrete (fig. 9) is in advanced status of implementation in the surge shafts. Backfilling is the appropriate measure for reinstating continuity of the hydraulic works.

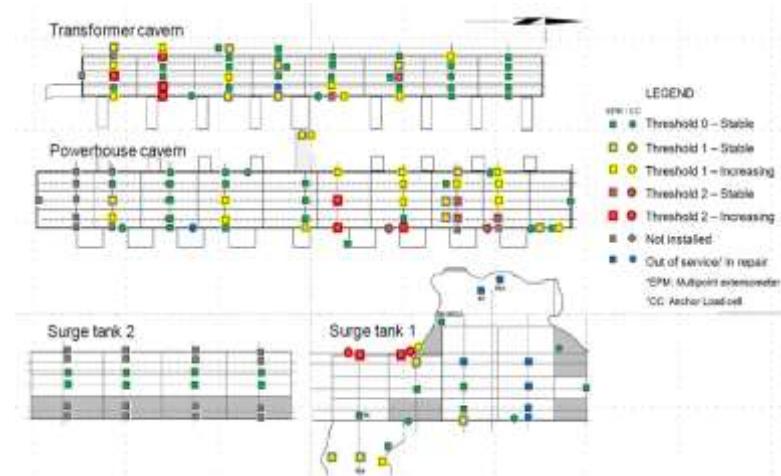
Figure 10: Extensometer readings

A few extensometers do not show achievement of full equilibrium (see fig. 10). Detailed review of future trends might suggest the need of additional rock mass reinforcement.

Measurement interpretation uses three reference “Thresholds: 0, 1, and 2”; the IAP is not privy to such thresholds and would like to know about them.

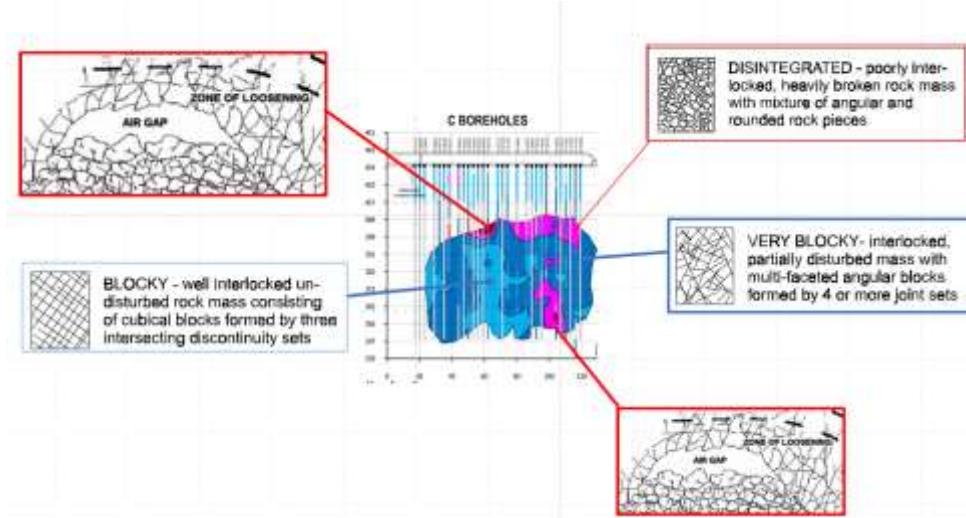
Figure 11: Conceptual model of the Disturbed Rock Mass

them can be explained by a low total core recovery, not necessarily associated with voids. Also, a major part of the surrounding is just jointed rock mass. This is clear comparing the recorded grout consumptions with those anticipated. A good number of inclined check holes will be necessary to confirm that strengthening and filling works are acceptable.

It should be expected that, as excavation works reveal the actual rock mass conditions, some areas showing instability or excessive damage will require special reinforcement and/or concrete backfill. The characteristics of such areas will have to be considered in the design of the shafts' permanent lining.

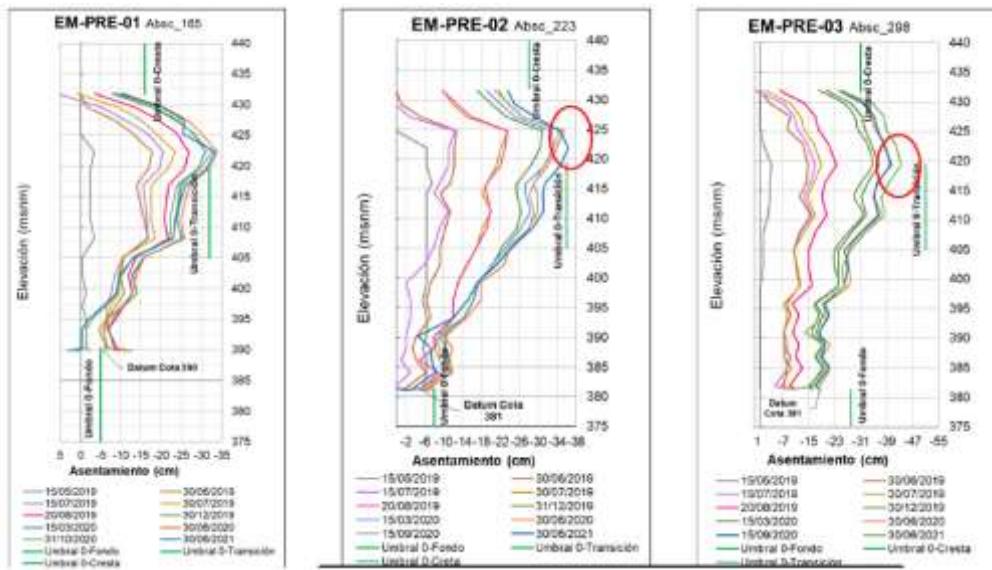
Figure 12: Magnetic extensometers: Vertical settlement in the D-wall

Magnetic extensometers indicate stable vertical settlements of the D-wall (figure 12). These instruments have been showing values below the accuracy range of the devices (2,5 to 10 mm) since the completion of dam's construction.

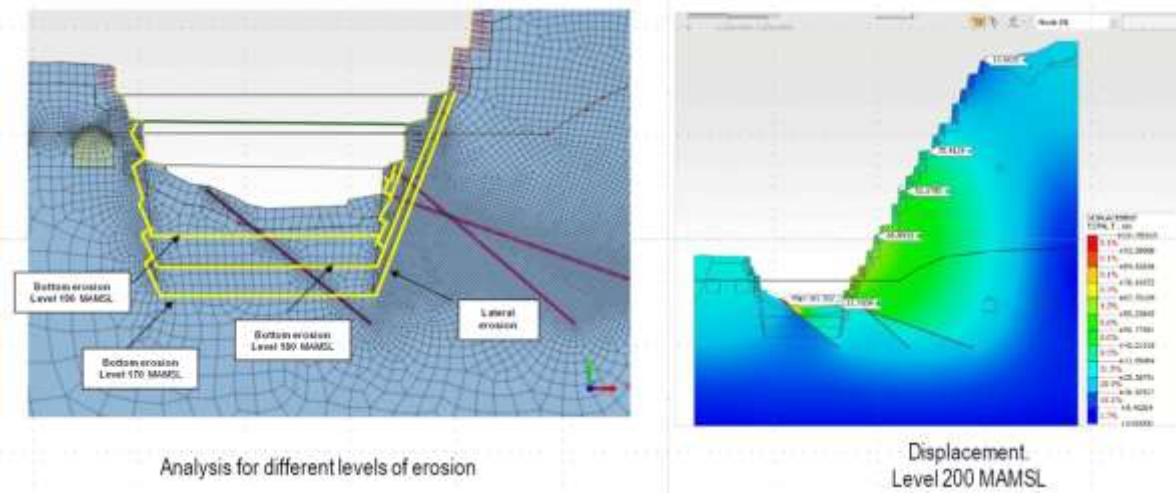
Figure 13: Slope stability analysis – Profile A-A

Slope stability analyses have been conducted with a finite element code using a strength reduction factor (SRF). The meshing seems adequate; however, the full dimensions of the model are not obvious. If that shown in fig. 13 represents the total FEM model, it is possible that the boundaries may be affecting the results.

High pore pressures, that could denote a more unfavourable condition, do not seem to exist. The IAP assumes that seismic conditions were also checked and would like to be briefed about them in the next visit.

Although Profile B-B suggests a more favourable case compared to Profile A-A, with respect to slope height, and this is observed in the resulting displacements, the SRF values for both profiles are identical. The adopted SRF values appear to be quite high, especially for profile A-A. The matter deserves clarification.

For the "Extreme condition - Level 170 m.asl" of Profile B-B, the presented results are identical to those of Profile A-A and not matching with the rest of the results of Profile B-B. It is likely to be a typo.

It would also be useful to show the maximum shear strain contours, at the critical SRF, that are indicative of the critical failure surface.

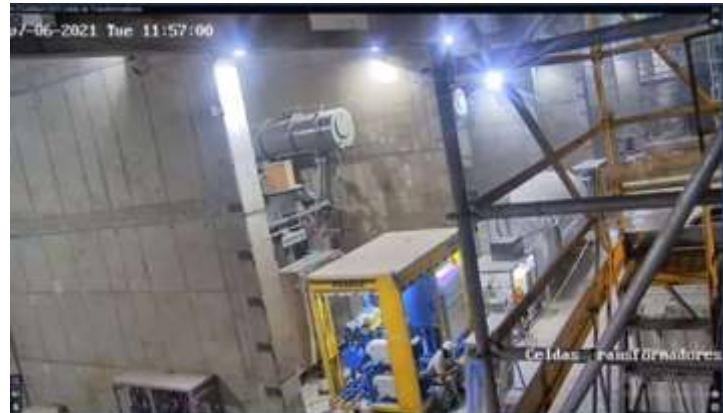
Figure 15: Single-phase transformers 5 and 6

Currently, 6 transformers are in their final positions; 4 of them were in place in February 2021.

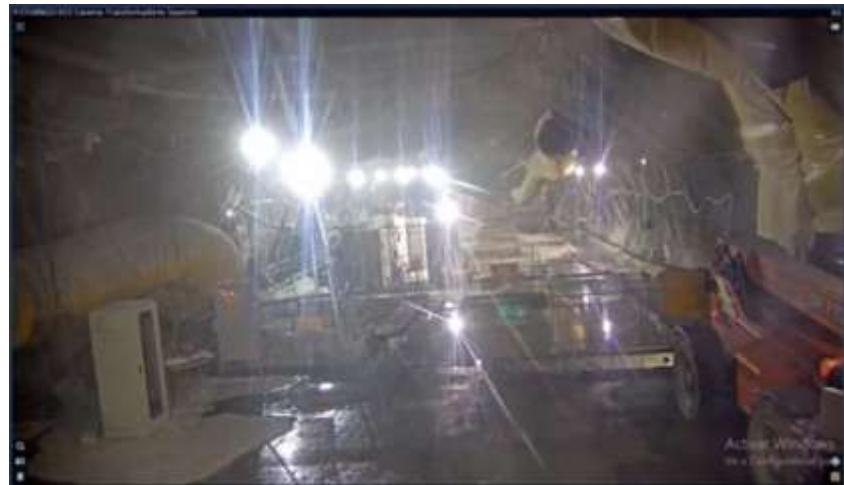
Figure 17: Ongoing civil works at the cable gallery before installation of cable trays

Consolidation of civil works are still ongoing on the southern part of the transformer gallery and in the cable gallery above it.

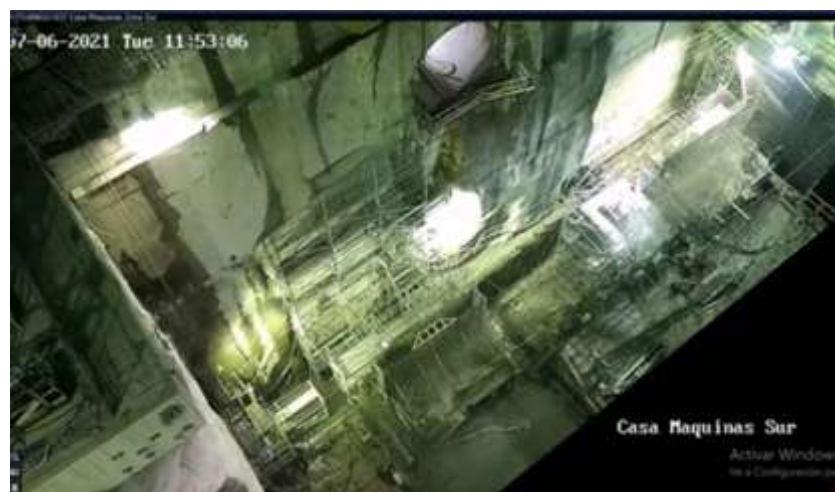
Figure 24: Concrete demolition at units 3 and 4

Rehabilitation of units 1 and 2 started from first phase concrete. Complete removal of units 3 and 4 concrete is ongoing.

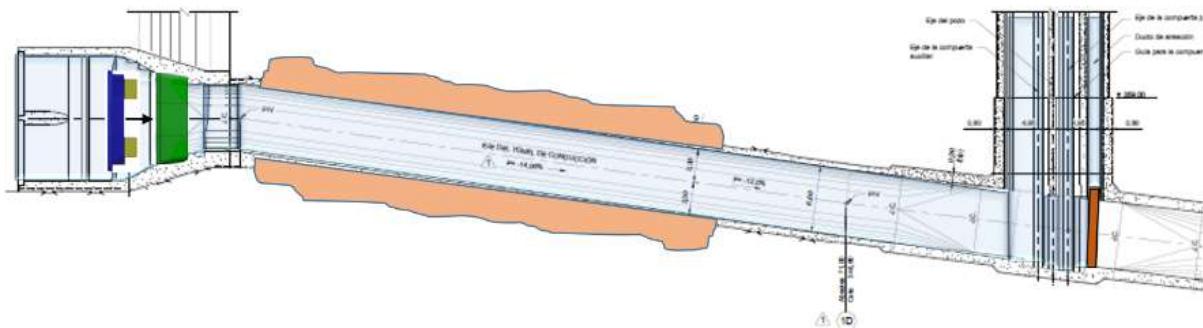
Figure 30: The 20 m unfinished concrete lining of Power intake 2

The works to be executed are complex and specialised (fig. 29 and 30). Management of unforeseen conditions is a key factor in underwater works. In the IAP's view, this is the most challenging activity for the commencement of operation of units 1 and 2.

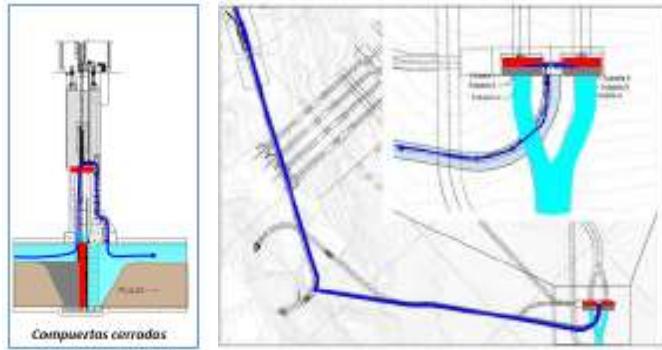
Figure 42: GAD gates in their final position with temporary direct by-pass system (left) and through the IDG (right)

The two GAD vertical sliding gates were successfully lowered in February 2020. A concrete plug was placed on the top of the gates to block any movement (with such installation the tunnel is technically plugged) and the lifting systems and cranes were removed and utilized elsewhere. Two temporary by-passes are installed (fig. 42) to alleviate the reservoir pressure on the gates and to further increase safety until the permanent plugging of GAD will be built. One by-pass is direct (currently operated), the other is routed through the IDG (it will be operated at the time of plugging the GAD). After successful plugging of the GAD, the gate control chamber will be abandoned.
