Independent Advisory Panel to IDB Invest
IAP Report N° 1, September 2018

Ituango Hydropower Project
Colombia

The emergency-originating event was a collapse of the tunnel with a sinkhole that obstructed the river diversion tunnel (GAD). The collapse was caused by the interaction of water with the rock mass. It is most likely that local unevenness of the lining, due to the rock mass structure and, possibly, very weak rock in the area over the tunnel, which went undetected during excavation, may have favored rapid propagation of localized erosion and, consequently, progressive failure. The subsequent mass movements, that took place in different parts of the waterways, were a consequence of the uncontrolled flow of water through interconnected galleries, some of which were never intended for conducting water.

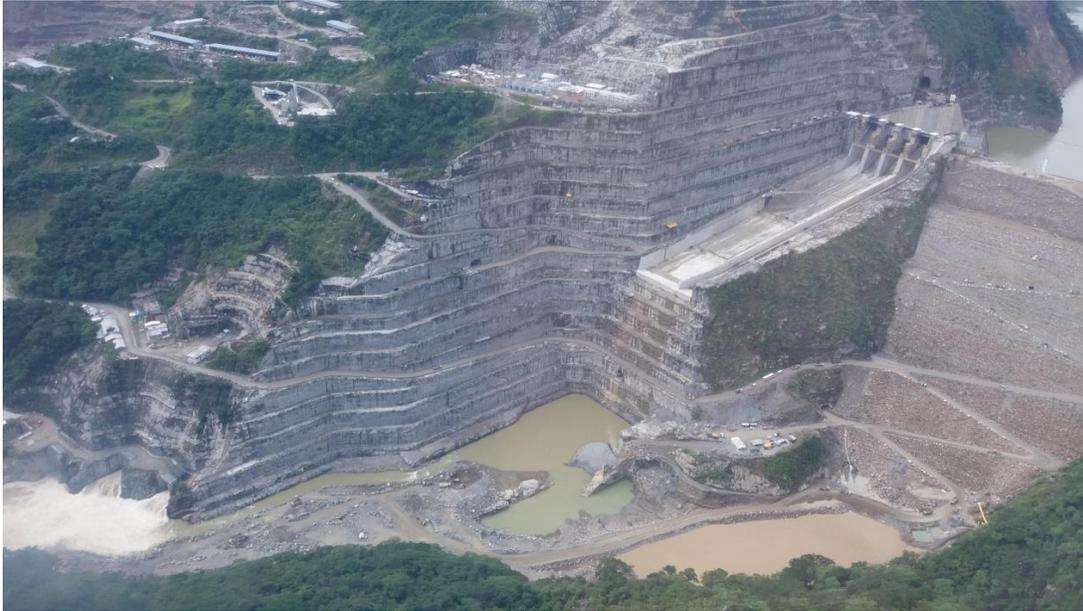
The good quality of the gneissic rock mass can be observed, at both small and large scale, on the spillway's cuts as modeled and exposed after the removal of the distressed zone and the

Figure No.9: Sound and good rock mass under the distressed zone on slope. Cuts for the spillway. Photo on the 3rd of August from the helicopter.

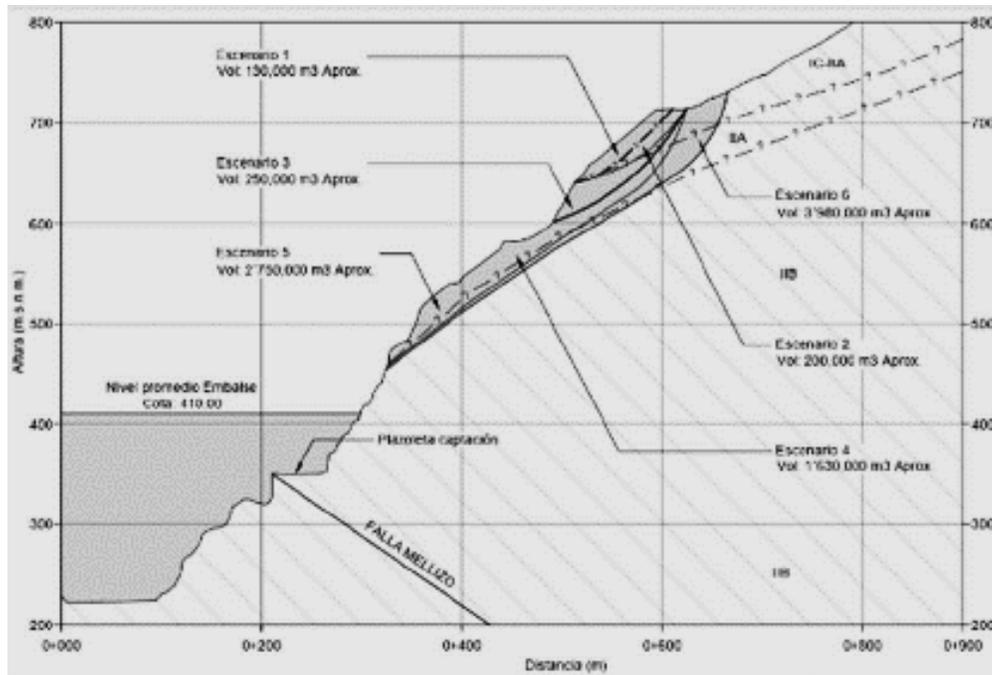
To investigate possible failure modes and associated volumes, the Designer undertook two types of analyses for the “El Romerito” landslide zone: deterministic and probabilistic. Figure No. 14 illustrates the sliding surface scenarios considered.

- shallow surfaces, practically within the superficial soil mantle (scenarios 1 to 3), and
- deeper surfaces passing through the underlying weathered and distressed rock mass (scenarios 4 to 6).

Although not familiar with this type of analysis, the IAP understand that it is a crude estimation of the potential extent of landslide movements, which are qualitatively compared to field evidence. Based on this comparison, the Designer considers that the possibility of a deeper failure, involving significant part of the weathered bedrock, is negligible. This conclusion has to be validated considering the current equilibrium state and future slope movements (if any). Involvement of a larger mass could manifest at a later stage, due to creep movements and gradual transition to residual shear strength of materials.

Figure No.14: Section from the analyses of the “El Romerito” landslide (June 2018 Designer Report “Diagnostico Geológico Geotécnico de la Contingencia”)

- The methodology for defining and examining failure surfaces per scenario is not clear in the report. The available images illustrate one representative failure surface for each scenario, together with some sets of very different failure surfaces. The IAP suggests focusing the sensitivity analyses on surfaces similar to the representative one. This can be done either by drawing more surfaces or by using the optimization tool of the software. The particular tool makes geometrical

- The IAP regards too large the difference between failure probabilities of scenario 1 and scenarios 2 - 3. The Designer should check whether in scenarios 2 and 3 the lower and outer part of the considered failure surface is in weathered rock, which would drastically improve the safety factor in case the software does not have the “freedom” to adjust surfaces as mentioned above.
- Combined surfaces extending within both soil and rock should also be considered. It is not clear why wedge-type failure has been checked for only one specific slope.

Finally, the IAP recommends the execution of a couple of boreholes, in the “El Romerito” area, in places where access is possible, to reduce uncertainties and inform the design of the protection measures.

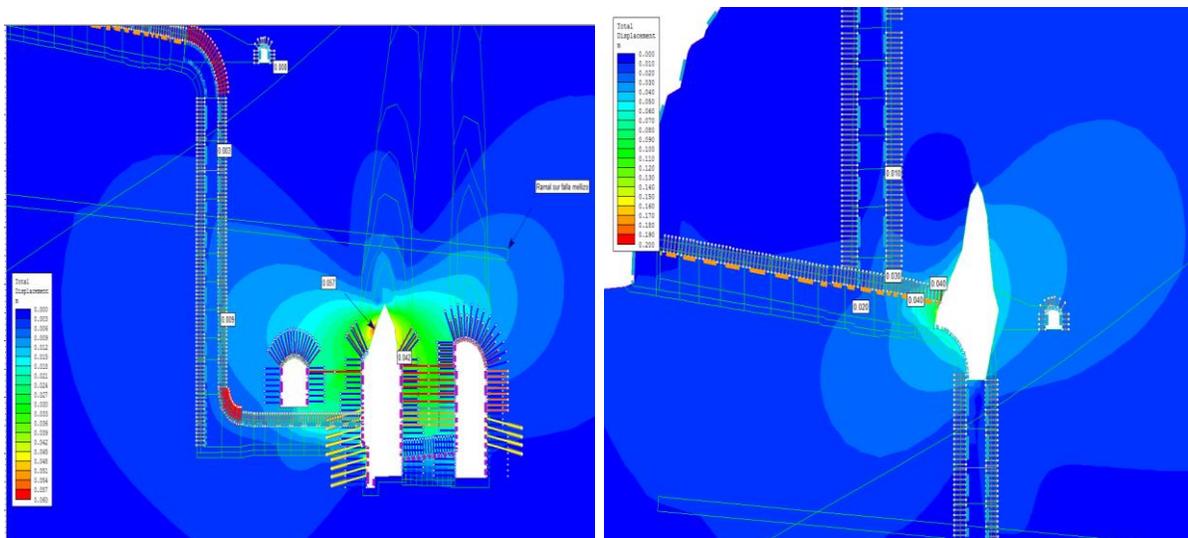
Based on experience, and given the quality of the gneissic rock mass, the IAP reckons that damage to the cavern, caused by the water flows and pressure oscillations, can be in the form of block and wedge detachments of different sizes. This was also recognized by the Designer (Diagnóstico Geológico Geotécnico de la contingencia, Junio 2018) and reported by the advisors (Prof. Gabriel Fernández, June 2018, ppt, 2018).

The FEM analyses (see Figure No.16) show that any extended collapse is not likely to affect the stability of the parietal slope and adjacent access tunnel.

Figure No.16: Global stability of the caverns and possible influence to the parietal slope (from the Designer report, “Diagnóstico Geológico Geotécnico de la Contingencia” June 2018)

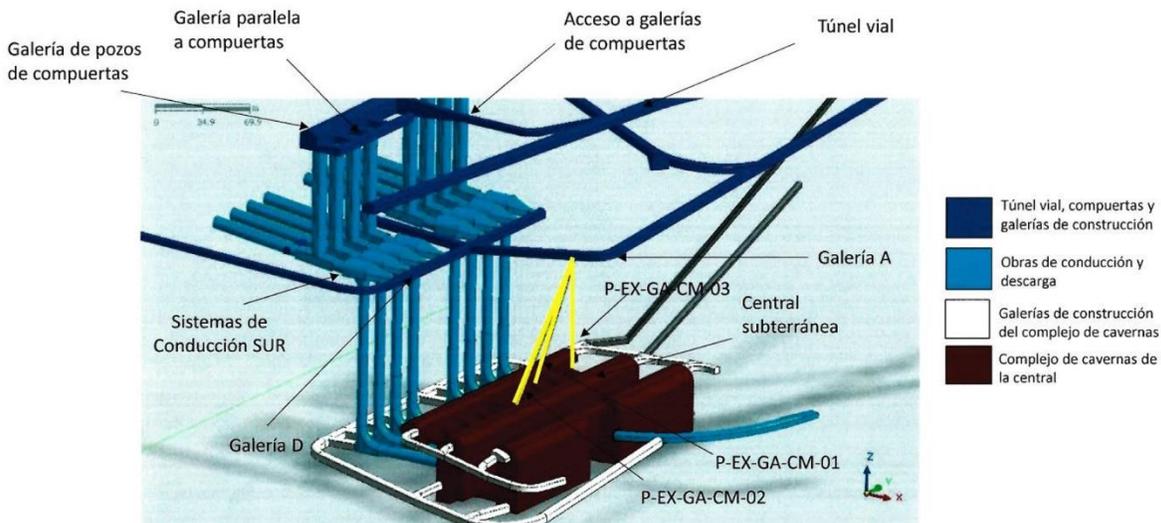
PERFORACIONES EXPLORATORIAS Gal A – CM

In September 2018, EPM drilled three boreholes from Galeria A with the objective of crossing a sizeable area of rock mass above the crown of the powerhouse cavern. The following figure shows the location of the three boreholes which were fully core recovered.

Figure No.17: Exploratory boreholes in the powerhouse roof area

In all three holes, core recovery was 100%; RQD was generally between 60 and 70%, with values of 80% in proximity of the cavern roof; no water losses occurred any time during drilling. Such observations indicate that the rock mass has not been disturbed, over the cavern, in the investigated location. Not even in the zone crossed by the Mellizo Fault (borehole 03). Borehole 02 pierced the cavern roof and was able to sample 20 cm of shotcrete lining to the cavern roof (see Figure No.18).

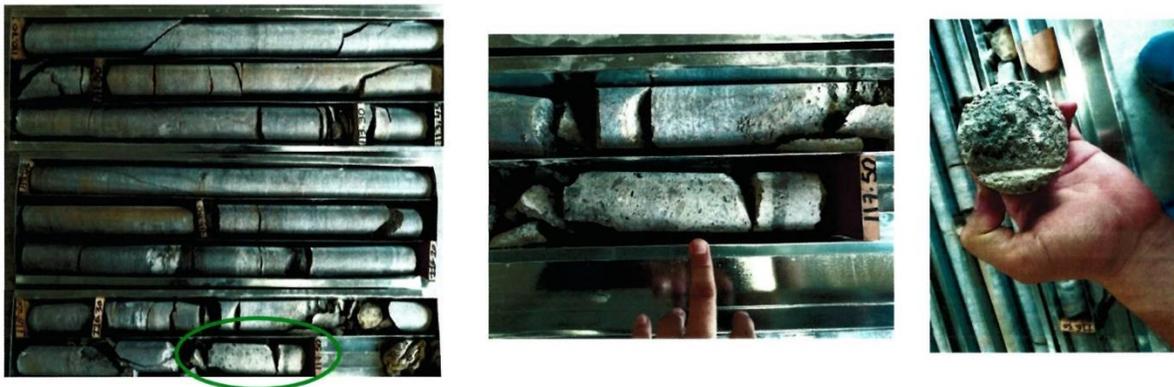
P-EX-GA-CM-02 (Gal A – CM – Sistema de conducción 5)

Figure No.18: Borehole 02 recovering shotcrete sample for roof lining

Information provided by the three holes is positive but, as normal with boreholes, is localized. However, given the good quality of the rock mass and the size of structures, it is very unlikely that extended or general collapse took place in the cavern of the Powerhouse. EPM is continuing exploratory drilling, which will add valuable information before direct inspection of the cavern will allow to draw a final assessment of the underground conditions.

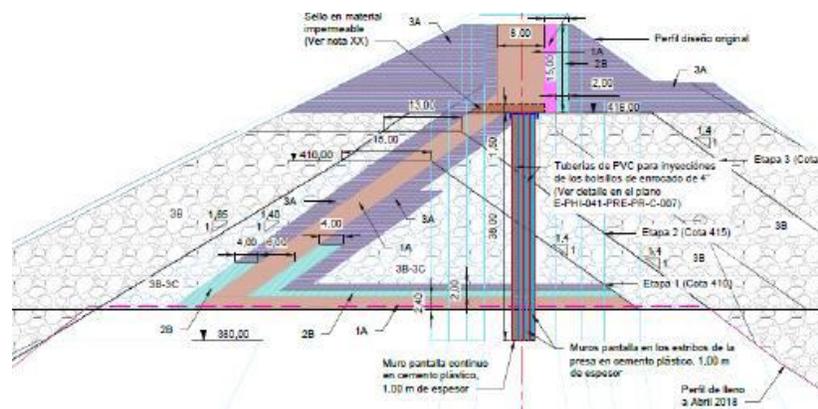
Dam zoning was modified, above el. 385 m asl, to speed up embankment rising during emergency response. A plastic diaphragm is being constructed to improve water tightness of the zone (see Figure No.21).

Figure No.21: Priority Embankment design

The Designer is investigating the global stability of that part of the dam (Diagnóstico Geológico Geotécnico de la Contingencia, June 2018).
