**Independent Advisory Panel to IDB Invest
IAP Report N° 2, April 2019**

**Ituango Hydropower Project
Colombia**

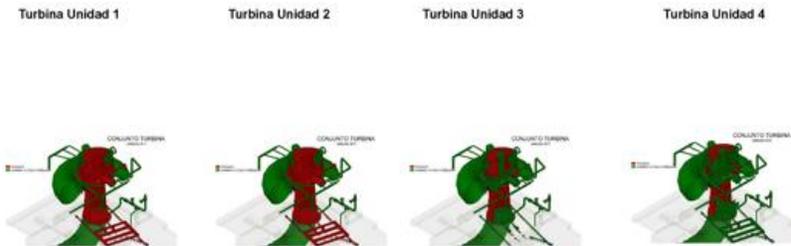
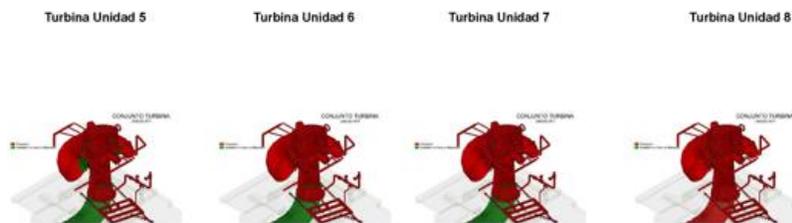
Figure No.9: Progress in the installation at the time of flooding

At the time of the Power House flooding the progress of the installation of the lowest part of the units was as shown in the following figure (green color shows installed equipment).

Installation of the north side turbines was well advanced, especially Unit 4 and 3 that were to be commissioned first.

Unit 2 is in bad conditions and Unit 1 is the most affected. Situation of the draft tubes are little known, and their situation should depend on the length of time the flow of water needed to find an alternative way to flow through the tailrace tunnel.

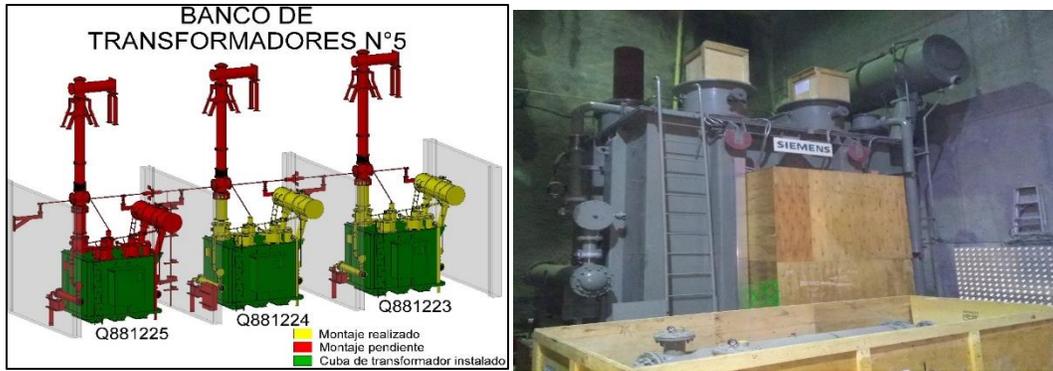
Figure No.11: Progress in the installation of the transformers at the time of flooding

Two single-phase transformers of the south powerhouse were in similar conditions, 4 were in transport condition (with nitrogen) while 6 are currently in standby in a Colombian port.

Preliminary visual investigation by EPM did not remark any sign of losses of oil from the transformers and excepting the presence of thin debris in the transformer cavern no damages to this area was reported.
