**Independent Advisory Panel to IDB Invest**  
**IAP Report N°4, June 2020**  
**Ituango Hydropower Project**  
**Colombia**

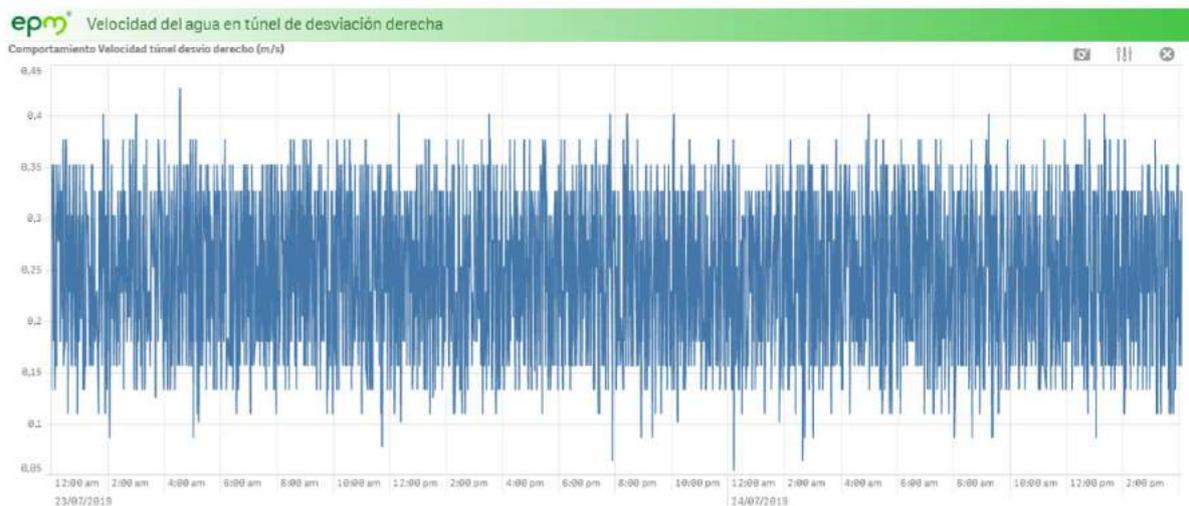
Fig. 2: Water velocity in the right diversion tunnel (DT2): real time monitoring

The alert condition for the downstream population is still at yellow-level and will remain such until the GAD and DT2 are definitively plugged. Comprehensive monitoring provides confidence that safety is under control. Figure 2 below is a case in point. It shows the water velocity through the DT2, in real time.

Any change in the velocity pattern would signal a potential deterioration of the existing plugs and the early warning measures could be adopted.

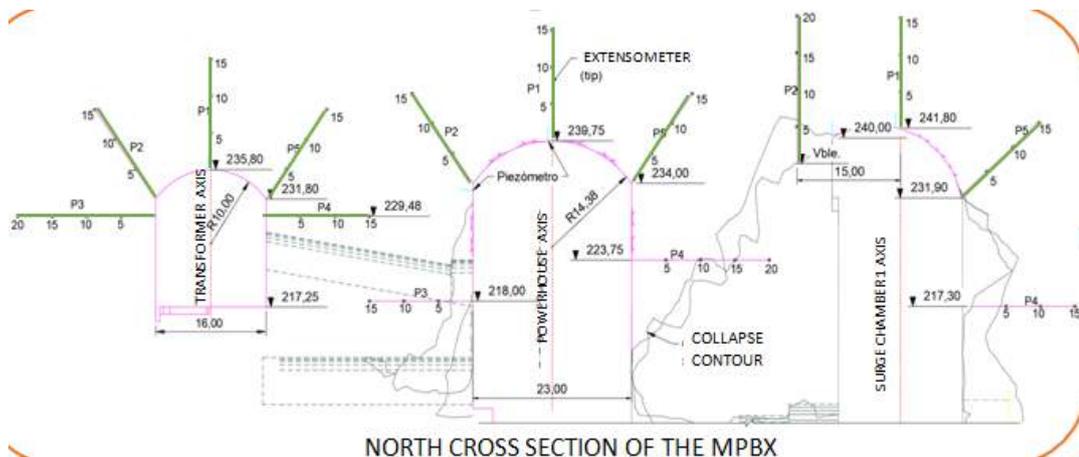
Figure 6 Powerhouse complex. Multipoint borehole extensometers

The major underground openings are fully instrumented (fig. 6). Most extensometers and other instruments show stable trends, indicating that the interior of the rock mass is not disturbed.

In few places slight deformations have been recorded. Reportedly, the largest displacements (5mm) have been recorded at specific locations where major interventions took place. That is evident from the orange line in fig. 7.

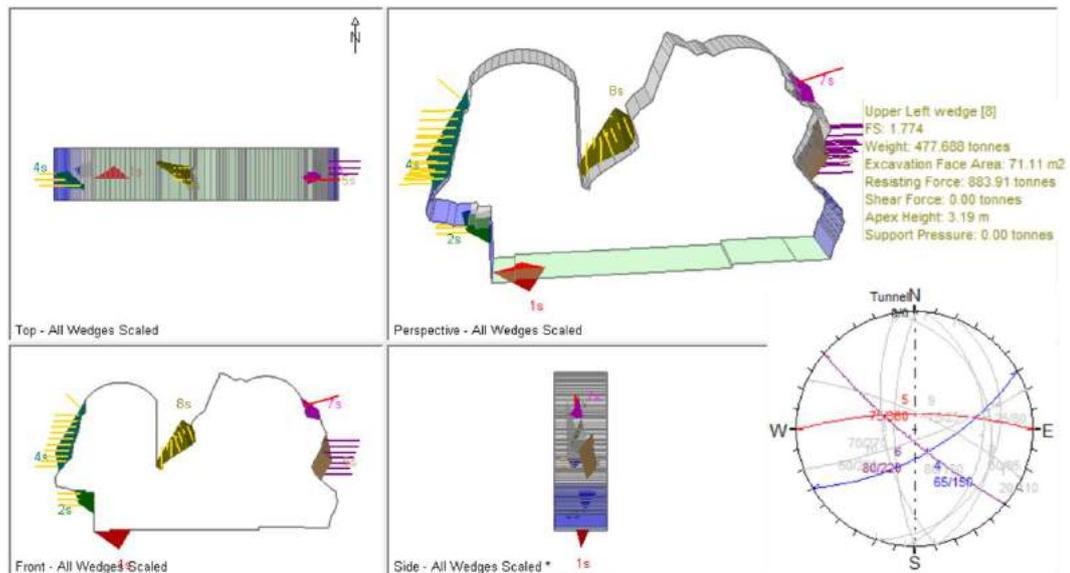
Figure 8: PH complex wedge analyses

The Consultant has carried out calculations of structural wedge failure and numerical stress analysis of the PH complex. Representative excerpts are shown in fig. 8 and fig. 9 respectively.

The analyses model the current geometry of the excavations and the applied support / reinforcement measures within a jointed rock mass. The resulting safety factors are satisfactory. To evaluate the results of this analysis, the IAP would like to review the basic assumptions, with particular reference to the topics listed in the following table.

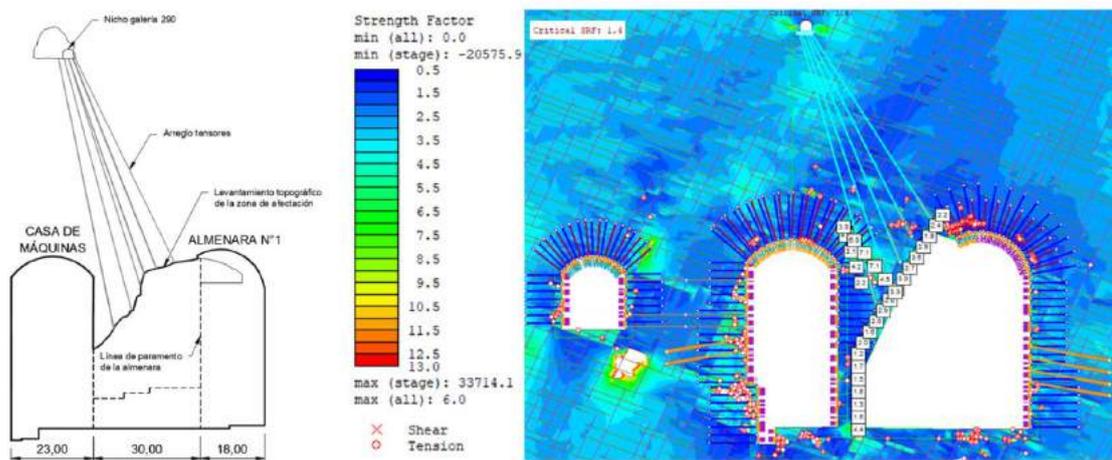
Fig. 9: PH complex Stress Analysis

Joint pattern and strength, rock structure and strength in the zone adjacent to the openings and away from them.
Assumptions regarding disturbance factor close to the disturbed walls of the opening are very important, especially around the collapsed area and within the thin pillar between the Powerhouse and Almenara No1.
Numerical analysis staging. Description of stages from the initial conditions to the final modelling stage.
Modelling of the support measures at the time of the failure events.
Strength reduction factor process. Description of critical failure mechanism as per the results of the model, assumption of elastic or plastic response of support, consideration of SRF estimation for stages earlier than the final one to investigate potential intermediate stages of the rehabilitation process with lower levels of safety.
Postulated treatment / strengthening measures in the lowest, thin part of the pillar between the Powerhouse and Almenara No1 (see fig. 9).

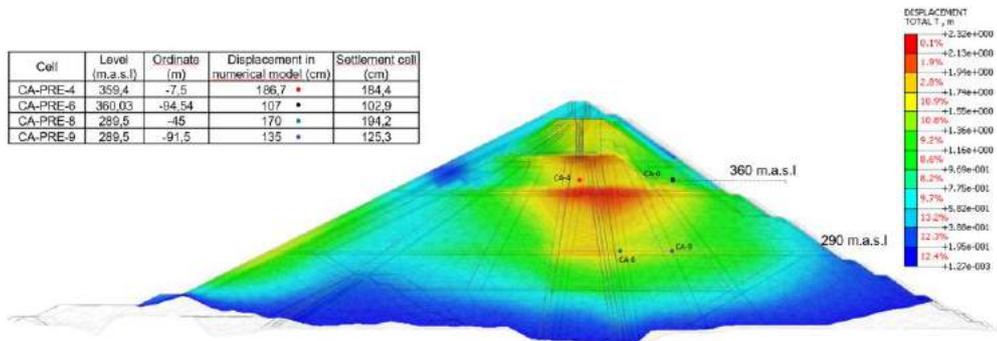
Figure 11. Settlement cells (calibration of the numerical model) - Abscissa 480

Settlements are possibly lower than expected, especially in consideration of the haste in which the upper part of the embankment had to be completed. Settlements are very small in comparison to other dams of this type and height. Rate of settlement is currently 0.1-0.2mm/day, which is satisfactory.

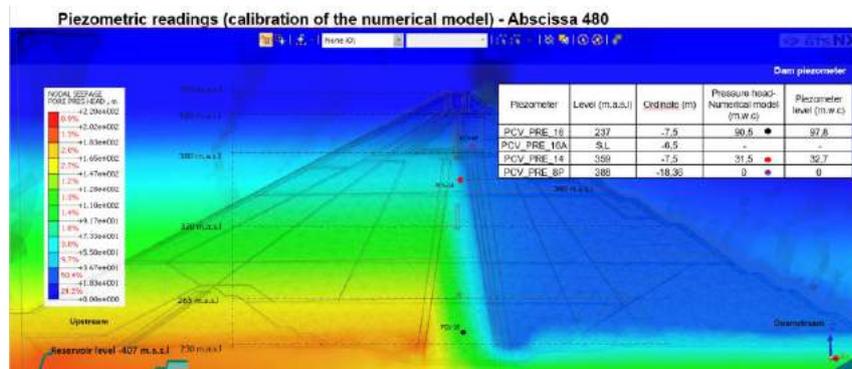
Figure 12: Piezometric readings (calibration of the numerical model) - Abscissa 480

As shown in figures 12 and 23, a particularly good correspondence exists between calculated and measured values of deformations and piezometric levels.

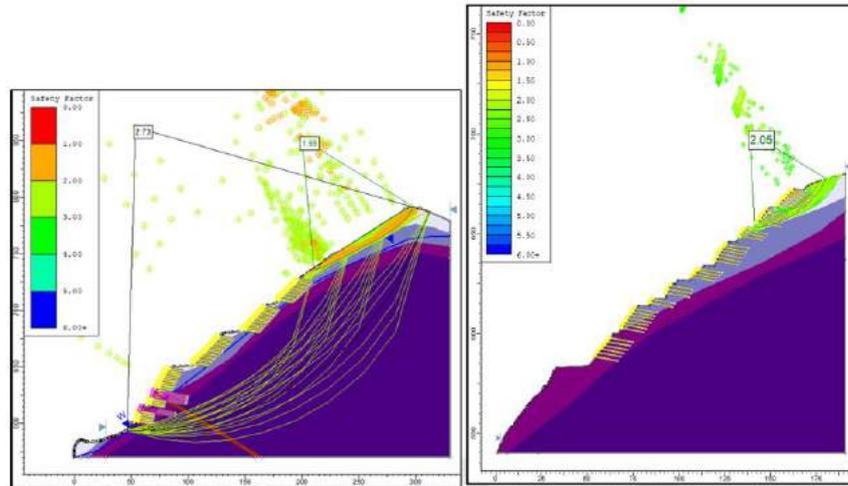
Figure 15: Static slope stability analysis. Left: Cross section A. Right: Cross section B

The static analyses of local (superficial) and global (deeper) sliding surfaces indicate acceptable factors of safety. The strength parameters used (Fig 14) are rather on the conservative side. Groundwater conditions appear different in the two adjacent cross-sections presented to the IAP (Fig 15). In section A, the assumed water table is quite close to the surface. Certainly, a conservative assumption, given ground water level observed in the section of site 7, slightly to the north. In section B, no water table is visible.

Some cracks have appeared on the upper parts of the slope. Of these, the cracks in Zone 1 do not necessarily agree with the results of stability calculations and may need to be reconsidered in modelling the slope (e.g. tension cracks).

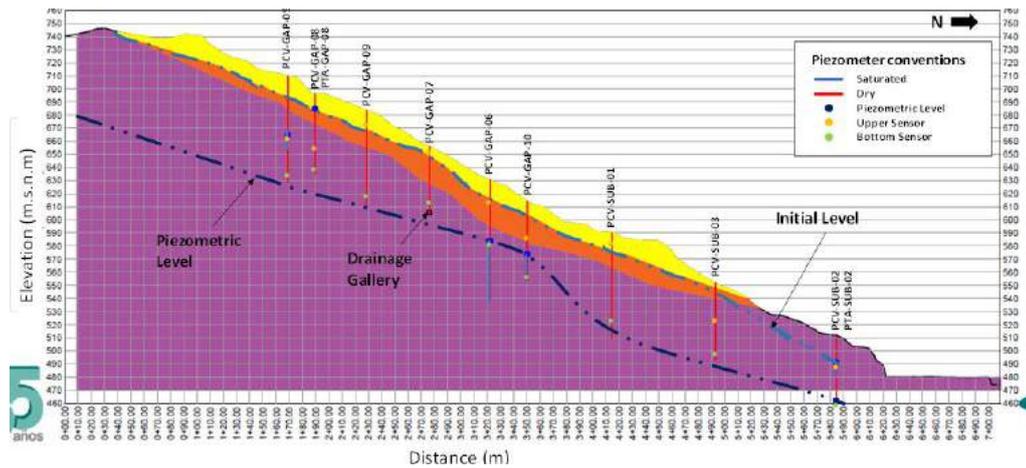
Figure 17: Drainage gallery – Piezometers. Site 7

The effectiveness of the executed drainage gallery at the northern slope side is not clear to the IAP. Apparently, it is in relation to Site 7 slopes, at the North margin of Romerito's treatments. Besides, the gallery is located above the assessed water table. The perched water table, above, looks insignificant. Anyway, drainage is always useful in slope stability and the IAP has no specific recommendations.

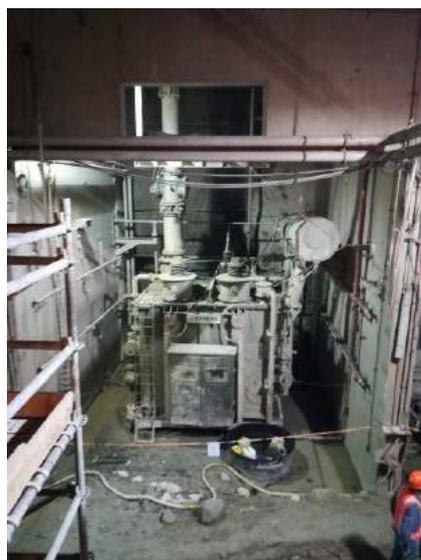
The transformer's oil tanks were unaffected and various assessments by EPM did not report any losses of oil (see fig 21). Oil was subsequently removed from the transformer tanks and properly disposed.

*Figure 21: single phase transformer[archive]*

At the time of the May 2020 virtual visit, the transformers were still in place. The activities of the company that purchased them as scrap material are on hold due to Covid-19; however, a team of 60 persons of EPM is working to dismantle the transformers.

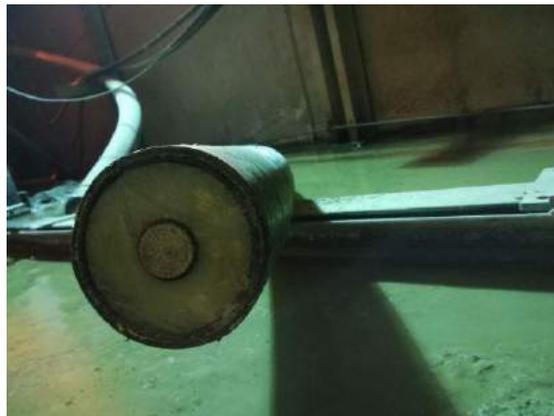
11 HV single phase cables already procured and their deliver to site is expected by the end of 2020. They are not on the critical path.

*Figure 22: HV single phase cable[archive]*

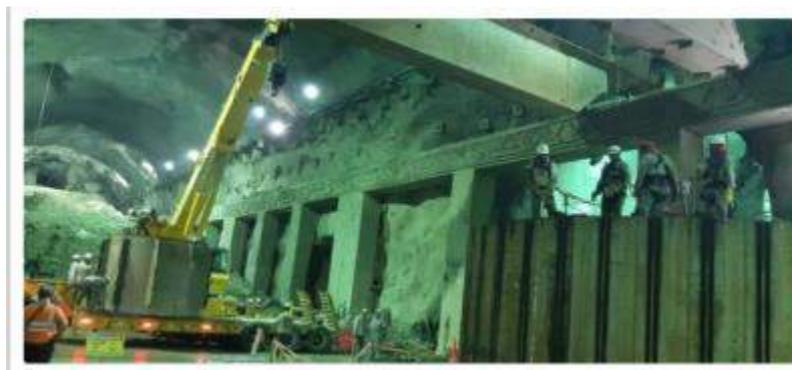
The two overhead traveling cranes are still in place but unsuitable even for temporary activity. The 2 x 300 tons new overhead cranes are already procured; their manufacturing shall be completed within June 2020 and their delivery to site is expected for August / September 2020. Their delivery schedule will not directly impact the project schedule because EPM is using mobile cranes in the meantime (see fig. 23).

*Figure 23: The second crane at work in the southern part of the powerhouse*

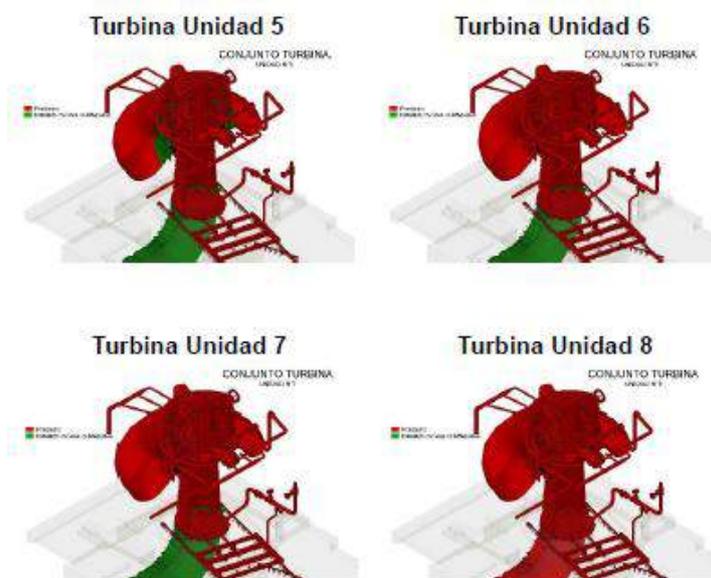
Fig. 25 shows the erection progress of the draft tubes of units 5 to 8, at the time of flooding the powerhouse (green: installed; red: to be installed).

Figure 25: Turbine equipment available in the warehouse

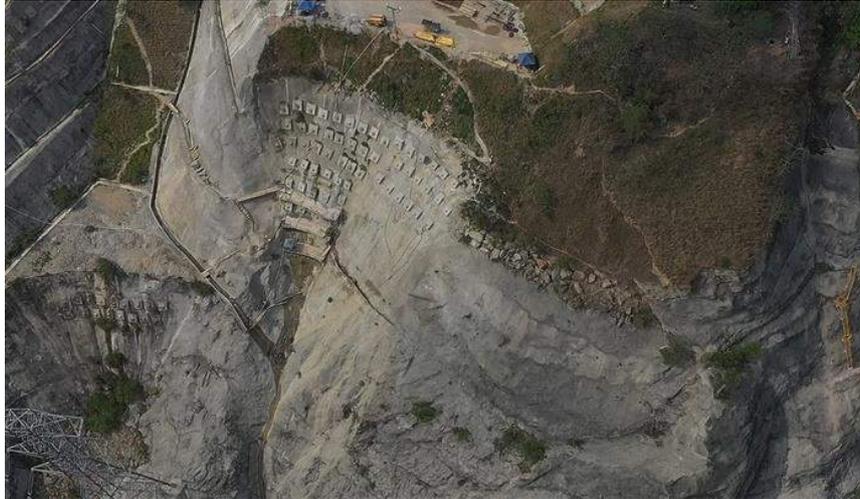
The 500 kV switchyard is completed. Several HV power cables and most of the power and control cables, coming from the power plant, will have to be reinstalled. The cable gallery and its connections with the 500 kV GIS switchyard are in good conditions. Stabilization works were carried out in the slope above the switchyard area (fig. 27).

Figure 27: The stabilization works [switchyard on the bottom left corner]

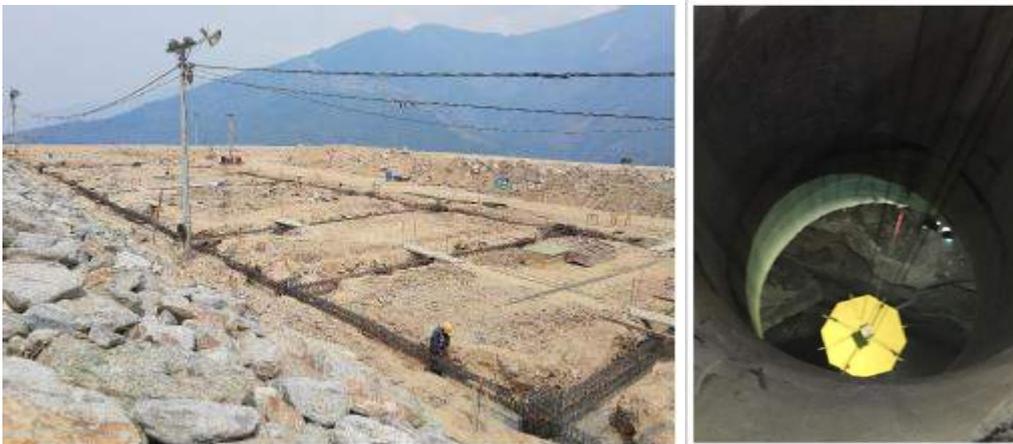
The original design foresaw steel lining only on in the horizontal section between the lower elbow and the spiral case of the units. Given the large cavity in the area of pressure shafts 1 and 2, it ought to be assumed that the rock mass had lost its capacity to collaborate with the lining in withstanding internal pressures. The adoption of a self-standing, ductile, steel lining was recommended by the IAP. EPM acted rapidly, to avoid schedule delays in commissioning the first and signed the corresponding contract in 2019. Fig. 29 shows: (left) construction of the warehouse for manufacturing the penstock segments, and (right) the cable lift being lowered in the area of shafts 1 and 2.

Figure 29 - Left: penstocks assembling area. Right: shafts 1 and 2, steel lining installation

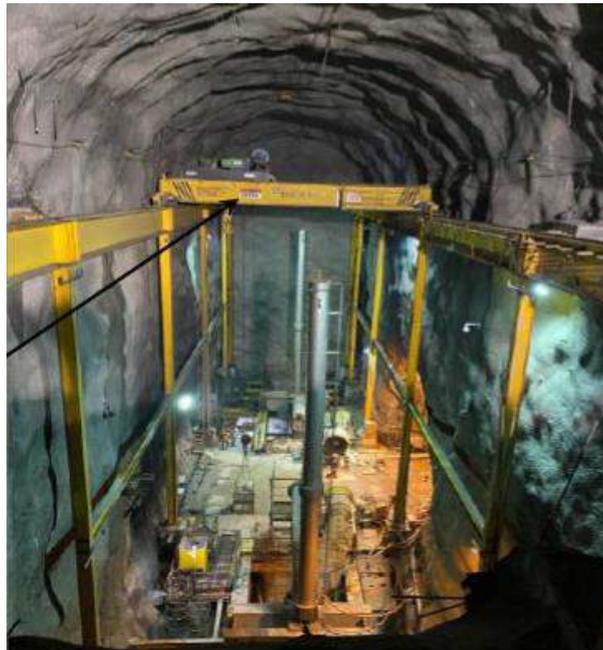
EPM did not report any O&M problems for the equipment already installed and operated. After successful plugging of the GAD, the gate control chamber will be abandoned (fig. 31).

Figure 31: Removal of the crane from the GAD control chamber

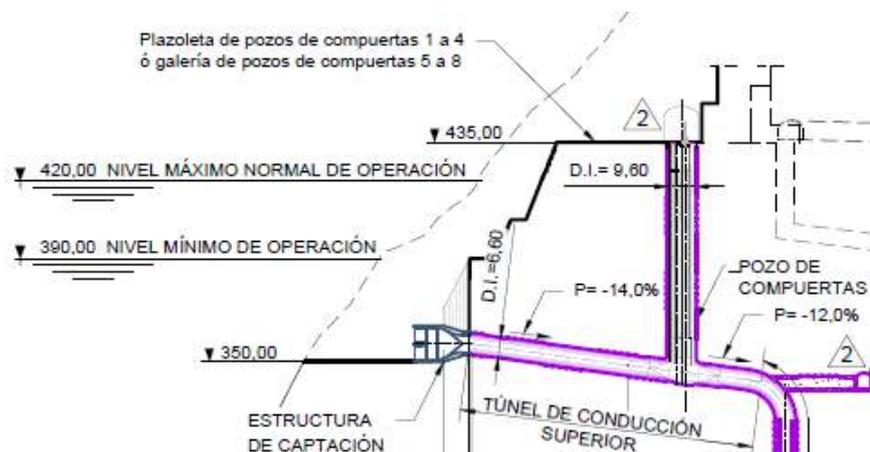
The operating head of Ituango reservoir, as defined in its design, is nominally limited to 30 m range: between 420 and 390 masl (fig 35).

Figure 35: Maximum normal, and minimum operating levels

The design decision for that range was made long time ago and its reasons seem somehow be lost. Project layout and the reservoir geology do not appear be the reasons for such decision, nor the presence of floating debris may be considered the constraining factor.

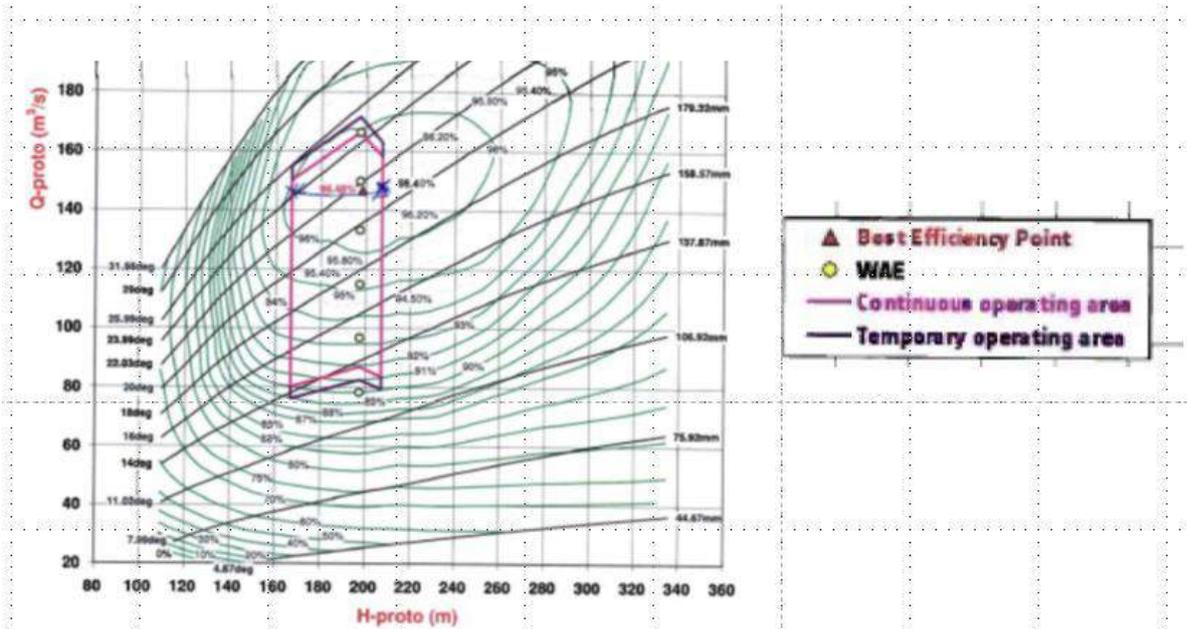
Figure 36: Ituango Turbine Hill Chart

Fig. 36 shows Ituango’s turbine “hill-chart”. The “Continuous Operating area” appears the result of EPM’s request for an area of very high efficiency rather than a physical limitation. The ratio Gross Maximum Operating Head / Gross Minimum Operating Head based on reservoir level is approximately 85% and the ratio Minimum Head / Maximum Head of the prototype as per Model Test is 80%. Both numbers are on the low side.

Moreover, it should be noted that the operation of the turbine below its official minimum head would still fall in an area of high efficiency (above 90-91%), especially for high values of Q (the ones more interesting). That indicates respectable turbine performance.

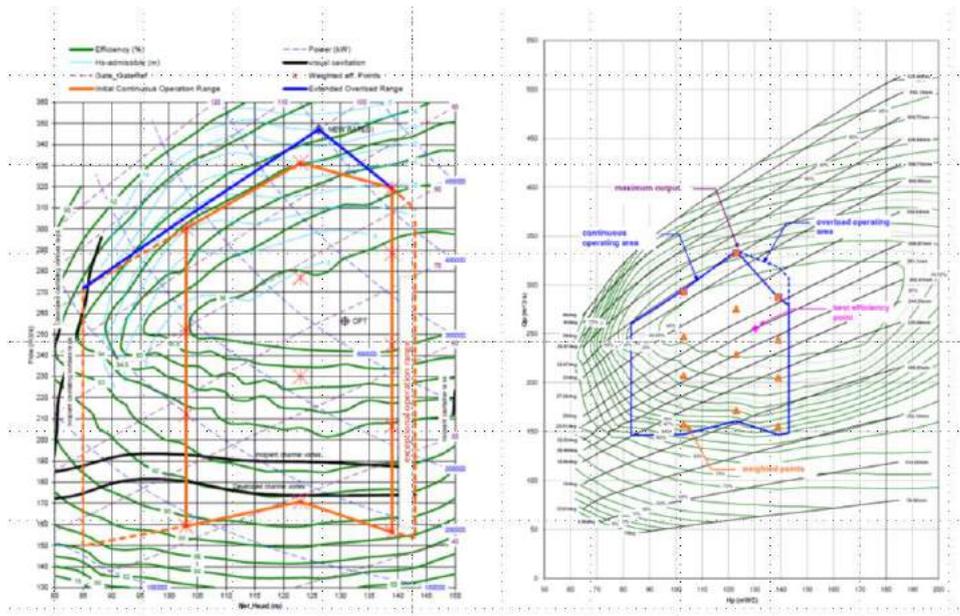
Fig. 37: Hill charts proposed by two manufactures for the same turbine

Finally, fig 37 shows examples of hill charts proposed by two different manufacturers for exactly the same turbine to be installed in different parts of the same power plant; those turbines are similar, in size, to Ituango's. It may be noted the wide range of operation and, not less important, the differences among manufacturers.

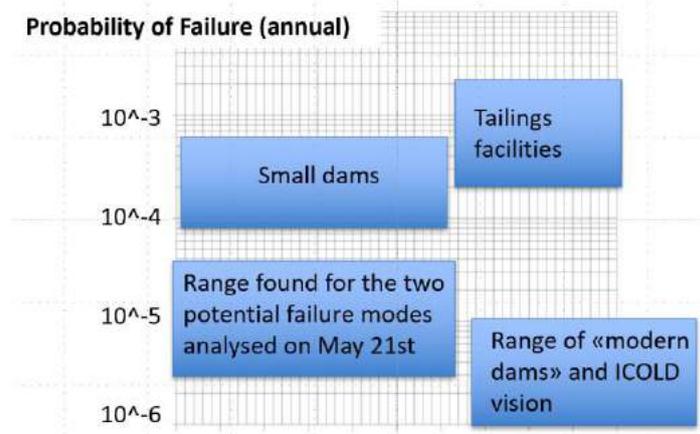
Fig. 38: Probabilities of failure put in context

The PF obtained, for the two PFM analysed on May 21<sup>st</sup>, range from  $5 \cdot 10^{-5}$  (maximum) to  $3 \cdot 10^{-6}$  (minimum). To put such values in perspective, it should be noted that the PF of modern dams is generally considered to be around  $10^{-5}$ <sup>3</sup>, and that the ICOLD “vision” and commitment is to further reduce that PF to  $10^{-6}$ . Figure 38 puts the above values in perspective (indicative ranges for small dams<sup>4</sup> and tailings facilities<sup>5</sup> are shown for comparison). *If one reverses the figure, i.e. Safety Margin =  $1/PF$ , the picture may become more familiar for those not acquainted with probabilities.*

It is desirable, for a project of the importance and hazard level such as Ituango, to aim at the “ICOLD range”. Two key measures can achieve that result:

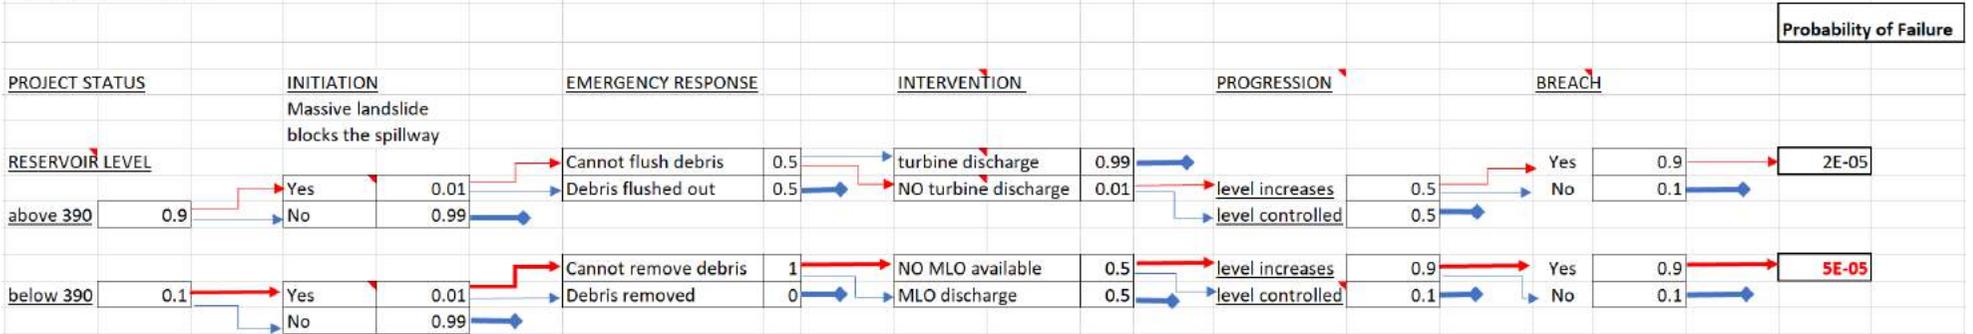
#### Spillway Blocked

Multiplication of the probabilities along the tree's branches that reach "breach" give the probability of failure.

The lower branch postulates the availability of a Mid Level Outlet (MLO). Should turbines be unavailable during the emergency, the MLO could control the reservoir and failure averted. Should no MLO be available, the process could continue to attain dam breach. The overall probability of failure would be  $5 \cdot 10^{-5}$ , i.e. 5:100,000, slightly higher than the previous one.

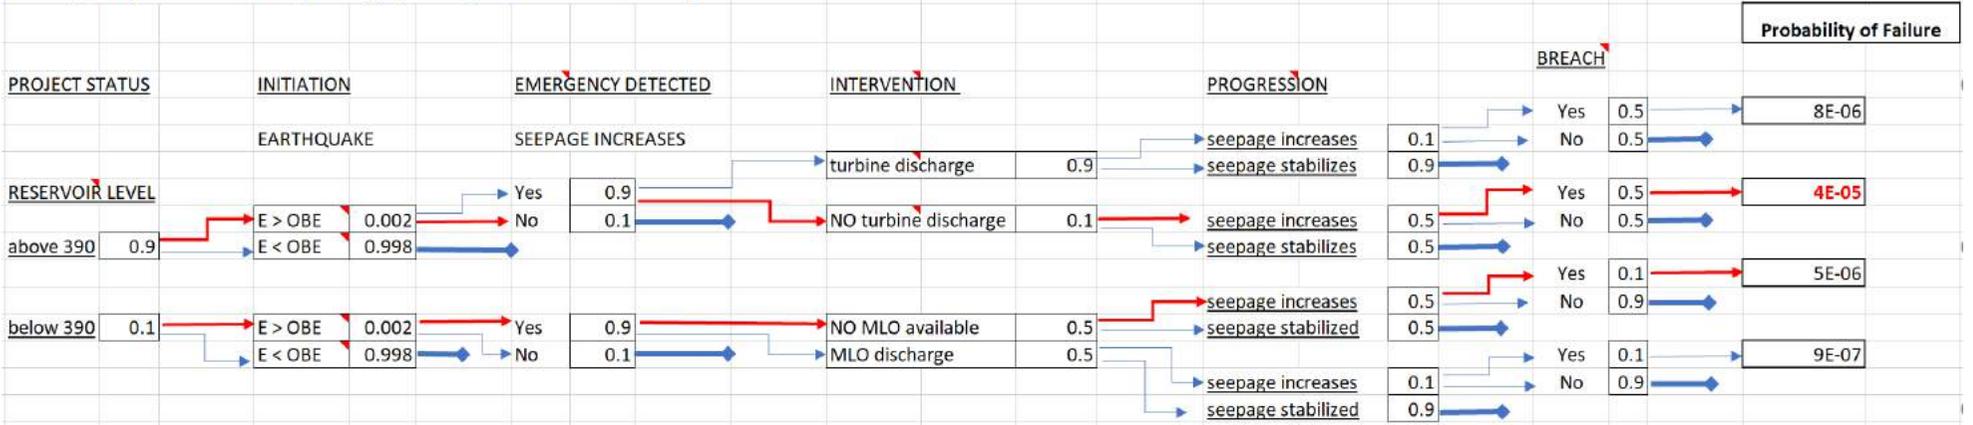
#### Emergency Drawdown (strong quake/ internal erosion)

During operation, emergency reservoir drawdown could be required following a strong earthquake and/ or evidence of severe internal erosion. Postulated mechanism of failure:

As in the previous case (PFM SB), the upper branch of the event tree counts only on turbine discharge for controlling the reservoir. Should turbine not be available during the emergency it would be impossible to lower the reservoir to a safe level, and the process could go on attaining dam breach. The overall probability of failure would be  $4 \cdot 10^{-5}$ , i.e. 4:100,000, a very low but not negligible value. The lower branch postulates the availability of an MLO. Should turbines be unavailable during the emergency, the MLO could control the reservoir and failure averted. Should no MLO be available, the process could go on attaining dam breach. The overall probability of failure would be  $3 \cdot 10^{-6}$ , i.e. 3:1000,000, lower than the previous one.
