**Independent Advisory Panel to IDB Invest  
IAP Report N°5, March 2021  
Ituango Hydropower Project  
Colombia**

## EXECUTIVE SUMMARY AND RECOMMENDATIONS

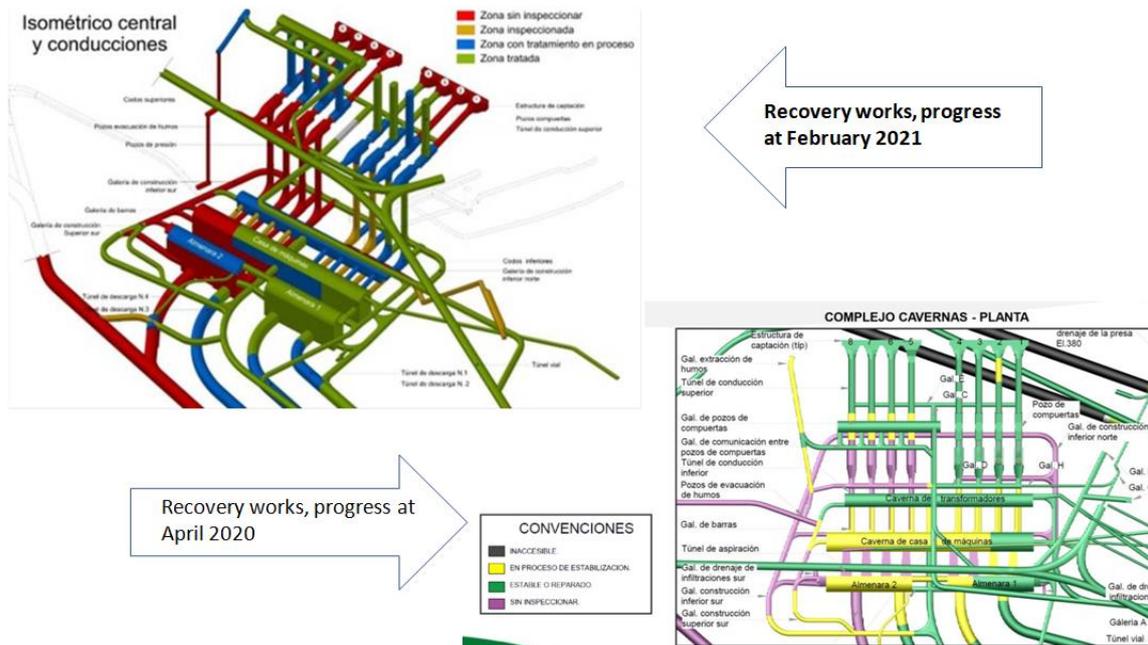
Figure 16: Recovery and stabilization of the work

Figure 16 shows progress in the recovery and stabilization of the underground works, compared to the situation in April 2020.

The pillar between the surge tank 1 and the power cavern, where a big collapse occurred, has been re-constructed and final treatment works are in progress.

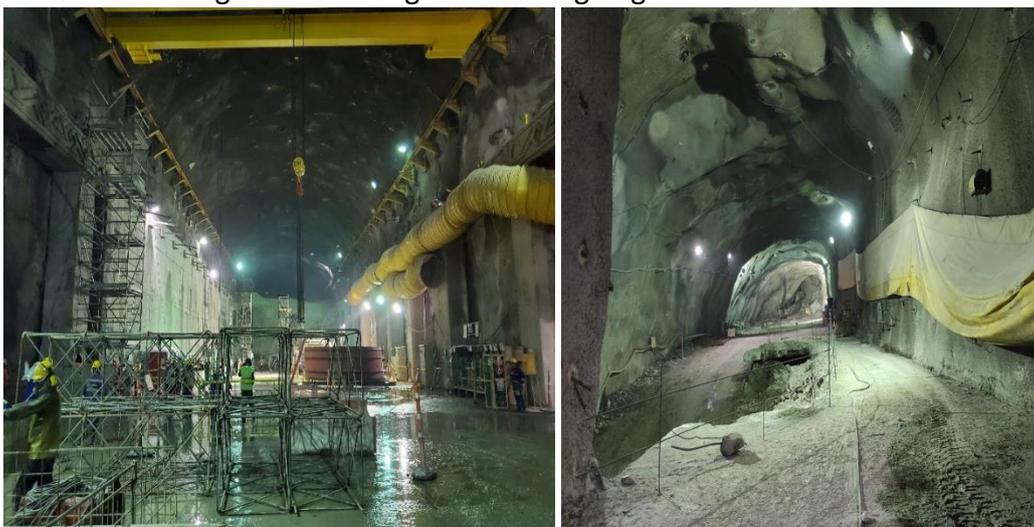
Figure 17: Machine Hall, generator level (left) and backfilled North Surge Shaft (right)

Figure 17 shows two significant images of the ongoing activities.

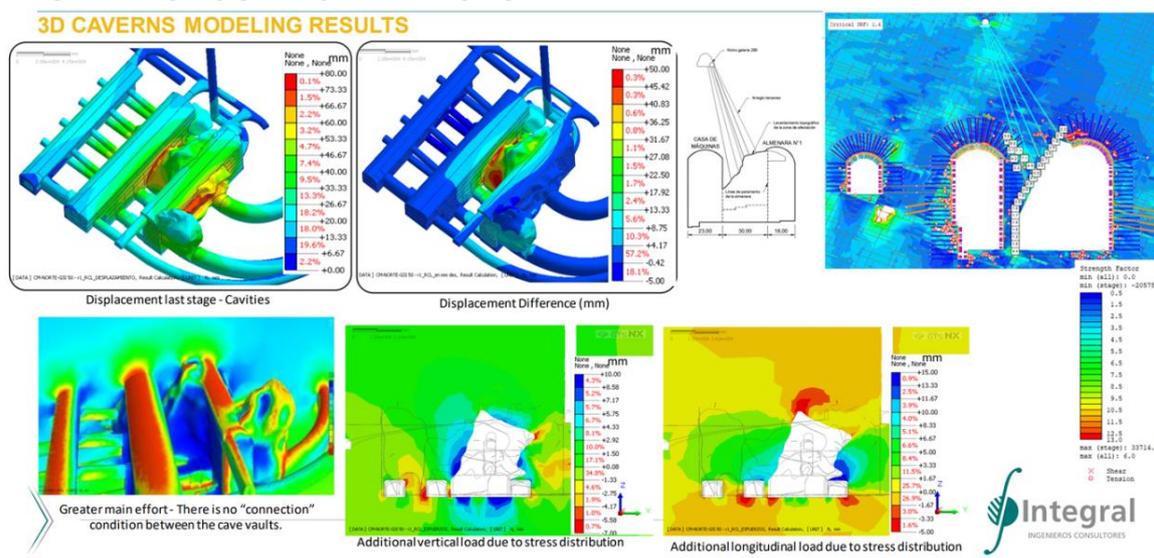
Figure 18: Underground works. Stability assessment

Observations to date allow to confirm the no progressive failure due to stress re-distribution has occurred. Only several gravitational, structurally controlled failures, took place, few of them of big size. These local stabilities are being treated satisfactorily and voids are thoroughly backfilled with concrete. Mellizo and Tocayo, the two faults present in the caverns area, are not active and therefore they are not expected to affect the stability of the underground works after the implementation of the reinforcement measures.

A finite element analysis of the underground openings has recently been carried out, which provided satisfactory results under static conditions (fig. 18).

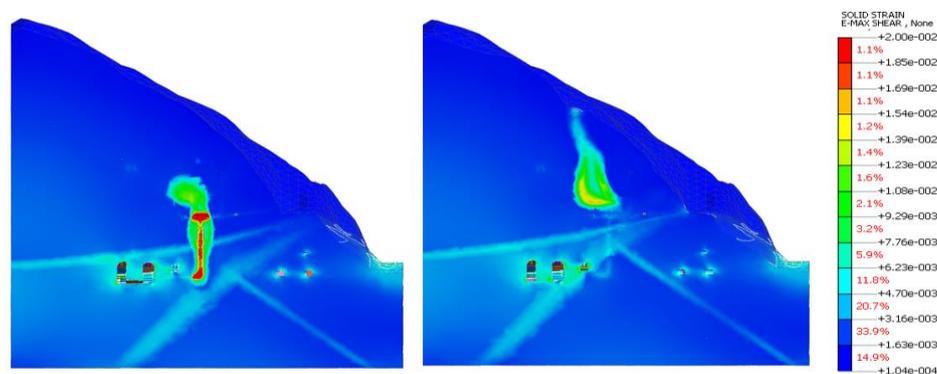
Figure 19: Shear strains in the rock mass under a seismic scenario

Seismic behavior was also investigated to study shear strains in the rock mass. According to the results shown in figure 19, shear strains increase in the DRM zone, but they do not extend along the surface slope, the faults, and the main underground excavations. This allows concluding that the underground complex is stable under seismic actions.

Upon completion of the reconstruction works, the underground spaces will be delimited by sound rock and large-scale concrete backfills. The subject of differential dynamic response of such structures, under earthquake loading, was discussed during the meetings. The IAP observed that, usually, underground caverns do not present such problems because all elements tend to move together. Only isolated structures, such as columns, may be affected. Having said that, given the permanent nature and the size of the caverns, EPM may want to seek the advice of its Board of Advisers about the opportunity to carry out an analysis of induced deformations under seismic actions.

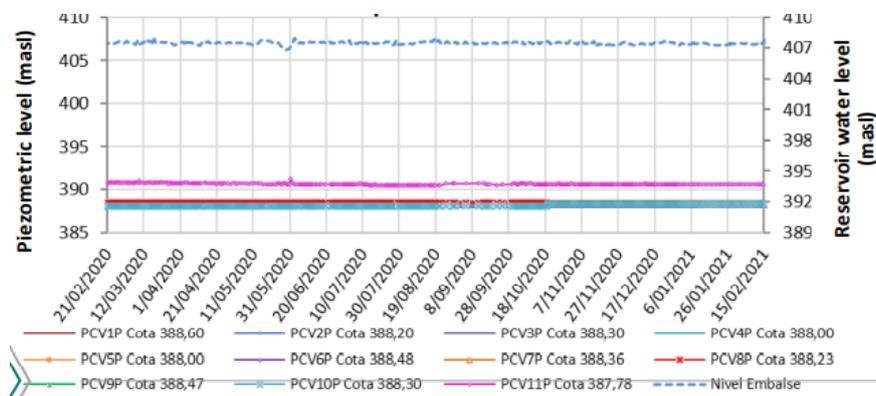
Figure 23: Piezometric readings downstream the Priority Fill

the transition zone next to the core, or the integrity of the core. An anomaly presented in the readings of one of the piezometers went back to normal (fig. 22). Piezometric readings also indicate good performance of the priority fill (fig. 23).

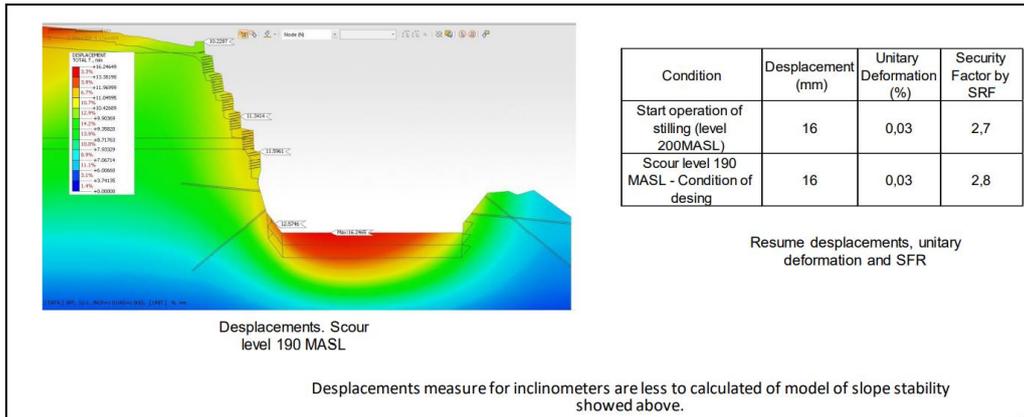
Figure 27: Slope stability- Section B-B

Erodibility and stability analyses have been carried out to evaluate the effects that progressive pool scouring could have on the slopes (Fig. 27).

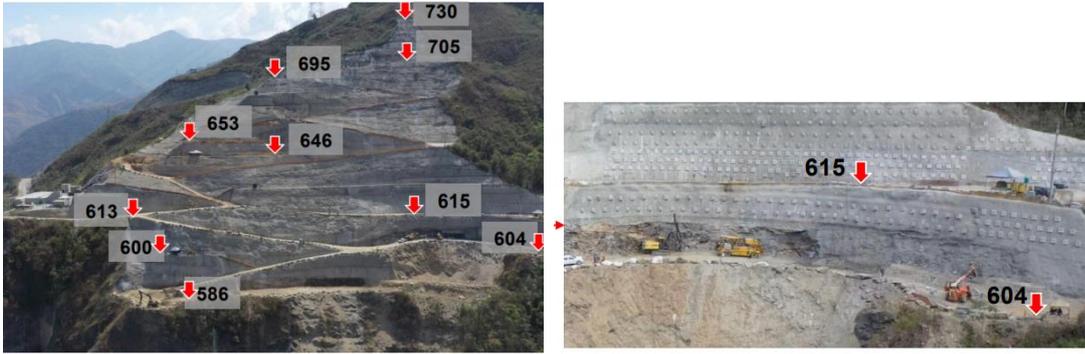
Figure 29: The high part of the slope over the intake's platform

This is the slope over the platform of the intakes, including the *Romerito* collapse area. Excavation and stabilization work of the high part of the slope, down to elevation 570, is almost complete (fig. 29). Instrumentation continues to show an overall satisfactory performance of the slope (fig. 30).

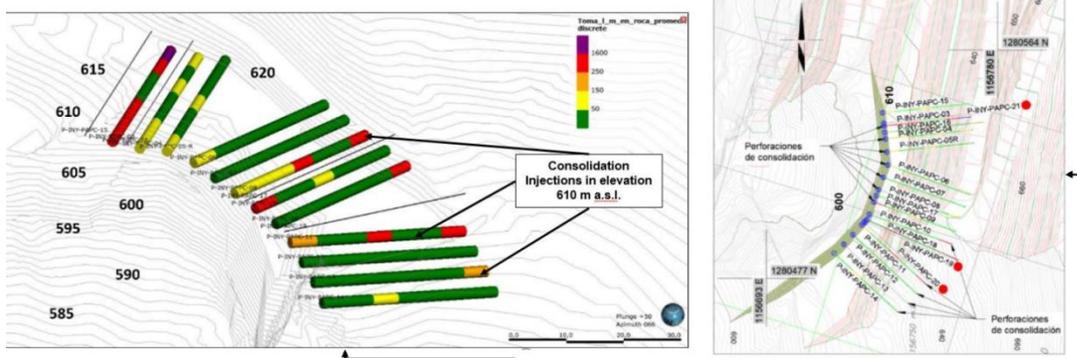
Figure 31: Consolidation grouting of the Romerito's rim

From the available information, the Romerito failure zone does not show any retrogressive evolution of the past events. In addition to anchors, consolidation grouting is contemplated for the reinforcement of the cavity's rim which is characterized by weak rock mass with shear zones (fig. 31). The IAP consider that anchoring can offer effective stabilizing forces, and grouting will provide additional safety. Drainage measures should be provided to limit the access of surface water, from the slopes above, into the cavity's rim.

Taking into account the geomechanical characteristics of the high part of the gate shaft platform towards the elevation 610 m.a.s.l. The consolidation injections are proposed by the method of successive thickening with type A to F grouts to increase the properties in this sector.

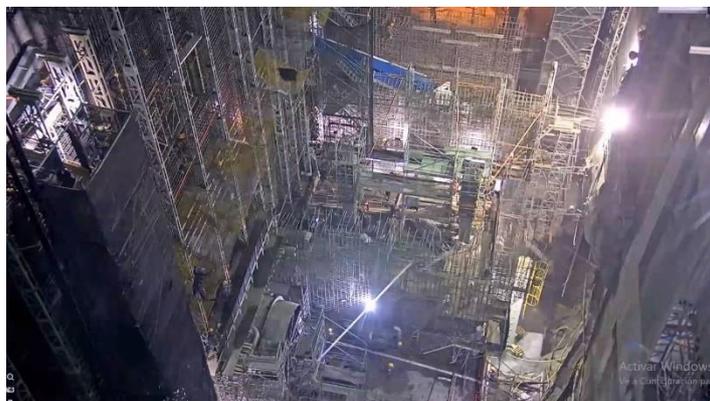
*Figure 41: Unit 1 construction and installation activities*

At the end of 2019, the lowest parts of the units 1 to 4 and corresponding first and second phase concretes were finally assessed to be unsuitable for any remedial action. Rehabilitation of units 1 to 4 therefore started from first phase concrete.

Construction and installation activities for Unit 1 are ongoing, though civil works concrete had to start approximately 20 m below the lowest part of draft tube for the cavity that was evidenced after removing the first phase concrete. As a result of the negative assessment of unit 3 and 4, EPM decided to go back to the original sequence for commercial operation, proceeding from 1 to 4. Unit 1 will be the first one to go in operation.

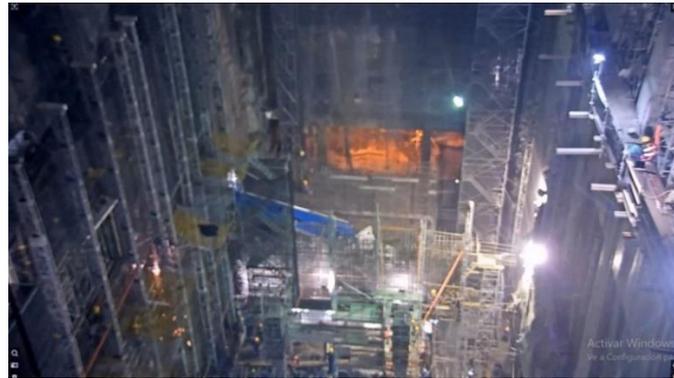
*Figure 42: Unit 2 construction and installation activities*

Construction and installation activities for Unit 2 are ongoing, in parallel to the ones of Unit 1, with some delay.

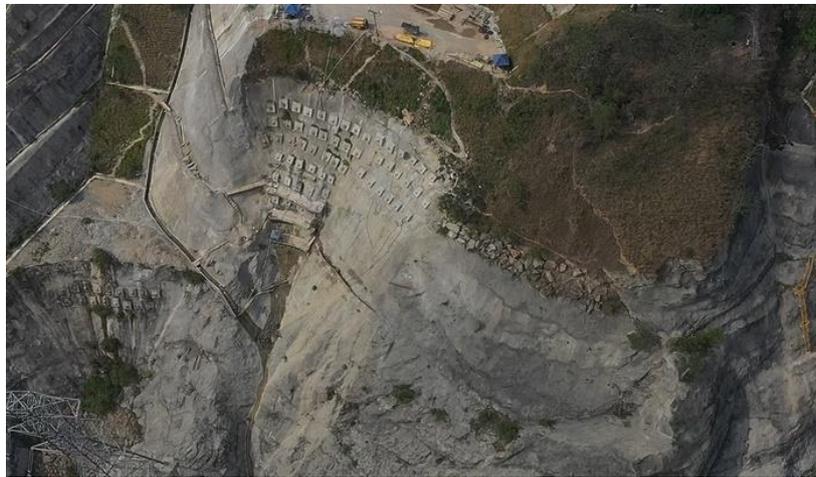
*Figure 52: The stabilization works [switchyard on the bottom left corner – archive]*

The 500 kV switchyard is completed. Several HV power cables and most of the power and control cables, coming from the power plant, will have to be reinstalled. The cable gallery and its connections with the 500 kV GIS switchyard are in good conditions. Stabilization works were carried out in the slope above the switchyard area (fig. 52).

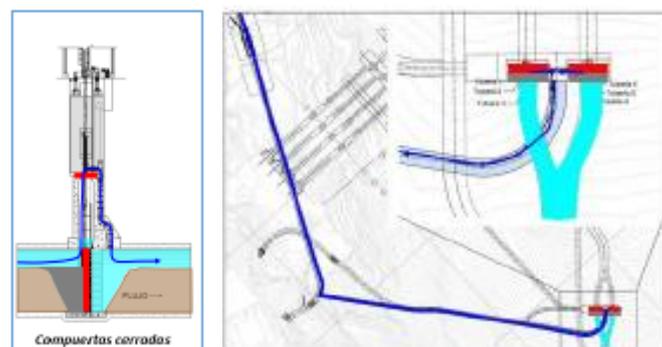
Figure 60: GAD gates in their final position with temporary direct by-pass system (left) and through the IDG (right)

The two GAD vertical sliding gates were successfully lowered in February 2020. A concrete plug was placed on the top of the gates to block any movement (with such installation the tunnel is currently technically plugged) and the lifting systems and cranes were removed. Two temporary by-passes are installed to alleviate the reservoir pressure on the gates and to further increase safety when the permanent plugging of GAD will be built. One by-pass is direct (currently operated), the other is routed through the IDG (it will be operated at the time of plugging the GAD). After successful plugging of the GAD, the gate control chamber will be abandoned.

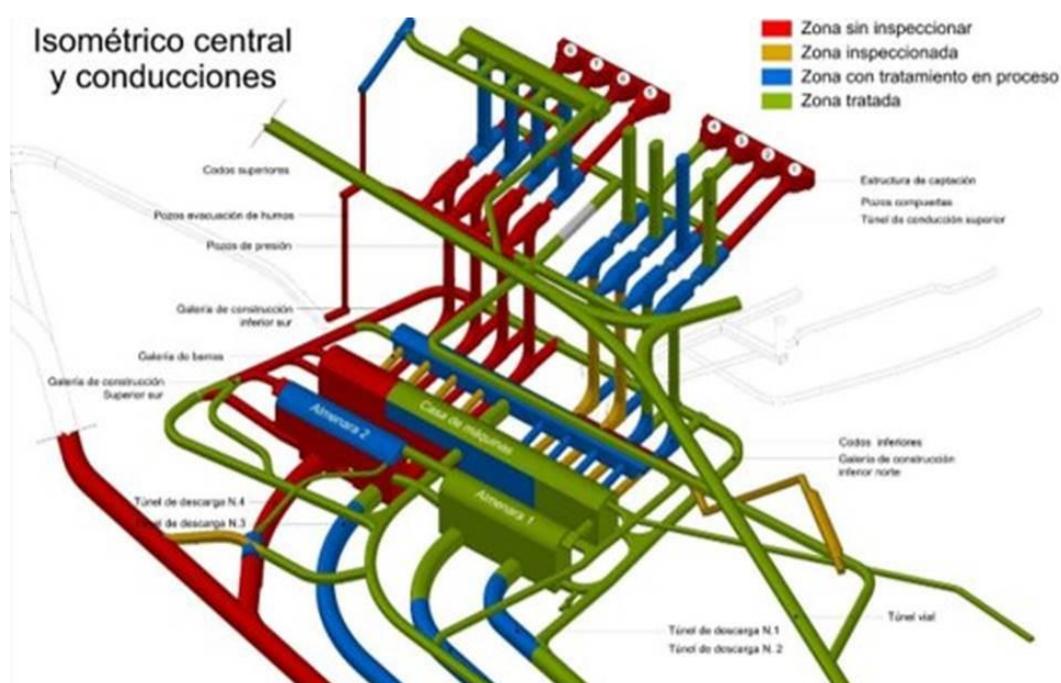
Fig. 61: Recovery of underground works, progress overview as of February 2021

The scheme shown in fig. 61 provides a snapshot of the progress of the repair and recovery works in the powerhouse cavern complex. The following can be observed:

- Intakes 1 and 2 still require complex completion works (red).
- The rest of the waterways and underground structures associated with units 1 and 2 have been repaired/ recovered (green) or are in the process of being stabilized (blue); selected portions were re-evaluated for additional treatments.
- The transformer hall, reported as fully recovered a year ago, is undergoing additional treatments (blue).
- Recovery works pertaining to units 1 and 2, are behind schedule because voids were encountered in the draft tube area, that had to be excavated and backfilled.
- The waterways of units 5 to 8 have not yet been inspected and repairs are underway in the underground structure of the South part of the plant.
- Treatment of the pressure shafts to units 5 to 8 is ongoing and it is anticipated to be of significant extent.
