Independent Advisory Panel to IDB Invest

IAP Report N°6, July 2021

Ituango Hydropower Project

Colombia

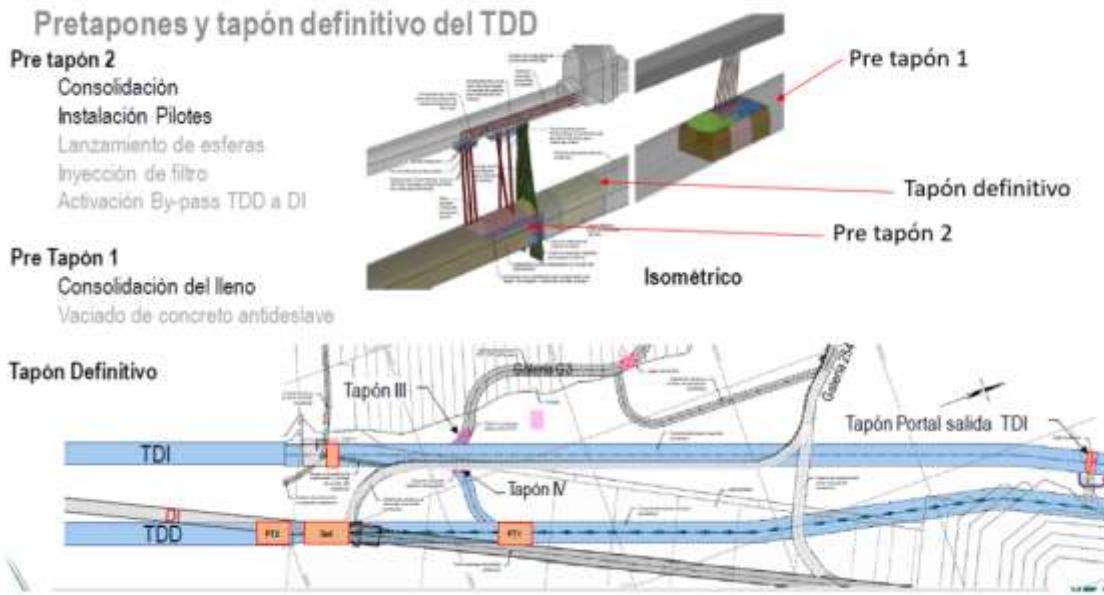
Figure 2: Solution for sealing the TD2

TD2 is largely obstructed by debris. The resulting gap allows a discharge which has stabilised at about 8 m³/s and is constantly monitored. Water pressures are also monitored. Continuous monitoring is essential because the hydraulic gradient through the obstruction, estimated at 0.55, is high enough to potentially initiate internal erosion. At the same time, the turbidity carried by the river, contributes to a progressive sealing of the debris, a phenomenon that can be associated with the declining trend of water pressures. In sum, while the TD2 cannot yet be considered “technically plugged”, all evidence permits to assign a low probability to the potential collapse of the natural obstruction.

Sealing of the TD2 will have to take place with water flowing and it therefore requires a complex and carefully planned procedure. Due to its unprecedented nature in hydropower projects, TD2 sealing has been thoroughly studied and a feasible solution, involving two pre-plugs and final plugs, is being implemented (Figure 2).

progressively reducing the spaces among the micro piles' grid. This is expected to force the residual flow through the by-pass system and to facilitate progressive clogging of the waterway by means of gravel and sand first, and of special grouting after. At that point, grouting will be performed with special resin-based mixtures to totally seal the temporary barrier. That is expected to further reduce the flow to nominal values that will permit construction of the permanent plug under safe conditions.

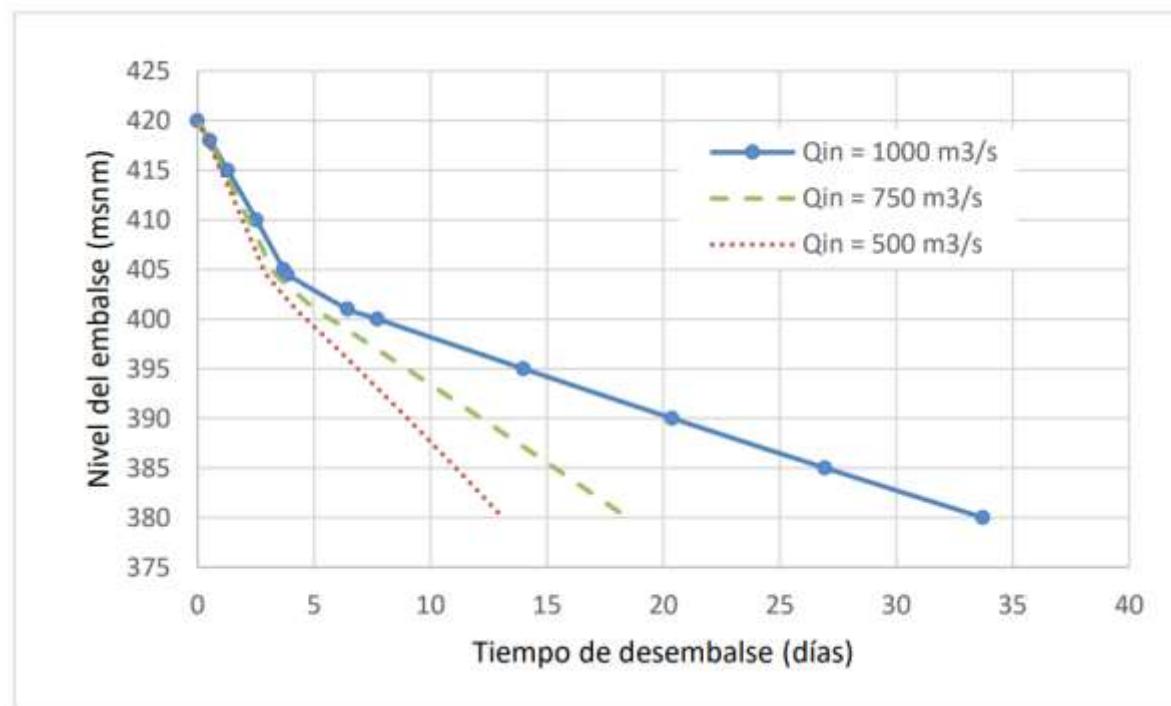
Figure 6: Reservoir lowering times (Integral)

In emergency conditions, discharging through the units is the only course of action to lower the reservoir below elevation 405 m a.s.l. (spillway sill). Figure 6 shows reservoir lowering times for different river flows. The calculations assume that all the 8 units are in function.

It must be pointed out that the current plan envisages 4 units entering in operation by September 2023, and all the 8 units by February 2025. The data shown in figure 6 will therefore be valid in the long term. Until the year 2025, lowering times will be about twice

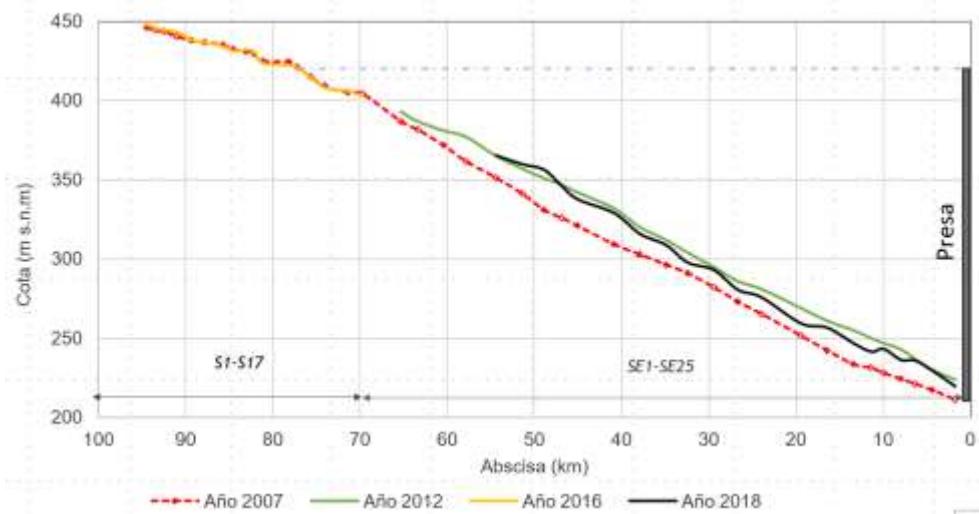
Figure 7: Rio Cauca's longitudinal profile

- The apparent incongruence between LiDAR (year 2012) and topography (2016), both executed before reservoir filling, is explained by the fact that LiDAR does not fully penetrate wet areas.
- The same explanation applies to the LiDAR survey profile being above the 2018 bathymetric survey.
- Besides, those differences apply only to elevation near to the river bed and, as such, any discrepancy would have a negligible contribution to the reservoir volume (see figure 8).

In this initial stage of the Project, the key decision to make is about the baseline reservoir's geometry to associate to future bathymetric surveys. Based on the above observation, the IAP believes that the cartography of year 2007, validated by the 2016 topographic surveys, represents a suitable baseline.

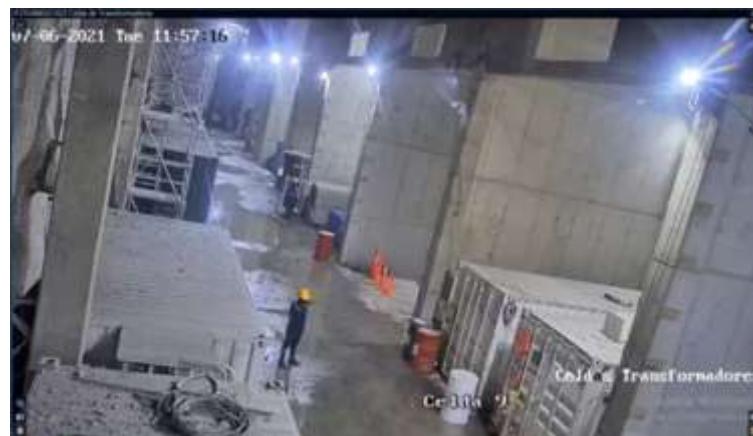
Figure 16: Single-phase transformer 9 and view from north side

Consolidation of civil works are still ongoing on the southern part of the transformer gallery and in the cable gallery above it.

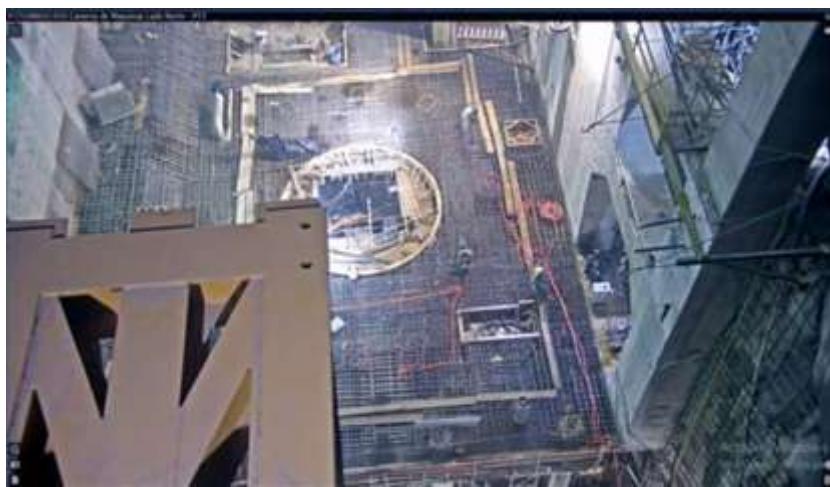
Figure 22: Unit 1 construction and installation activities

Rehabilitation of units 1 and 2 started from first phase concrete. Complete removal of units 3 and 4 concrete is ongoing.

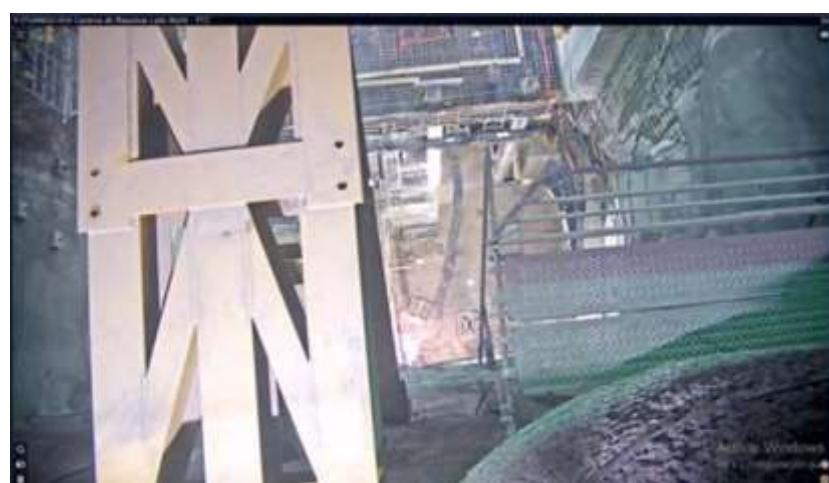
Figure 25: Civil works in the foundation of Control Room North

EPM decided to replace the original reinforced concrete Control Room North with a, faster to build, steel structure; the foundation may be seen in picture 25.

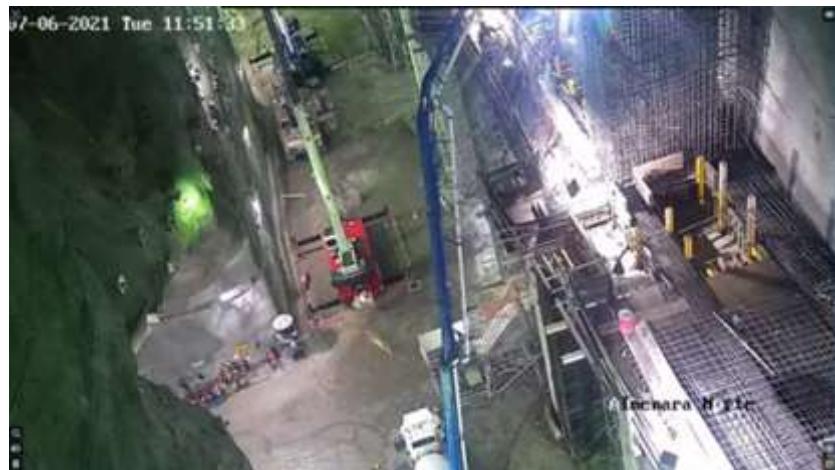
Figure 26: Ongoing works on the draft tube gates in the North Surge Shaft

The civil works necessary for the installation of the guides of the draft tube gates are in progress.

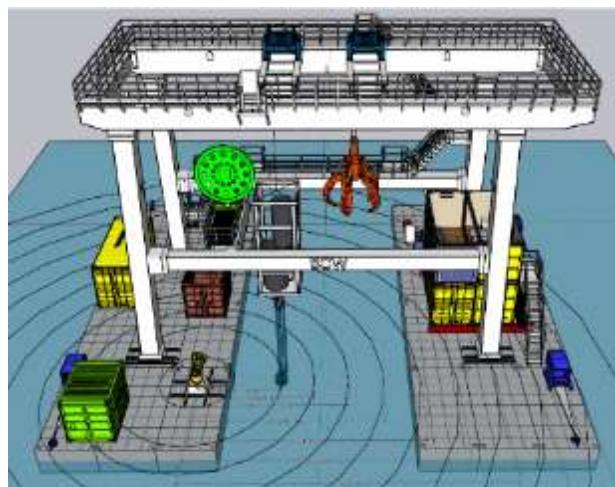
Figure 29: Schematic representation of the ponton for underwater works

The underwater works for the activation of the power intakes, including cleaning the debris upstream of the trash racks, have not started yet and the main contracts have not yet been signed¹.

The works to be executed are complex and specialised (fig. 29 and 30). Management of unforeseen conditions is a key factor in underwater works. In the IAP's view, this is the most challenging activity for the commencement of operation of units 1 and 2.

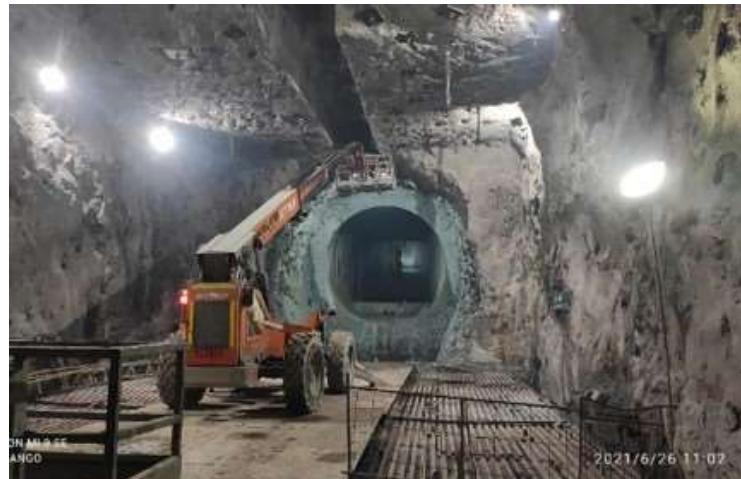
Figure 32: Foundation of monorail for installation of penstock 1

The activities in the D gallery and in the area above the upper elbow are well advanced and will be completed in the next few weeks (table 31 and fig. 32).

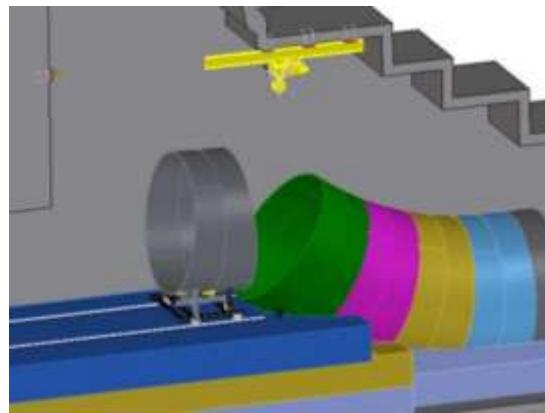
Figure 35: Method for installation of lower elbow

Detailed inspection of the steel lining of the lower elbow of units 1 and 2 recommended to replace and selectively rehabilitate these portions of the waterways. The corresponding activities are time consuming and must be carried out sequentially (table, fig. 34 and 35); they represent critical activities. Section 5.3 reviews schedule implications in detail.

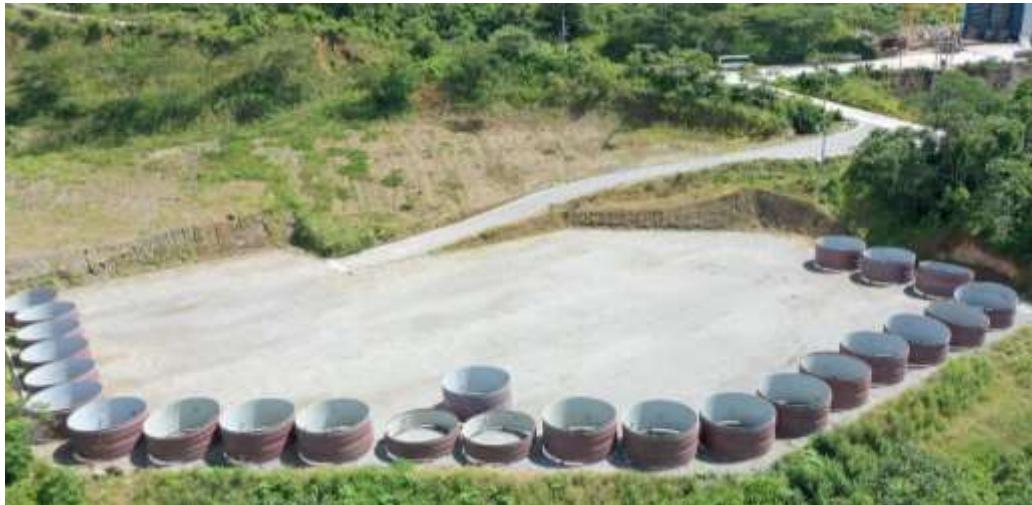
Figure 36: 28 out of 49 vertical sections for units 1 and 2 available in the storage area

Even though a significant part of the workshop capacity and raw steel plate were utilized to replace the steel lining of the lower elbows, the production of vertical sections of the penstock proceeded satisfactorily and it is not critical.

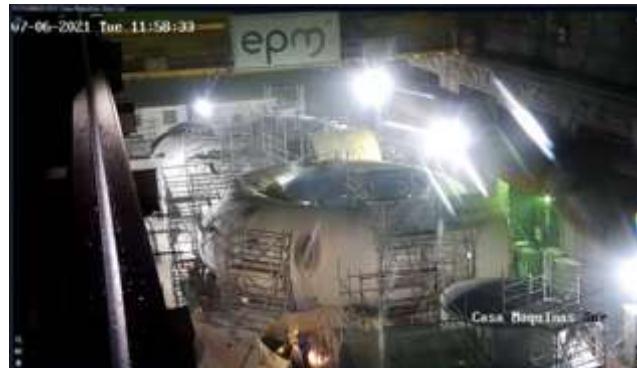
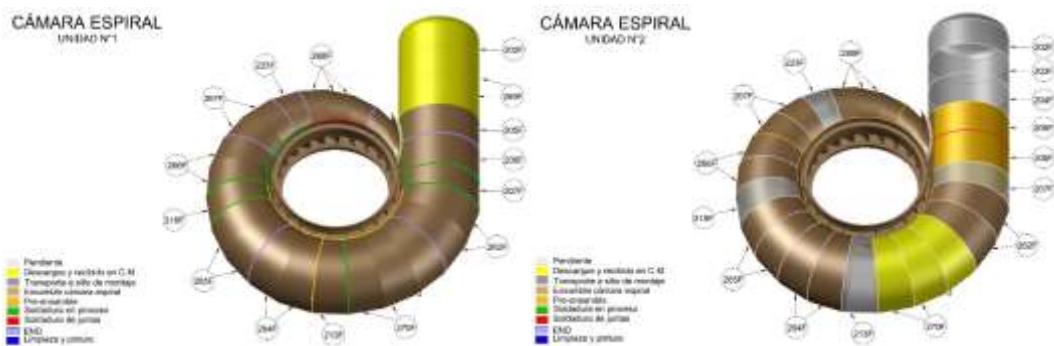
Figure 37: Spiral cases of Unit 1 and in the background of Unit 2

To shorten the schedule, EPM is using the temporarily backfilled bays of units 5 and 6 as additional loading bays for assembling the spiral cases of units 1 and 2 (fig. 37 and 38). Each spiral case (250 ton) will be translated to the permanent location by the 320 ton Overhead Travelling Crane. Such preassembly will not be replicable in the future because the area of Unit 5 – 8 will soon be affected by civil works.

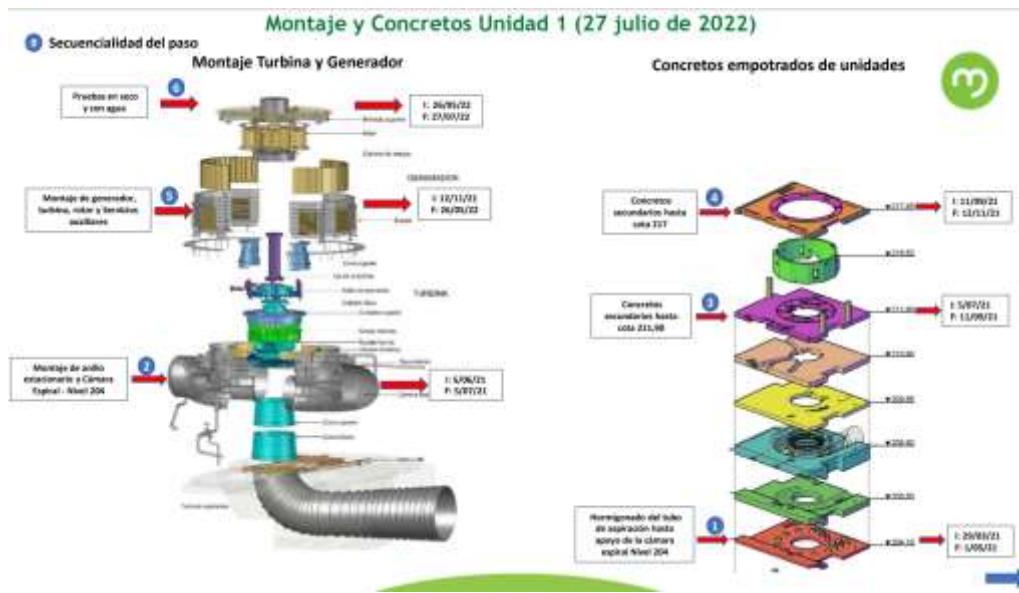
Figure 39: Unit 1 time to completion – electromechanical and civil works

Figure 39 shows the 6-phases sequence of electromechanical and civil works for the completion of Unit 1. It includes the civil works to complete the three remaining floors at elevation 204 m asl (Floor 2 - Turbine) 211,90 m asl (Floor 3 - Generator) and 217 m asl (Floor 4 - Plant Hall).

Phase 1 should have been completed on May 1st but, due to assembling of Spiral Case, Phase 2 scheduled to be completed on July 5th 2021 has accumulated some delay.

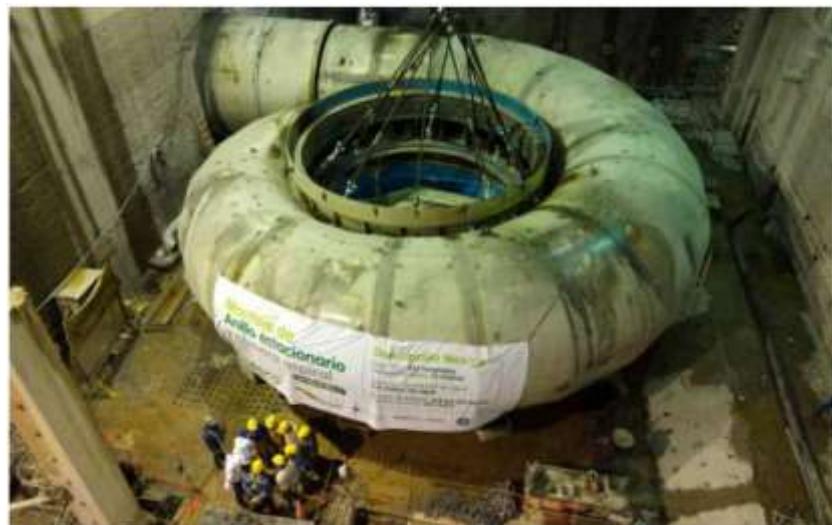
Figure 40: Unit 1 spiral case in place on July 25th

On July 25th, as this Report was being prepared, the IAP was informed that the spiral chamber of Unit 1 had been installed (fig. 40) and that the one of Unit 2 was in the process.

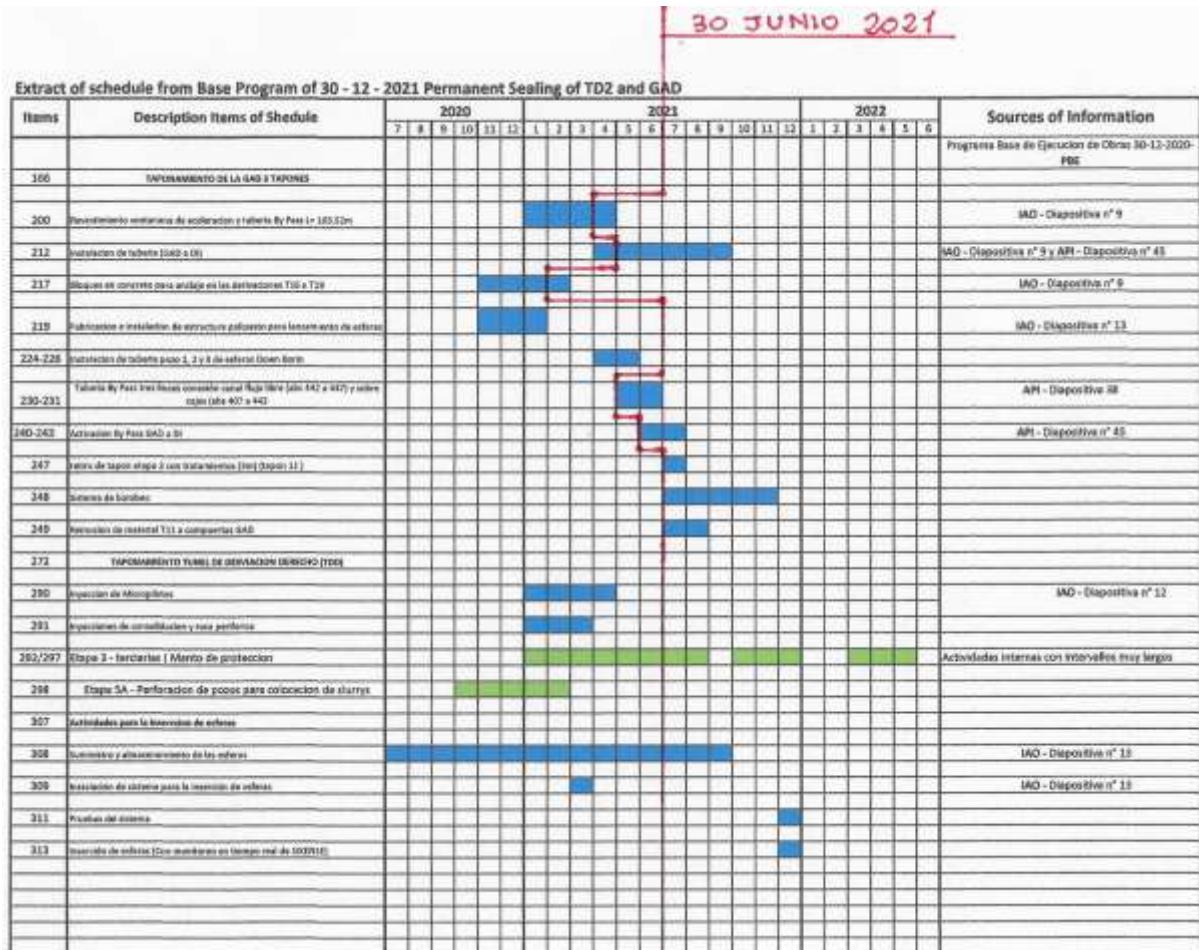
Figure 48: Time Line on 30 June 2021 Permanent Sealing of TD2 and GAD

The Time Line Now in fig. 48 reveals an accumulated delay of 5 months for item 217 (*Bloques en concreto para anclaje en las derivaciones T16 a T19*). Besides, there is evidence of a slow implementation pace of activities 292-297 between May and October 2021, the reasons for which are not evident to the IAP.

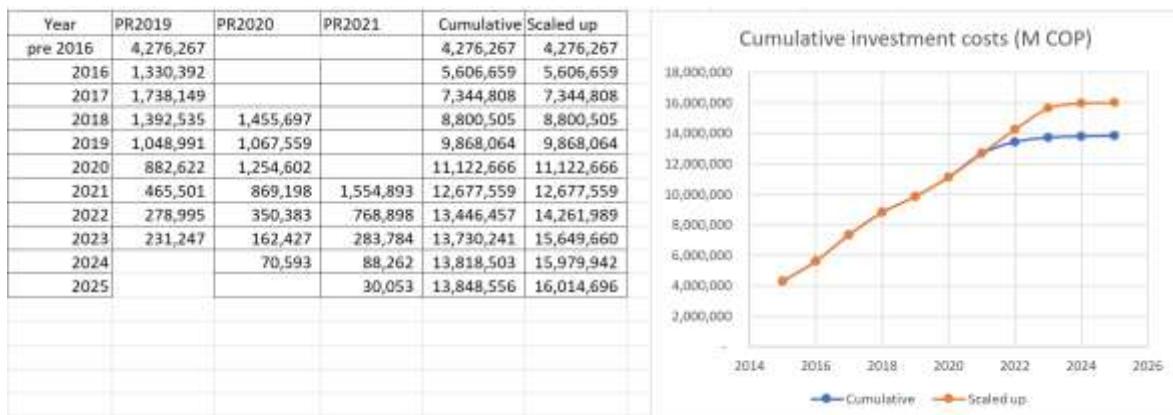
Figure 49: Annual and Cumulated Investment Costs

The orange curve ("scaled up"), with a cumulative investment cost of about 16,000 billion COP, was considered a realistic assessment of the investment costs to Project completion.

During the July 2021 mission, the IAP was informed that EPM's Management was about to decide on a budget increase for the completion of the works. Timing for the decision is based on the advanced understanding of the underground conditions and of the associated remedial works. The IAP understands that the budget increase is in line with the estimate in fig. 49 above.
